**SECOND FIVE-YEAR REVIEW REPORT
FOR
CABOT CARBON/KOPPERS SUPERFUND SITE**

**GAINESVILLE,
ALACHUA COUNTY, FLORIDA
EPA ID: FLD980709356**

April 4, 2006

FIVE-YEAR REVIEW REPORT

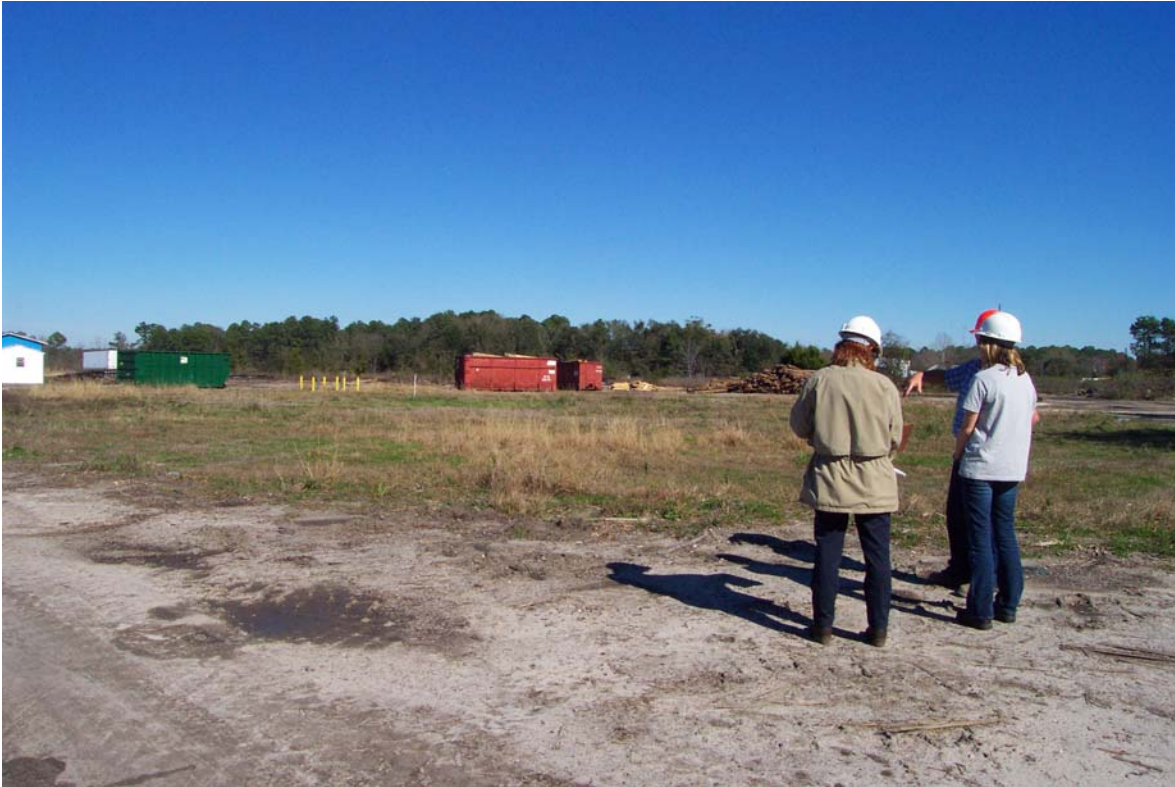
An active wood preserving plant and creosote treated timber storage is on this site. The North Lagoon was visited first. The North Lagoon was filled in years ago. The drip track area was visited next, where a new Floridan well had just been installed. The soil cuttings generated from the drilling of this well had to be transported off site and incinerated, due to the contamination. It was also noted that lighting had recently been installed in this area, with light poles, with the electrical wiring installed below grade. The monitoring wells and extraction wells were observed. The extraction wells have wooden fabricated pump houses. The treatment plant was visited next. Mr. McKinney described the pretreatment process. The drums containing drill cuttings from the ongoing Floridan well installation were also stored in the area of the water treatment plant, with Mr. McKinney in charge of composite sampling, characterization, proper hazard labeling and arranging for proper transport offsite.

PHOTOGRAPH 1. KOPPERS, NORTH LAGOON, FEB 1 2006

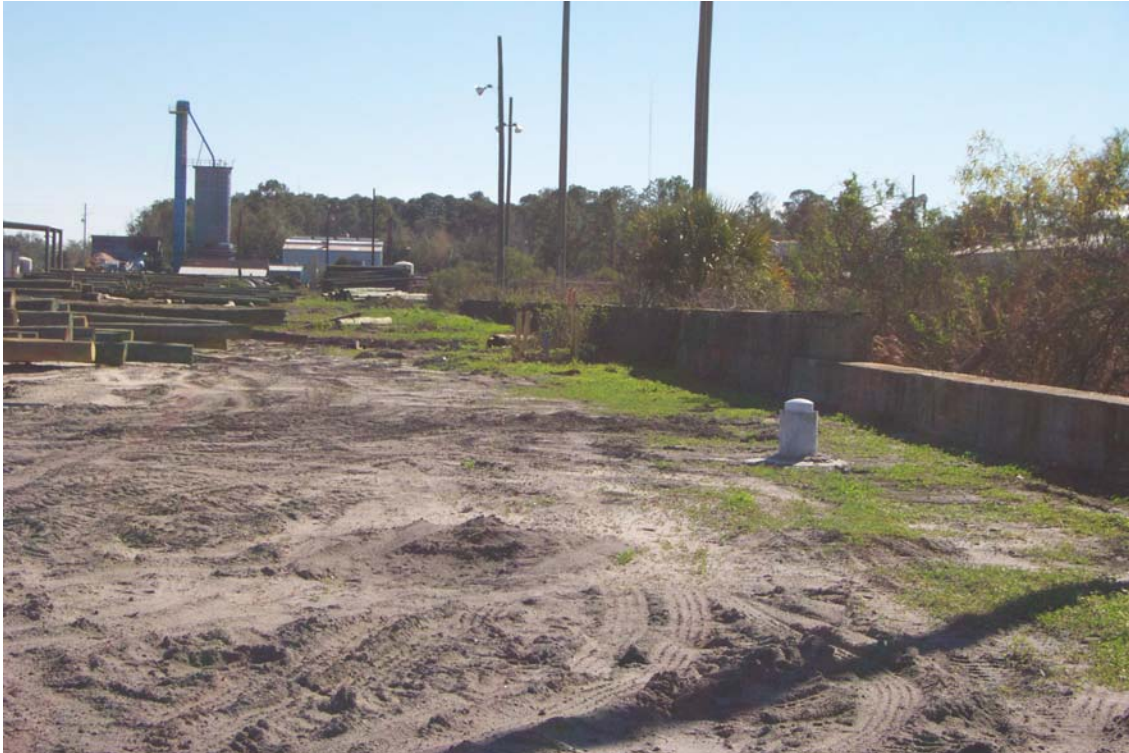
PHOTOGRAPH 10. CLOSE-UP, DRIP TRACK AREA, WITH NEW FLORIDAN WELL, KOPPERS, 1 FEB 06

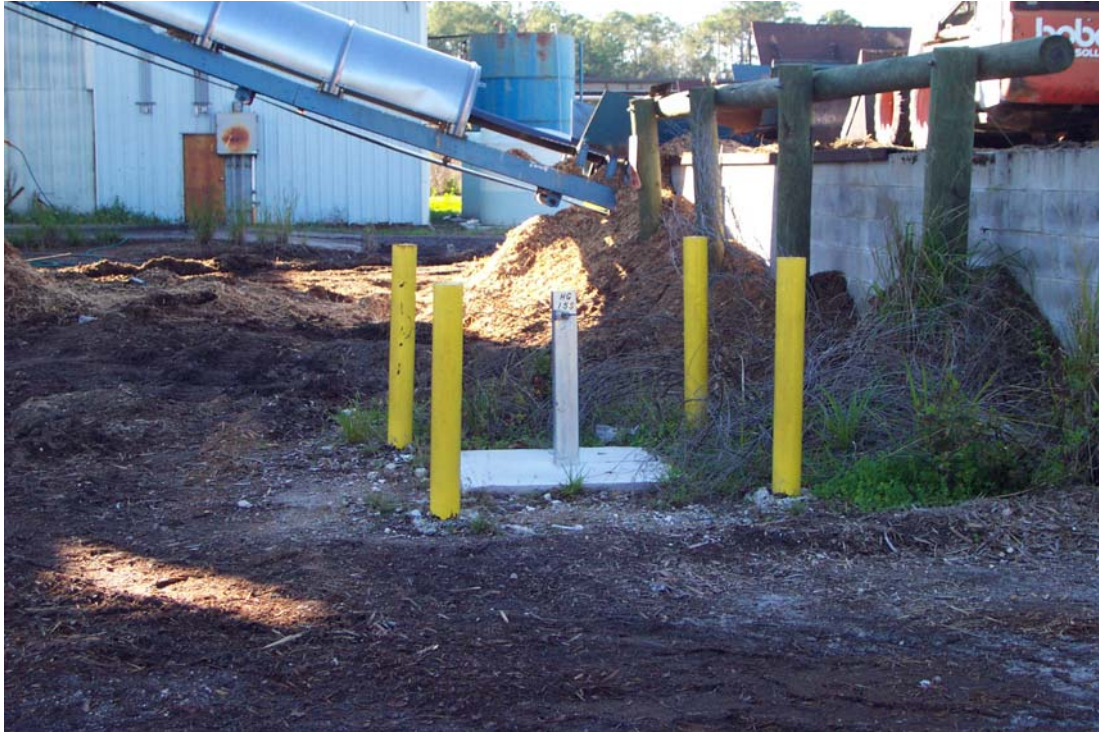
PHOTOGRAPH 12. INTERMEDIATE AQUIFER MONITORING WELL, WITH DNAPL, KOPPERS, 1 FEB 06

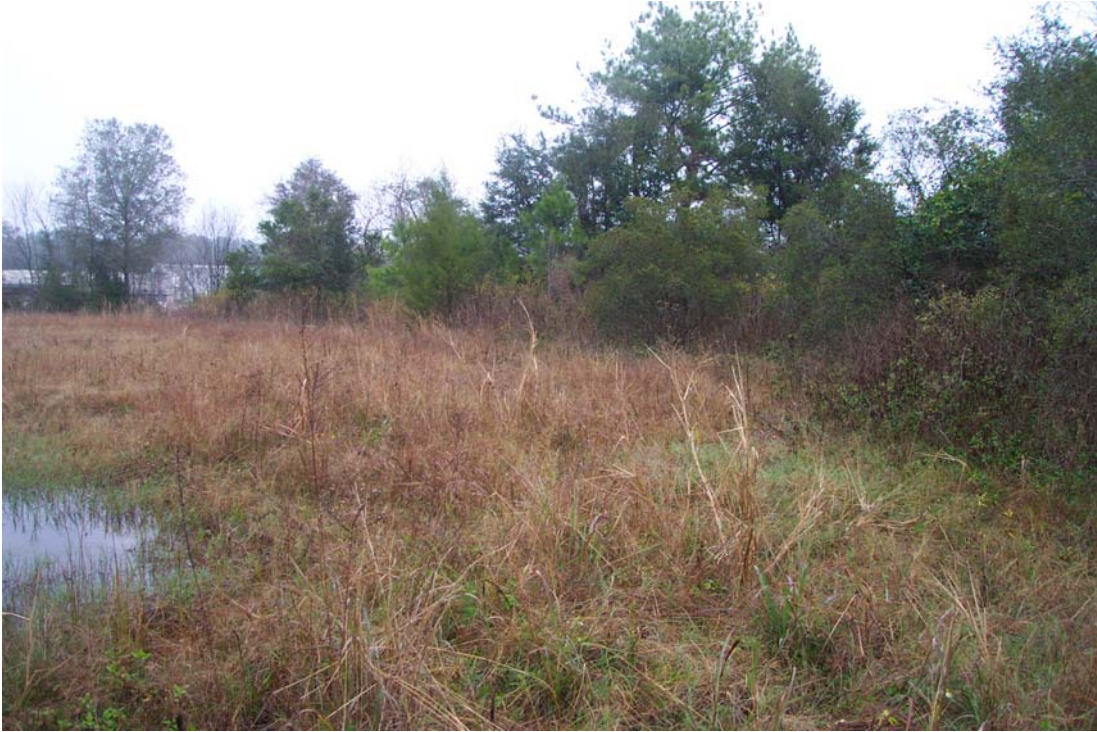
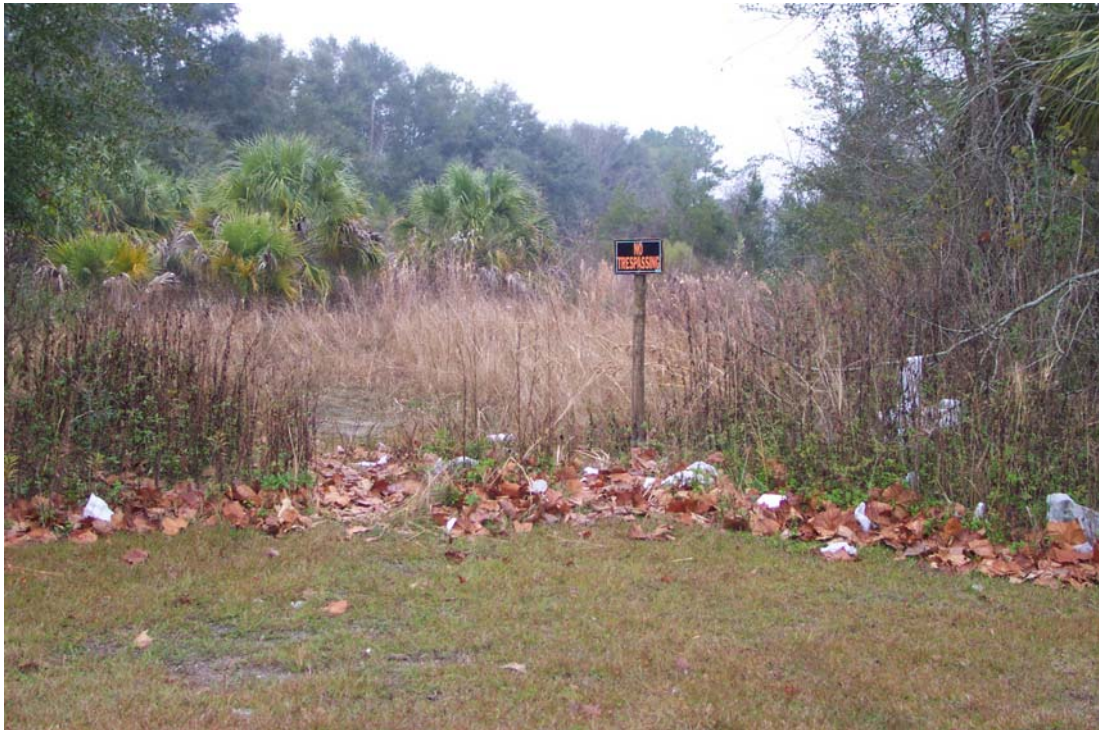
The former Cabot Lagoons area was visited first. A stormwater retention pond covers part of the former lagoon area. No trespassing signs were posted in the area. The trench area and the lift station were inspected next. The lift station structure, the fencing surrounding it, and the sump lids were replaced in January 2005. The lift station is near the Gainesville Dodge Dealership. The general manager met us and mentioned the frequency of the foul odors from the lift station, and the fact that the odors permeate the interior of his dealership. Outcome of the air sampling event in 2005, the recommendation for another air sampling event, and a carbon filter pilot study were also discussed.

**PHOTOGRAPH 14. AREA OF FORMER CABOT LAGOONS,
2 FEB 06**

**PHOTOGRAPH 15. AREA OF FORMER CABOT LAGOONS,
2 FEB 06**

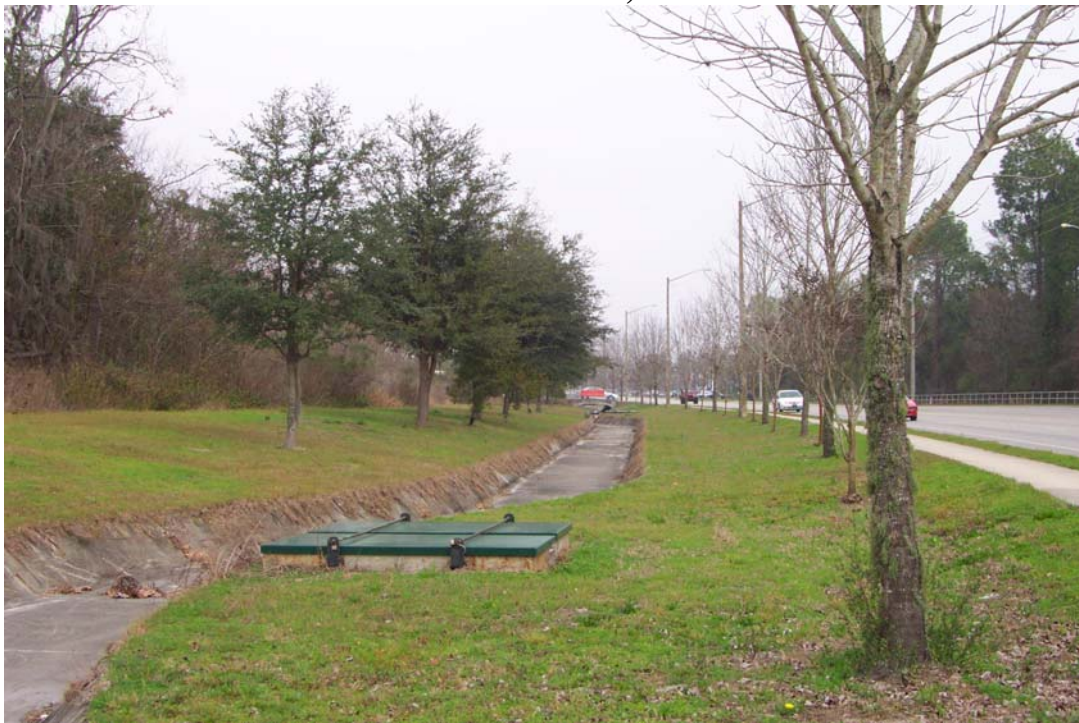
The trench, sump lids, lift station and appurtenances appeared to be in good condition. Erosion along the concrete side slope of the trench and drainpipe near the lift station that were observed and photographed in the last five year review were not observed during this site inspection. Bill

Campbell, site O&M operator, noted these deficiencies have been repaired since the last five-year review. Strong odors inside the lift station, over the grate of the flowing groundwater were noted. Odors near the sumps were also detected.

PHOTOGRAPH 17. SUMP, CABOT TRENCH, 2 FEB 06

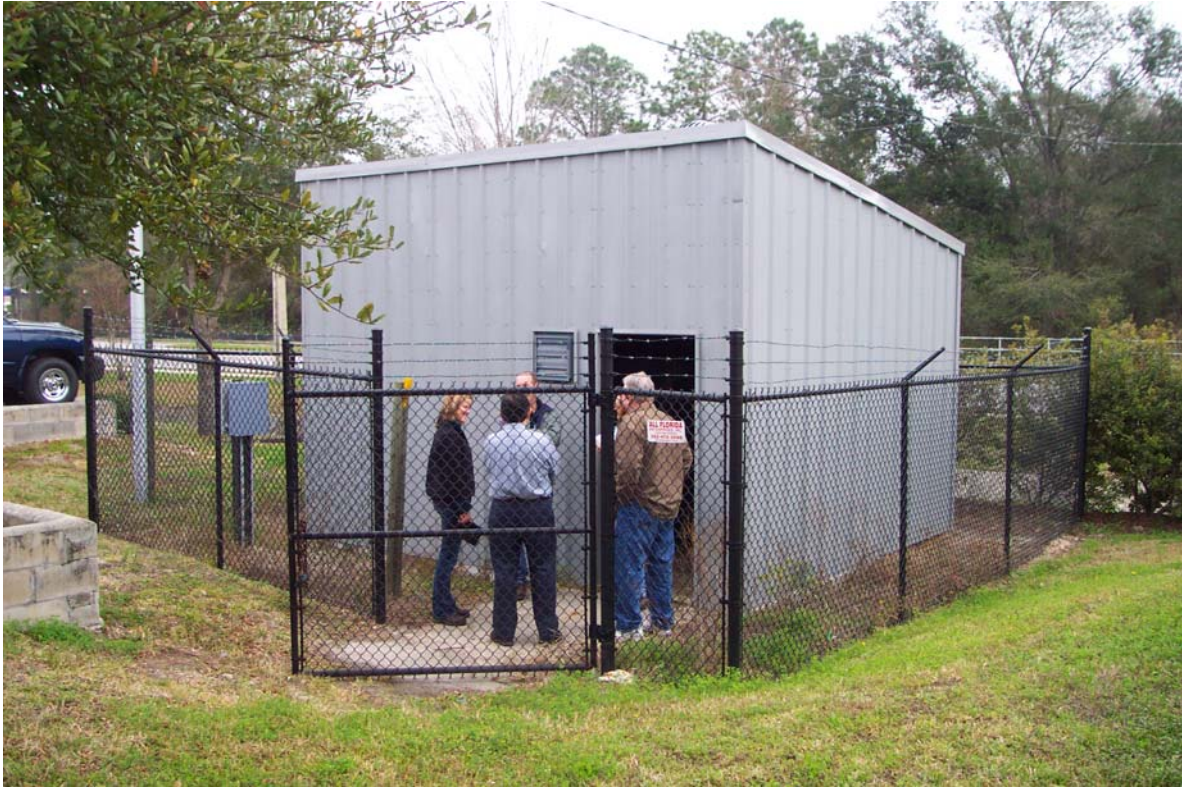
PHOTOGRAPH 18. CABOT LIFT STATION, 2 FEB 06

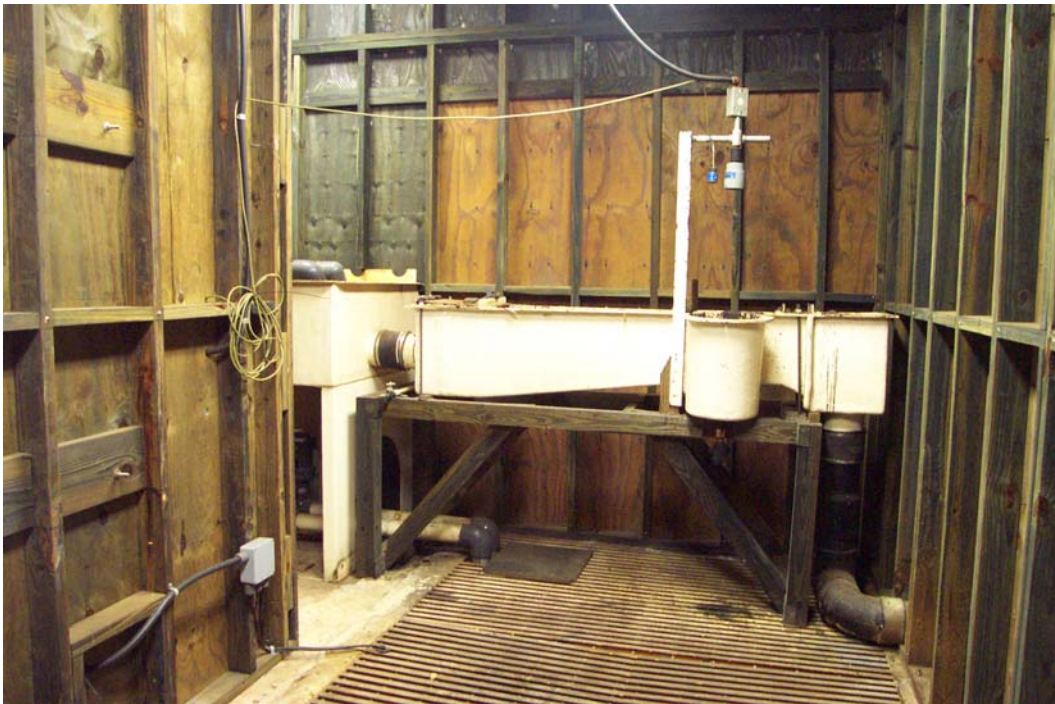
**PHOTOGRAPH 19. INSIDE CABOT LIFT STATION, CABOT
2 FEB 06**

10. Air quality monitoring at Cabot Lift Station and the sumps should continue. Air monitoring should be performed over a period of at least two days during the summer, and seasonally. Data should be evaluated based on health and nuisance effects. Local regulatory agencies should be contacted regarding nuisance ordinances. At the lift station, the air samples should be collected near the vent. The effectiveness of the carbon filters installed to reduce odors emitting from the vent at the lift station should be monitored, with replacement of filters as necessary. Pilot studies to determine optimum treatment options should be considered.

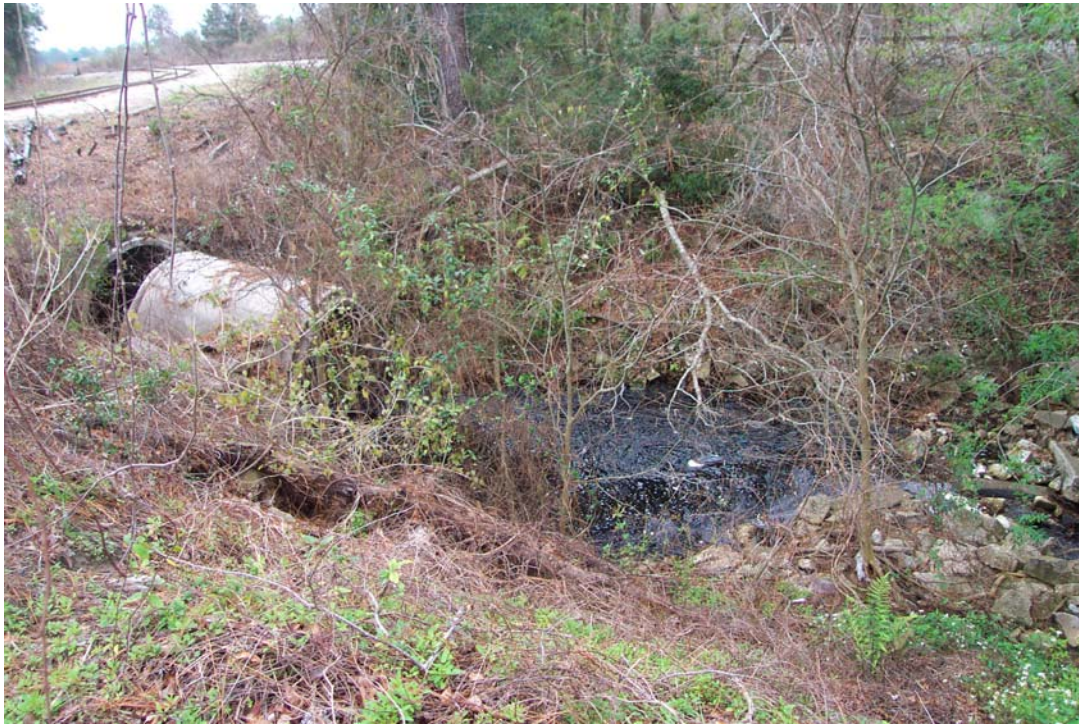
After the Cabot site inspection, Amy McLaughlin left, and John Herbert (GRU consultant) joined the group. John Mousa, Laura Roebuck, Kelsey Helton, and John Herbert traveled to the ditch, northeast and just offsite of Koppers. Faded FDER signage was posted along the ditch. Strong creosote odors were also detected at the bank. However, it was unclear if the odors were emanating from the Koppers property, where stacked creosote timbers were stored, or from the ditch and surface water. Dark, foamy substances in the surface water at the outfall in the ditch were observed.

**PHOTOGRAPH 20. DITCH NE OF KOPPERS NE BOUNDARY,
2 FEB 06**

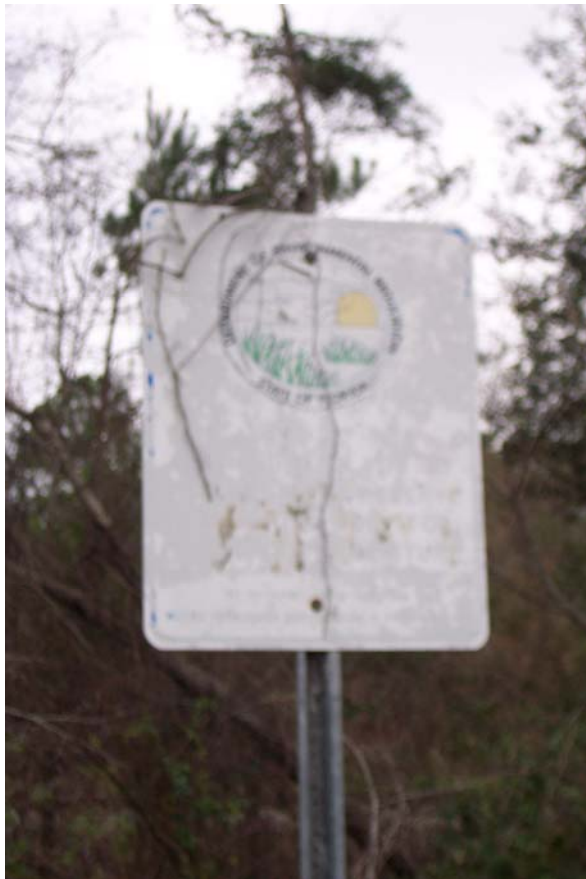
**PHOTOGRAPH 21.
FADED FDEP (FDER)
SIGN NEAR DITCH, NE
OF KOPPERS**
