## 5.1 Introduction

**Figure 5.1** Location of the Calf Pond Creek Watershed in Alachua County

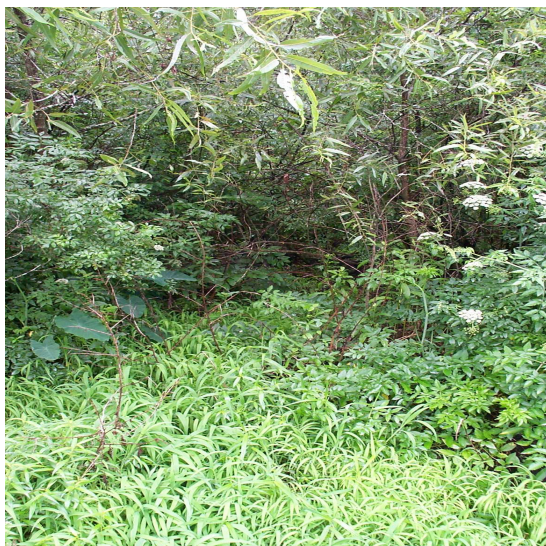
parian zone was fragmented, reducing its quality as a buffer. The creek is intermittent during droughts, primarily due to the small size of the watershed and typical low flows. During low rainfall periods, the creek often consists of disconnected pools of water.

**Calf Pond Creek during the dry season**

Calf Pond Creek is characterized by low flow. While only three flow measurements were made on Calf Pond Creek, the mean flow was 0.40 cfs (Appendix F). This limited dataset provides no indication as to the magnitude of stormflows. It is clear, however, that the stream has intermittent flow, and during low rainfall periods is comprised of disconnected pools of water.
