## 2.1 Introduction

### 2.2 Watershed Description

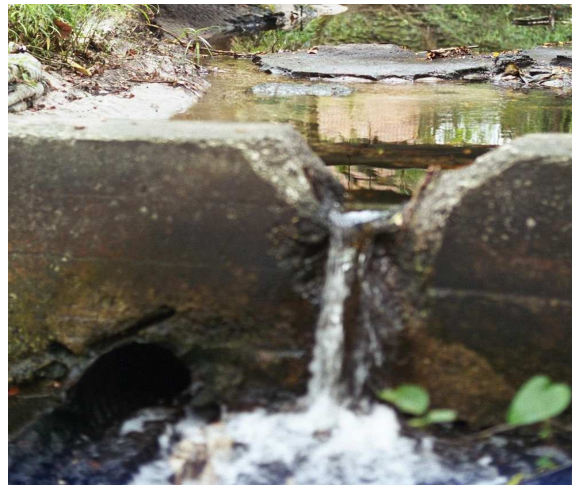
Tumblin Creek flows through the middle of the P.K. Yonge campus. Bank stability is a problem in this area. Two concrete weirs were constructed in the creek in an attempt to direct the majority of flow to the channel's center. These weirs do not appear to solve the problem however, as bank scouring is still obvious. The stream continues flowing southwesterly through a residential and commercial area. The stream channel is deeply incised and the banks are steep. Evidence of bank scouring is common. The creek continues flowing south under SW 16<sup>th</sup> Avenue.

Flow control weir on Tumblin Creek at the P.K. Yonge Developmental Research School

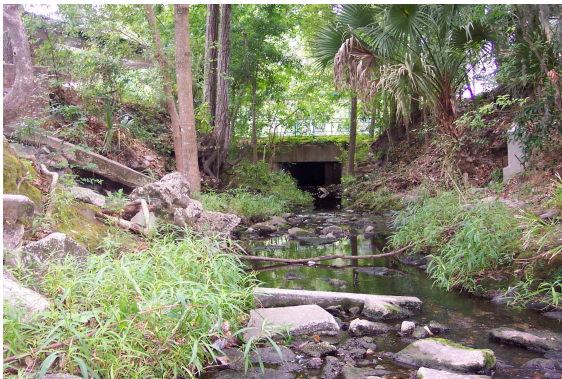
**Concrete rubble in Tumblin Creek at P. K. Yonge School**

locity, lack of a sufficient riparian zone, and poor quality of vegetation in the riparian zone. This site also has concrete rubble in the streambed, implying the Habitat Assessment score might have been even lower if the rubble had not been considered habitat. BioRecon scores were similarly very poor at this site, indicating an impaired status.

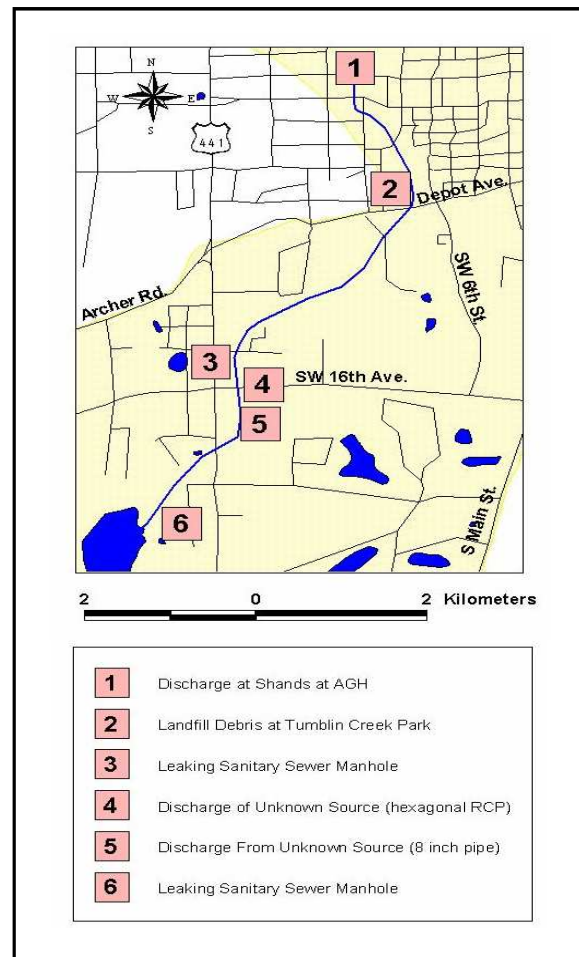
**Figure 2.4 Point source pollution sites along Tumblin Creek**

Several point source discharges to Tumblin Creek were observed throughout the watershed (Figure 2.4). Municipal sewer lines sometimes run under, parallel to, and

across Tumblin Creek in certain segments. Near SW 5<sup>th</sup> Avenue, a sewer line runs below the creek bed and parallel to the channel. It crosses the creek at St. Croix Apartments. At SW 9<sup>th</sup> Street, a lift station is located within 10 feet of the stream. As the channel parallels SW 13<sup>th</sup> Street (US 441), a sewer line runs adjacent to the creek. Finally, west of US 441, several manholes along the south bank indicate the presence of a sewer line running toward the forested floodplain. Most of the sanitary sewage in this area is transported to the Gainesville Regional Utilities (GRU)

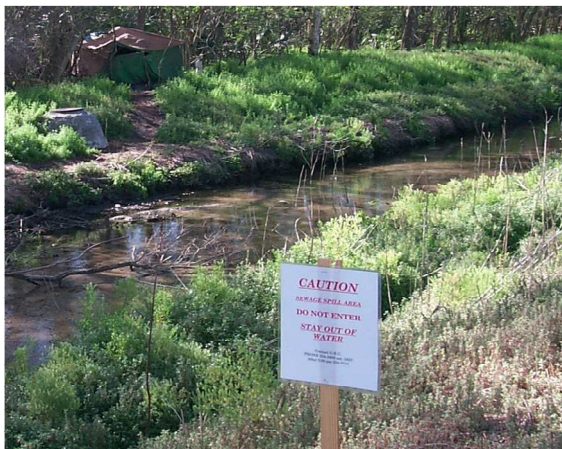
Two GRU sanitary sewer manholes were discovered leaking directly into Tumblin Creek at the time the stream survey was conducted. These leaks were the result of sewage backing up through manholes due to blockages in the lines. The first leaky manhole was located behind Joe's Deli on US 441. The second was found west of US 441, along the dredged channel just upstream of the forested wetland. In both cases, GRU was notified immediately and repairs were made. GRU has recently completed a wastewater collection system integrity testing program in both the Tumblin Creek and Sweetwater Branch Watersheds. This program is part of a larger effort to inspect all of GRU's sewer facilities and perform rehabilitation or repairs as needed to ensure the integrity of the system. The testing program includes smoke testing, dye testing, and closed circuit TV viewing of the insides of the sewer piping to identify potential leaks and damage to the system.

Sign along Tumblin Creek warning of a sewage leak

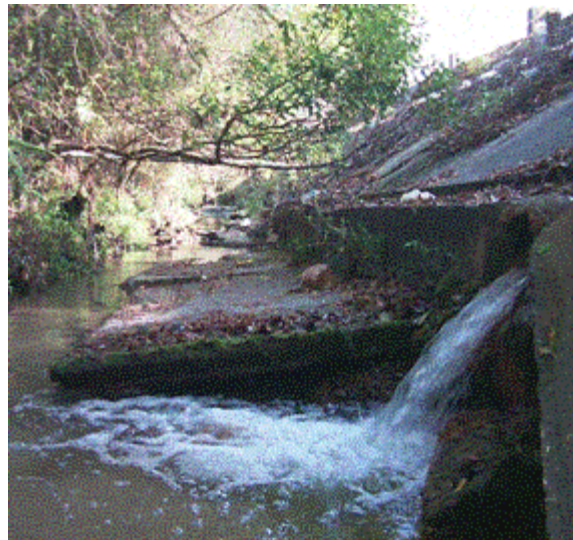
Two continually flowing pipes were also discovered feeding Tumblin Creek during severe drought conditions. Both were located south of SW 16<sup>th</sup> Avenue. The first discharge came from a hexagonal RCP under SW 16<sup>th</sup> Avenue. The source was unknown but the water appeared to be clean. The second discharge was located on the east bank of the creek just south of Pat's Quick Stop parking lot (off of US 441/SW 13<sup>th</sup> Street). The flow from this 8-inch pipe almost doubled the flow in Tumblin Creek, with water constantly flowing out at a high velocity. ACEPD collected a water sample for analysis. The water quality was representative of water from

Continually flowing discharge into Tumblin Creek near the parking lot off of SW 16th Avenue

the Floridan aquifer. The discharge was later determined to be cooling water from a heating and cooling system at Park 16 Apartments. The discharge, estimated to be over 1.0 MGD, ceased in April 2002 when the apartment complex installed a new heating and cooling system.

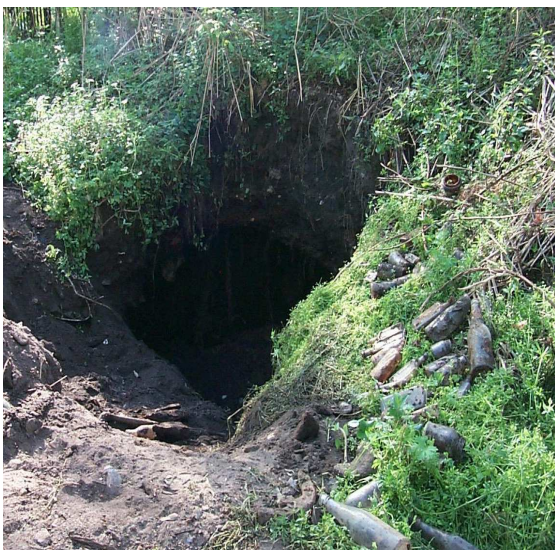
In Tumblin Creek Park, the stream has eroded the banks, exposing landfill debris including glass, brick material, and pottery pieces. Several deep holes along the east bank are evidence of the bottle looting that takes place here.

Evidence of bottle looters at Tumblin Creek Park

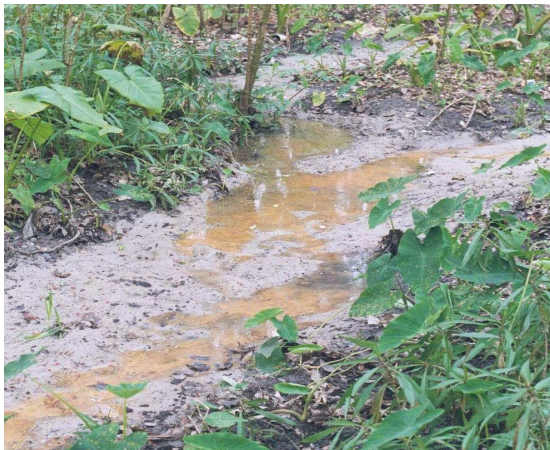
Aquatic vegetation, both submergent and emergent, is practically non-existent through-out Tumblin Creek. The exception is the Bivens Arm forested wetland which, in some places, is covered with the native wetland emergent plant golden club (*Orontium aquaticum*). However, there is also a large amount of exotic vegetation present in this reach.

Exotic vegetation in the Bivens Arm forested wetland

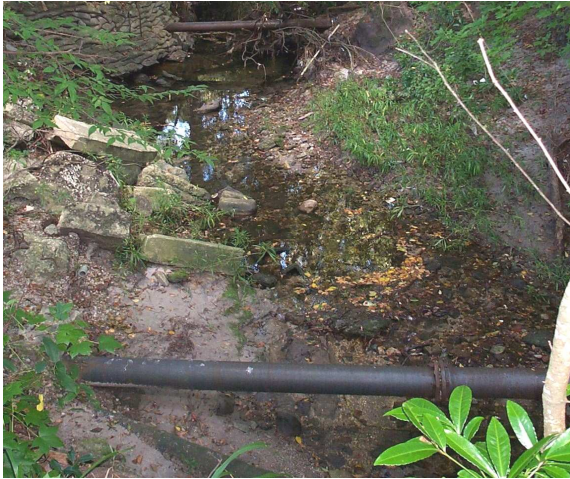
The concrete-lined channel, in the stream segment between SW 16<sup>th</sup> Avenue and US 441 was installed in 1969 to increase the flow of water under US 441, with the intent to curb flooding problems (Rankeillor 2000). However, this also increased water velocity upstream of the channel, leading to severe vertical streambed erosion. Downstream of the P.K. Yonge School, the streambed has been eroded approximately 5 feet since the concrete channel was installed at US 441 (Simons 1999). Sewer and gas lines, set several feet under the

**Sanitary sewer and gas lines that were originally laid below the streambed of Tumblin Creek**

streambed, now lie two to three feet above the bed. Under current conditions, the streambed will continue to erode.

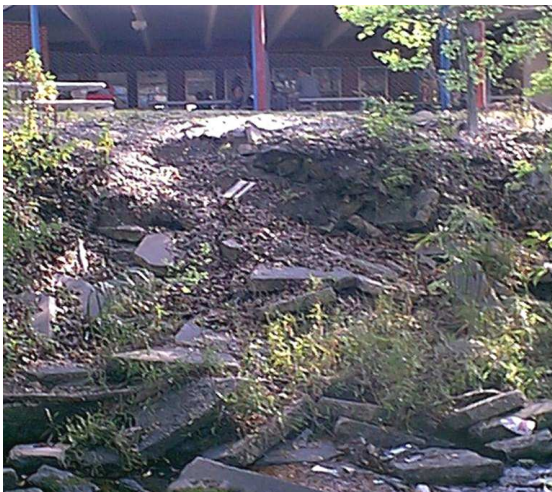
The increase in stream velocity is most destructive during rain events. Fragile banks are scoured, sending more sediment downstream. Scouring results in a stream channel that is constantly widening and deepening in some areas. Officials at the P.K. Yonge School have been addressing this problem as the creek bisects the campus. Two weirs were constructed in an attempt to concentrate flow to the middle of the chan-

**Tumblin Creek bank failure at PK Yonge School**

nel and minimize bank scouring. Concrete debris has been placed along the banks to increase stability. Despite these efforts, the banks continue to erode. Presently, there are concerns about the long-term structural stability of some of the buildings adjacent to the creek.

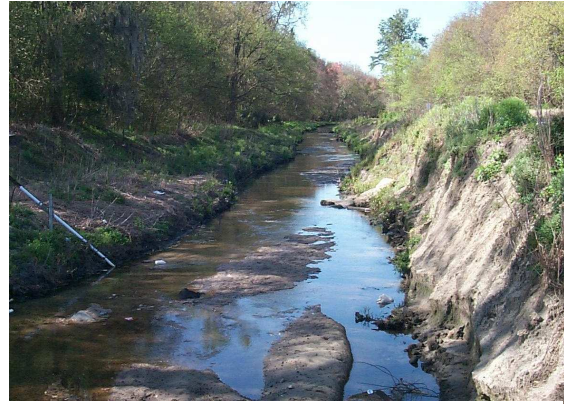
Sediment eroded from the streambed and banks during storm events turns the water gray. This increased turbidity affects light penetration, impairs fish spawning, and clogs gills of fish and aquatic invertebrates. The sediment is carried downstream and deposited in the dredged channel west of US 441 and in the Bivens Arm floodplain. Sand deposition in these areas can reach depths greater than three feet. Habitat for benthic macroinvertebrates is smothered, and the soft sand bottom is incapable of supporting rooted vegetation.

**Sand deposition in the dredged channel of Tumblin Creek west of US 441**
