9.1 Introduction

9.2 Watershed Description

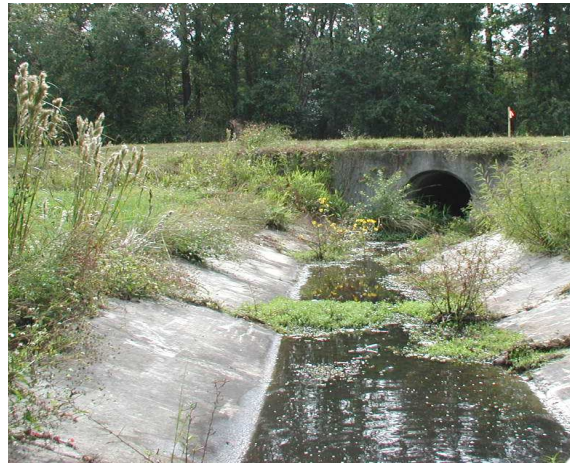
Hogtown Creek flowing in a concrete channel near NW 53rd Avenue

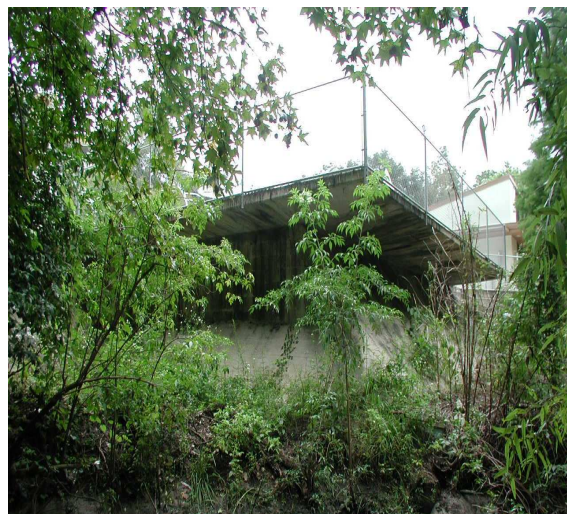
Serious erosion along Hogtown Creek

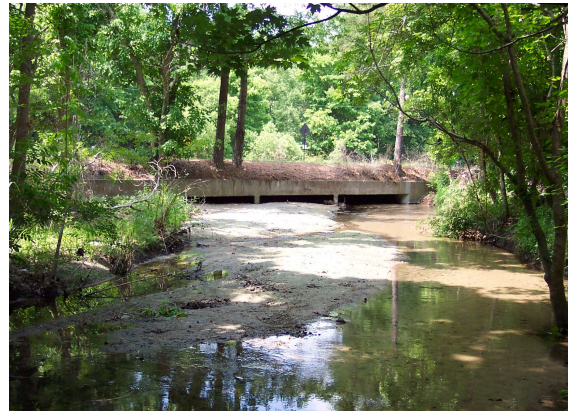
Hogtown Creek passes under NW 8th Avenue through a concrete box culvert. Sand constantly fills this culvert and causes flooding problems at upstream residences. Removal of the accumulated sediment has been a costly ongoing project for the City of Gainesville Public Works Department. Possum Creek joins Hogtown Creek downstream of the 8th Avenue culvert. This area of forested floodplain consists of many residences from the Black Pines and Central Park subdivisions, and in some instances residential backyards extend to the center line of the creek.

Sand filled culvert on Hogtown Creek at NW 8th Ave

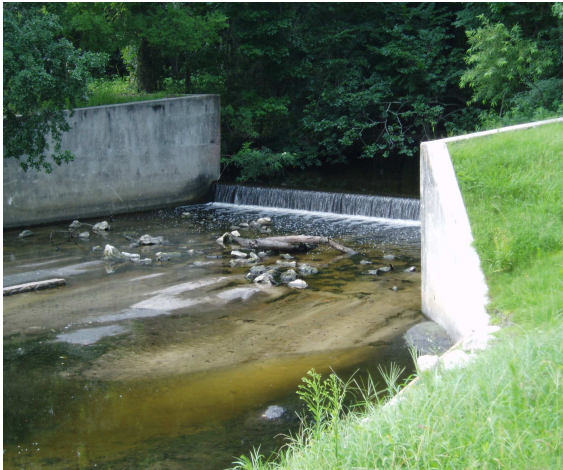
In the vicinity of the weir, bank erosion remains severe, with numerous trees either leaning over or having fallen into the streambed. Banks are tall, vertical, and deeply undercut. Although riparian zone widths are adequate, the banks are not vegetated. The creek is flanked by resi-

Weir on Hogtown Creek at NW 34th Street

dential housing and commercial establishments. Sand smothering is heavy upstream of the weir, as numerous sandbars were observed.

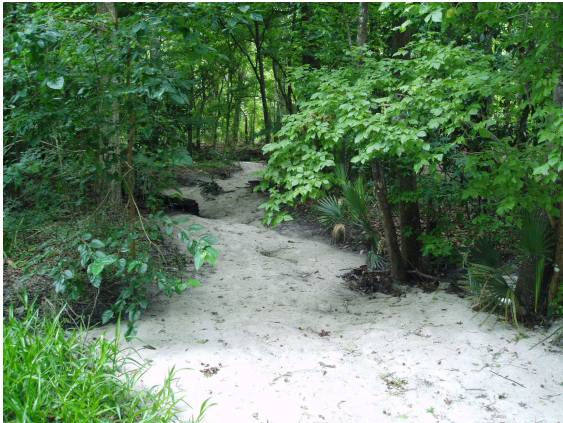
Severe sand deposition in Hogtown Creek floodplain north of 8th Avenue

lower reaches. Deposited sediment mobilizes during storm events and drops out further downstream. Without a stable substrate, in-stream aquatic vegetation is largely non-existent. Sand smothering of the streambed is common, occurring even in the natural, forested areas of the watershed.

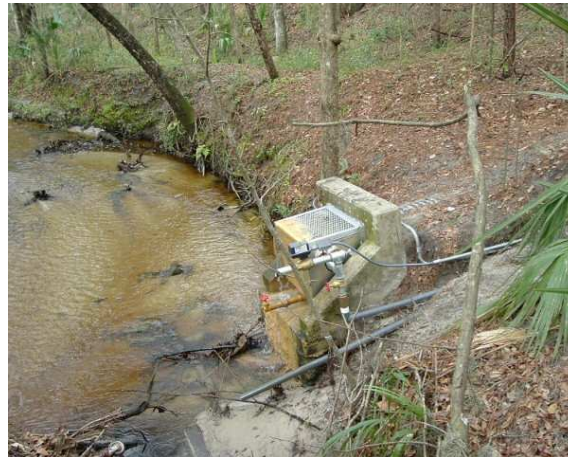
In November 2001, petroleum constituents (benzene, ethylbenzene, and naphthalene) were detected entering Hogtown Creek through the stormwater system behind the Gainesville Mall on NW 13th Street (ACEPD 2001b). The contaminated water was discharging to the creek through a 30-inch corrugated metal pipe (CMP) culvert that drains groundwater beneath the south

Hogtown Creek petroleum remediation site on the west side of the Gainesville Mall

end of the mall parking lot. The Florida Department of Environmental Protection (FDEP) made this a priority site, and in December 2001 OHM Remediation Services Corp. began conducting soil and water sampling to identify the source of the contaminants. A system was designed to treat the contaminated water prior to its discharge to Hogtown Creek. The treatment system was activated March 1, 2004. The identification of the sources of the contaminants continues. There are a number of facilities in the area that currently or historically stored underground fuel.

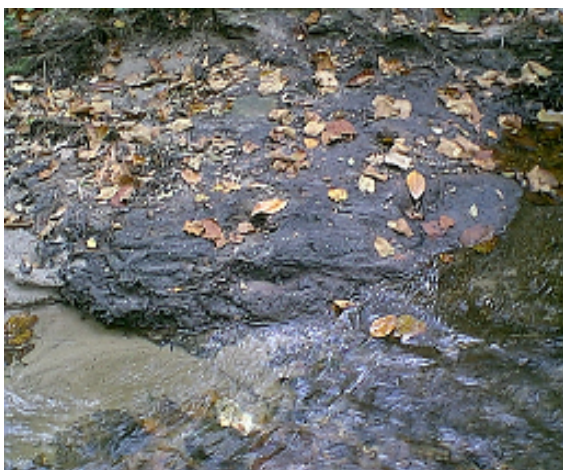
Since 1994, the ACEPD has received a number of complaints regarding the presence of contaminated sediments in the form of “tar-like” materials in Springstead and Hogtown creeks. ACEPD personnel have collected samples and have had laboratory analyses conducted for volatile organic compounds (VOCs), semi-volatile organic compounds (SVOCs), and selected metals. Analytical results showed the presence of compounds including ethylbenzene, toluene, xylenes, ace-

In February 2000, FDEP staff reported data from Springstead Creek sediment analyses that showed five constituents that violate leachability criteria (62-777 FAC), ethylbenzene, naphthalene, toluene, 1,2,4-trimethylbenzene, and xylenes. In October 2000, ACEPD staff located a sump in the Hogtown Creek floodplain on property previously owned by Guy Cleveland. This sump was used in the 1960's to collect discharges that resulted from breaching the dikes of impoundments on the former Cabot portion of the Cabot/Koppers property. The materials in the sump contained constituents similar to the “tar-like” material found in the creeks.

Sediments in Springstead Creek from nearby Cabot/Koppers Site

The ACEPD recommended to the U.S. Environmental Protection Agency (EPA) that sediment assessment and removal efforts be conducted at Springstead and Hogtown creeks. The ACEPD is confident that this work can be performed with minimal disturbance to the creek. Addi-

tionally, the ACEPD requested the following; (1) that contaminated sediment removal activities be conducted in a manner that minimizes disturbance of the natural ecosystems of Springstead and Hogtown creeks, (2) that a sump reportedly dug in the vicinity of the City of Gainesville Public Works Compound on Springstead Creek be located and assessed, and (3) that any contaminated materials remaining in the former sumps be assessed and either removed or remediated.

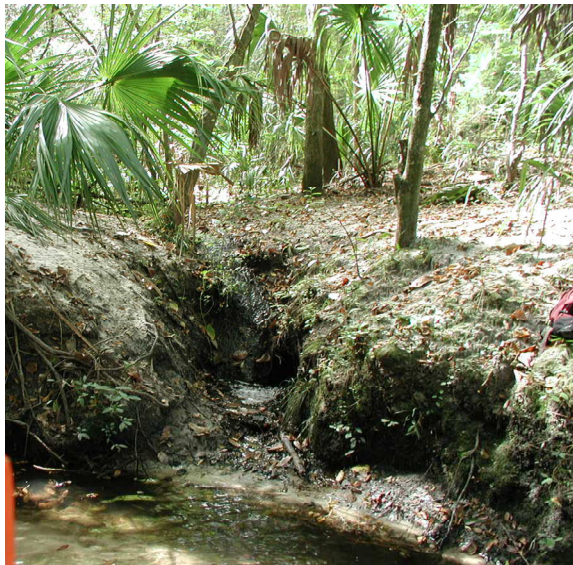
Failing banks and exposed tree roots are common. Erosion problems in the tributaries, including Springstead Creek, compound the severity of sedimentation in Hogtown Creek. The integrity of home foundations and other structures located along Springstead Creek east of NW 6th Street is threatened by bank instability.

Evidence of stormwater erosion along Hogtown Creek

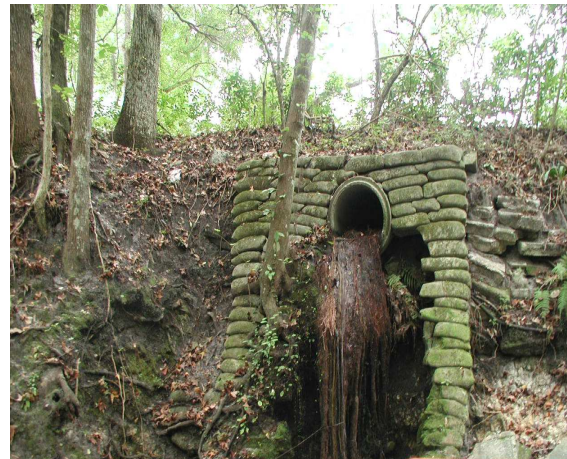
Eroded banks near a stormwater inflow
