### 3.1 Introduction

**3.2 Water Quality**

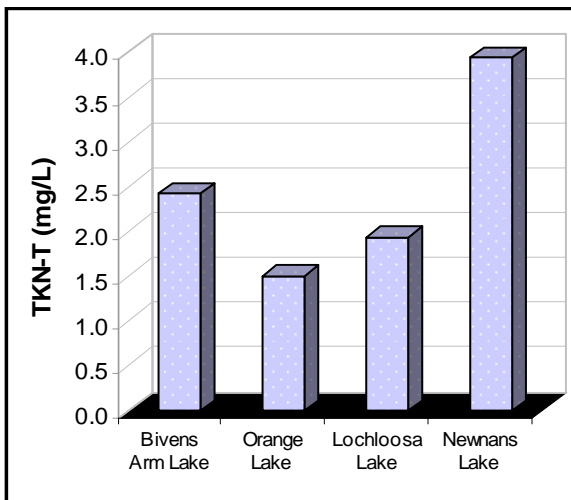
Figure 3.3 Median Total Kjeldahl Nitrogen (TKN-T) concentrations in Bivens Arm and surrounding lakes in the Orange Creek Basin

Table 3.1 displays median water quality data for Bivens Arm. Generally speaking, water quality in Bivens Arm is similar to other large lakes in the Orange Creek Basin (OCB). The median Total Kjeldahl Nitrogen (TKN-T) concentration in Bivens Arm, 2.160 mg/L, falls between median values for Orange and Newnans lakes, 1.501 mg/L and 3.947 mg/L respectively (Figure 3.3).

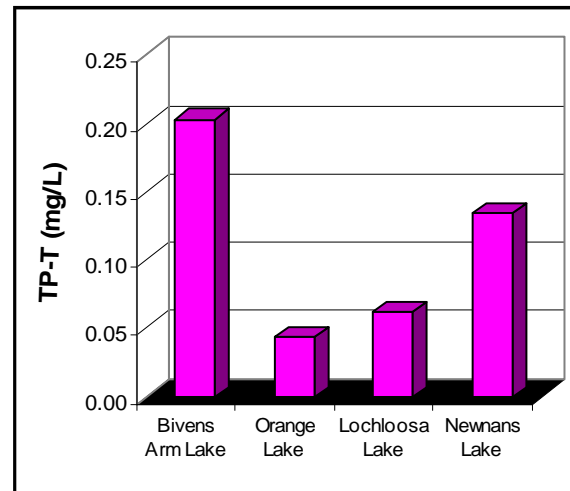
Figure 3.4 Median total phosphorus (TP-T) concentrations in Bivens Arm and surrounding lakes in the Orange Creek Basin

The median total phosphorous (TP-T) concentration in Bivens Arm at 0.181 mg/L, however, is higher than all the other large lakes in the Orange Creek Basin (Figure 3.4). The median chlorophyll a (corrected) concentration (56.23 µg/L) is mid-range among the other OCB lakes, with concentrations indicative of hypereutrophic conditions (Figure 3.5). High total phosphorous and TKN-T levels are likely caused by the nutrient inputs from Tumbling Creek and resuspension of nutrients deposited in the sediments as plants die and decay. Once these nutrients enter the lake, the longer retention times allow the nutrients to be utilized by algae and macrophytes.

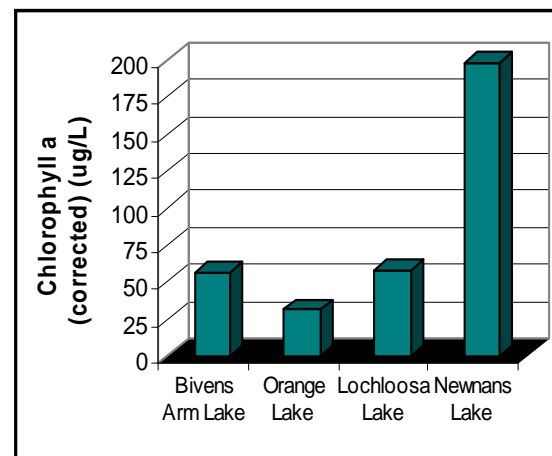
Figure 3.5 Median chlorophyll a (corrected) concentrations in Bivens Arm and surrounding lakes in the Orange Creek Basin

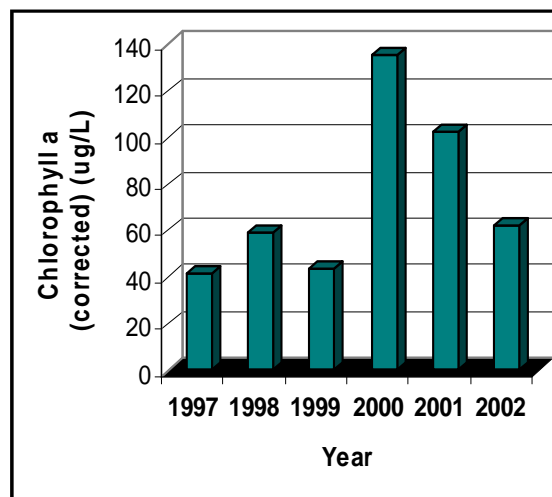
Figure 3.6 Chlorophyll a (corrected) concentrations in Bivens Arm Lake before and after the introduction of Grass Carp

Hydrilla (*Hydrilla verticillata*) was introduced to Florida in the 1950's and has become a major aquatic weed problem in many waterbodies in the state. Several strategies for control have been implemented in Bivens Arm. In the spring of 1999, Alachua County released 2,500 triploid grass carp (*Ctenopharyngodon idella*) into Bivens Arm to manage the hydrilla that was overtaking the lake. The management plan specified the addition of grass carp in combination with periodic spraying of the herbicide Aquathol®-K to reduce the levels of hydrilla. By summer 2000, the grass carp had cleared the hydrilla from all but the shallow bank areas of the lake. The grass carp were so successful in the summer of 2000 that there was no additional spraying of Aquathol® -K. This change in vegetation is reflected in water quality changes. After the removal of the hydrilla, algae became the dominant open-water plant species, turning the water a green color. This switch in primary productivity is reflected in a dramatic rise in chlorophyll a (corrected) concentrations in Bivens Arm Lake in 2000 (Figure 3.6).
