7.1 Introduction

Chapter 7: Little Hatchet Creek

June 2007

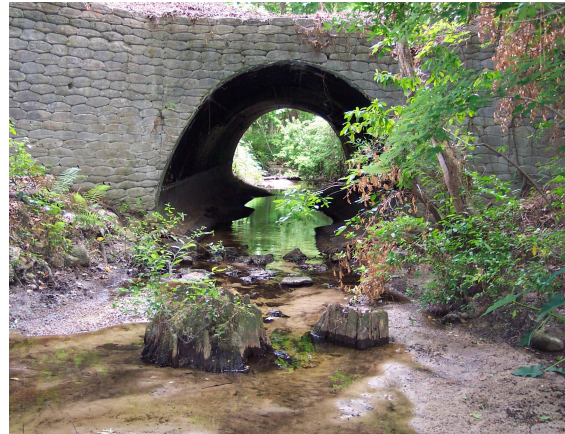
North branch of Little Hatchet upstream of culvert

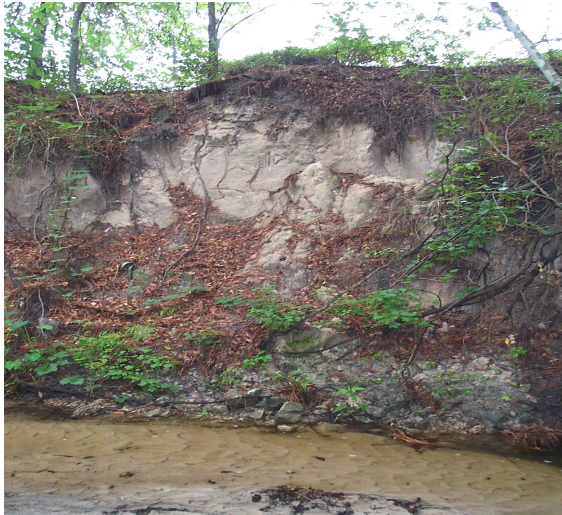
Severely eroded bank along Little Hatchet Creek near the airport

From Brittany Estates, Little Hatchet Creek flows east under Waldo Road via a large 72-inch reinforced concrete pipe (RCP) and continues through the Airport Industrial Park. This area of Little Hatchet Creek is heavily sand smothered, streambed erosion is moderate with some scouring observed, and banks are moderately unstable. Little Hatchet Creek continues through airport property where severe streambed erosion is evident. Banks here are high (13 to 20 feet), steep, and unstable with a scoured streambed of exposed sandy clay. These characteristics are most likely due to the large volume of runoff contributed by the airport runways.

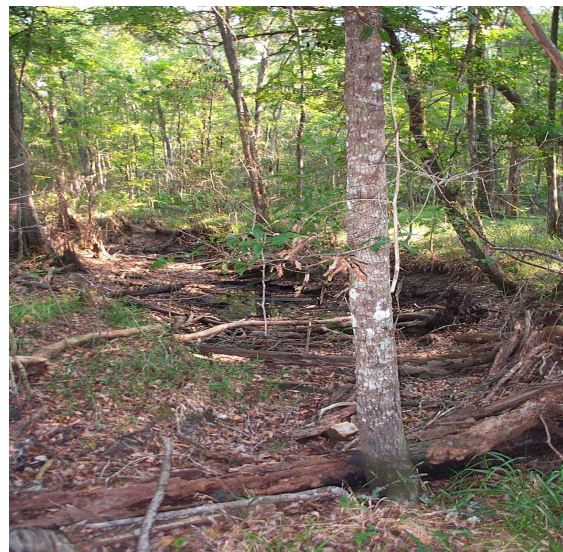
Little Hatchet Creek dry streambed near SR 26

tently dry for several months during the dry season. South of SR 26, the stream flows through a straight, dredged channel for approximately 300 feet before continuing through a forested wetland and into Newnans Lake.

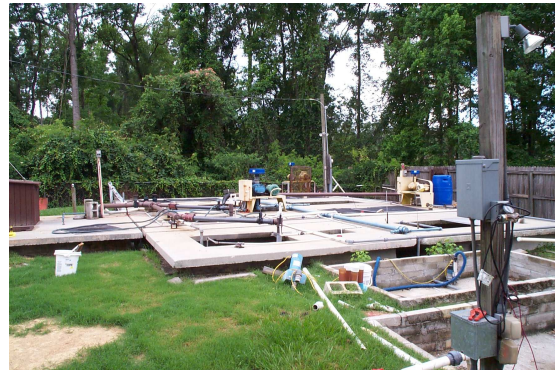
Brittany Estates wastewater treatment package plant

the facility and by the ACEPD often show elevated concentrations of nutrients in the reclaimed water. Total phosphorus (TP-T) in the Brittany Estates reclaimed water, sampled by the ACEPD from 1999 through March 2002, ranged from 0.15 mg/L to 4.04 mg/L with a median value of 2.08 mg/L. Total nitrate plus nitrite (NO_x-T) concentrations during the same time period ranged from 0.035 mg/L to 11.8 mg/L with a median of 0.64 mg/L. Figure 7.3 compares median values of TP-T and NO_x in Brittany Estates reclaimed water to three sites on Little Hatchet Creek.

- Investigate the need and feasibility for nutrient removal at the Brittany Estates wastewater package plant to reduce the nutrient load entering the North Branch of Little Hatchet Creek

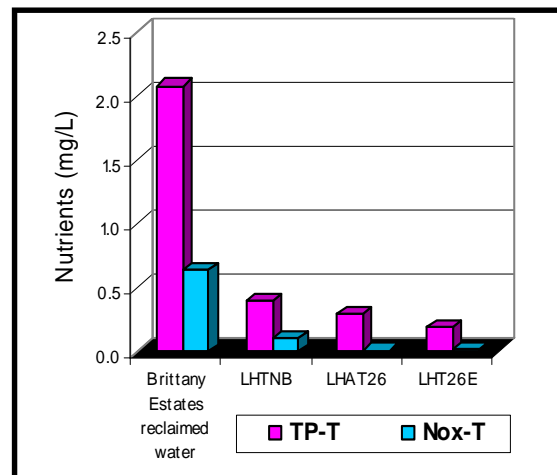
Figure 7.3 Comparison of nutrients in Brittany Estates reclaimed water with stream sites on Little Hatchet Creek

About 10% of the median flow of the North Branch of Little Hatchet Creek (LHTNB) is made up of the Brittany Estates reclaimed water based on the plant's 0.06 MGD discharge. The nutrients in the reclaimed water, however, comprise approximately 52% of the total phosphorus (TP-T) load and 60% of the NO_x-T load.

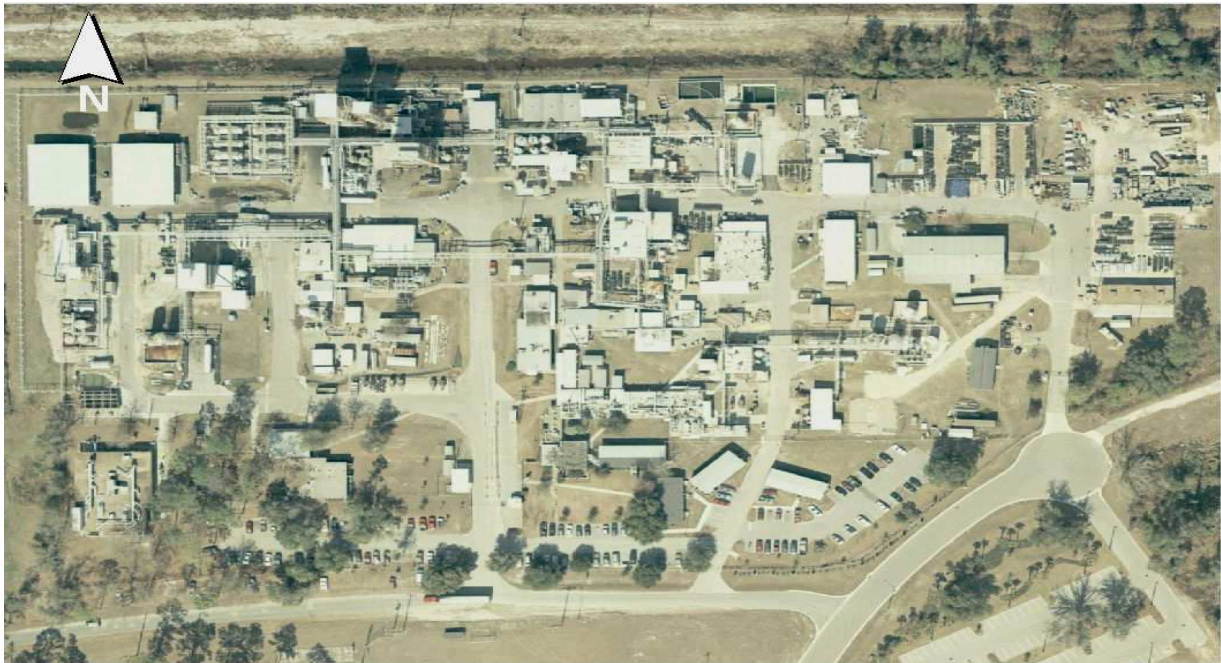
Aerial photograph of Clariant, Inc.

The Airport Industrial Park, located east of Waldo Road and north of the Gainesville Regional Airport, houses several facilities regulated by the Alachua County Hazardous Materials Management Code, all of which have the potential to contribute point source pollution to the watershed. Clariant Inc., formerly PCR Inc., manufactures specialty organic chemicals. Numerous chemical releases have occurred here in the past, and widespread contamination of the surficial aquifer at the site was detected in 1984. A remedial action plan for ground water cleanup began in 1999 (Bird 2000). Historical op-

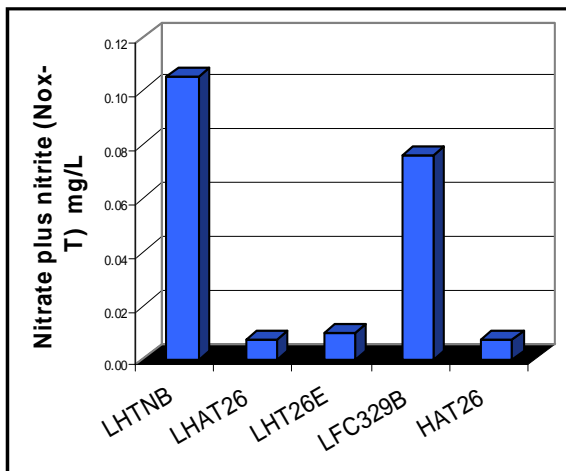
Figure 7.5 Comparison of median total nitrate plus nitrite (NO_x-T) concentrations during baseflow for streams in the Newnans Lake Watershed

Median total nitrate plus nitrite (NO_x-T) concentrations in the North Branch of Little Hatchet Creek (LHTNB) are considerably higher (Figure 7.5) than sites further downstream; however, this value is slightly lower when compared to the more urbanized creeks. LHTNB receives inputs of NO_x from the Brittany Estates reclaimed water, which makes up about 60% of the load in the North Branch. The North Branch also receives runoff from

Ironwood Golf Course and the airport industrial park, which are likely additional sources of NO_x. Like orthophosphate, NO_x-T levels decrease as Little Hatchet Creek flows through Gum Root Swamp.

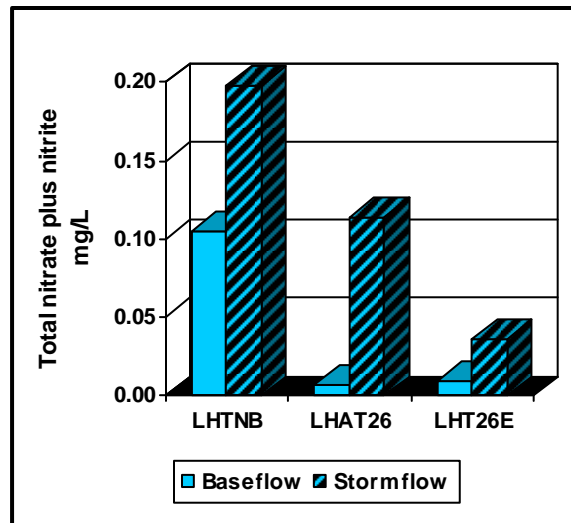
Figure 7.7 Increase in median total nitrate plus nitrite (NO_x-T) concentrations during stormflow at streams in the Newnans Lake Watershed

Increases in NO_x-T were greater than 200% during stormflow (Figure 7.7). The East Branch showed a 260% increase in NO_x-T (from a median baseflow value of 0.010 mg/L to 0.036 mg/L), while the West Branch showed a 1,521% increase (from a median baseflow value of 0.007 mg/L to 0.114 mg/L). Hatchet Creek, also in the Newnans Lake Watershed, showed a 329% increase.

The significant increase in NO_x-T concentrations during stormflow conditions in streams flowing through forested wetlands can be difficult to qualify as it influenced by several factors. First, runoff from agricultural and residential areas have the potential to contain NO_x from fertilizer application. Second, NO_x is present in rainfall due to naturally occurring atmospheric deposition. Additionally, NO_x-T levels can fluctuate in streams flowing through

forested wetlands as the amount of oxygen within the water changes. Under aerobic conditions, which may occur during stormflow, ammonia is converted to NO_x by bacteria. Under anaerobic conditions which occur more often during baseflow, NO_x is converted to ammonia, thus decreasing NO_x-T levels while increasing ammonia levels. In summary, it

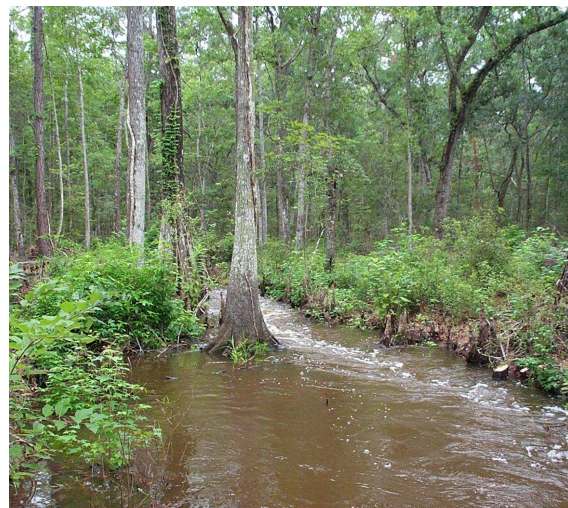
Stormflow on Little Hatchet Creek West Branch (LHAT26)

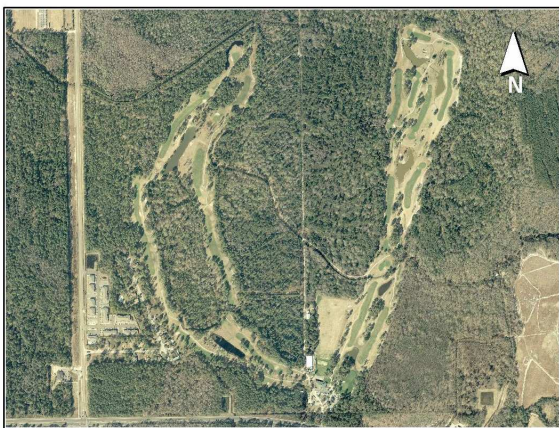
Ironwood Golf Course

The predominant source of nonpoint pollution in the Little Hatchet Creek Watershed is untreated stormwater runoff which includes runoff from the Ironwood Golf Course and from the large number of automotive businesses located in close proximity to the creek. Runoff from the golf course has the potential to contribute nutrients and chemicals from fertilizers, herbicides, and pesticides used to maintain the turf. The Ironwood Tributary serves as a

drainage canal with approximately one half of its total length devoid of a natural vegetative riparian buffer zone. In addition, the golf course extends to the banks of the tributary in many sections, thereby further facilitating pollutant runoff.

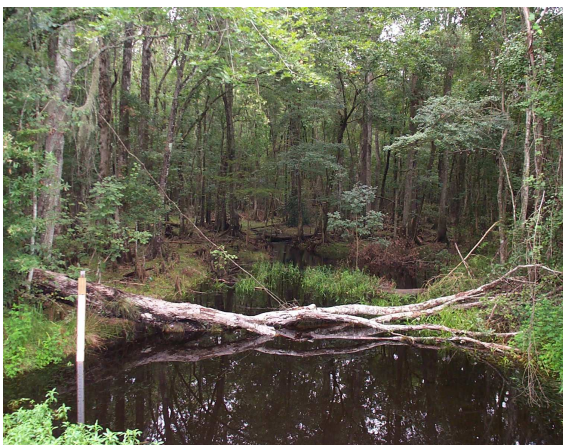
Little Hatchet Creek East Branch (LHT26E)

Further downstream in the watershed, ACEPD collected monthly flow measurements on both the West and East branches of Little Hatchet Creek. The mean streamflow for the West Branch (LHAT26) was 1.13 cfs; however, only 11 measurements were collected. The maximum flow measured by ACEPD at LHAT26 was 6.3 cfs. The mean streamflow on the East Branch (LHT26E) was 4.00 cfs with 30 monthly measurements. The maximum flow measured here was 27.3 cfs. Comparison of flows between the East and West branches, on the 9 dates when flow was monitored on both creeks, shows that flows on the East Branch are over five times higher than those on the West Branch (5.5 cfs and 1.1 cfs respectively).
