# Pilot Plan: Off-Property Soil Replacement

## **Cabot/Koppers Superfund Site**

Operable Unit Five (Koppers)

## **Version 1**

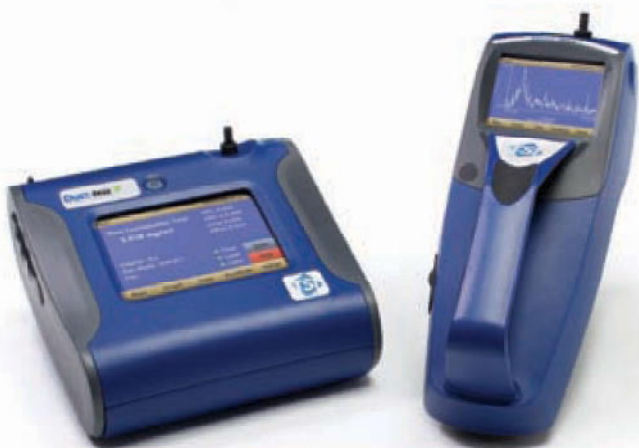
### Features and Benefits

- Easy to program, easy to operate
- New graphical user interface with color touch-screen
- Perform in-line gravimetric analysis for custom reference calibrations
- Automatic zeroing (with optional zero module) minimizes the effect of zero drift
- Measure aerosol concentrations corresponding to  $PM_{10}$ ,  $PM_{2.5}$ ,  $PM_{10}$ , or Respirable size fractions

Dust monitoring will occur beginning several days before soil-removal operations (for background levels), will continue through soil replacement and sod placement, and will be discontinued several days after completion of the work. Monitoring will be conducted each working day from the beginning of work to the end of work.

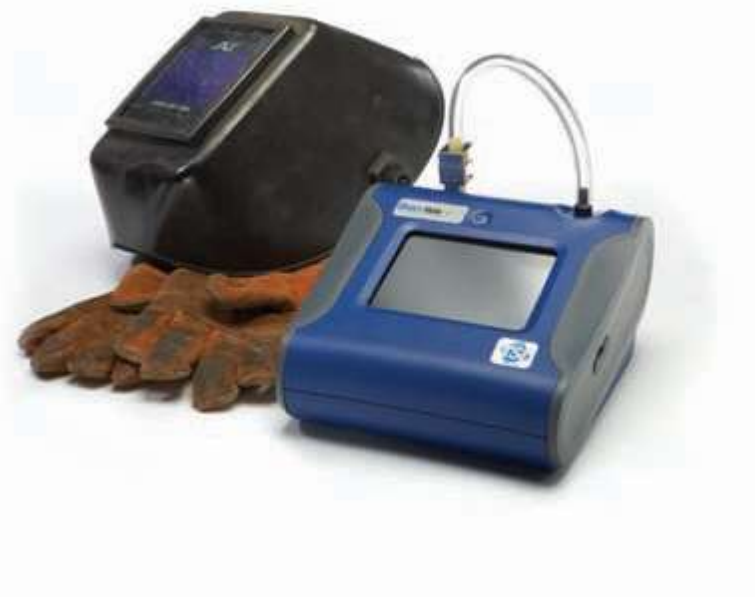
TRAKPRO™ Data Analysis Software allows you to set up and program directly from a PC. A new feature is the ability for remote programming and data acquisition from your PC via wireless (922 MHz or 2.4 GHz) communications or over an Ethernet network. As always, you can print graphs, raw data tables, and statistical and comprehensive reports for recordkeeping purposes.

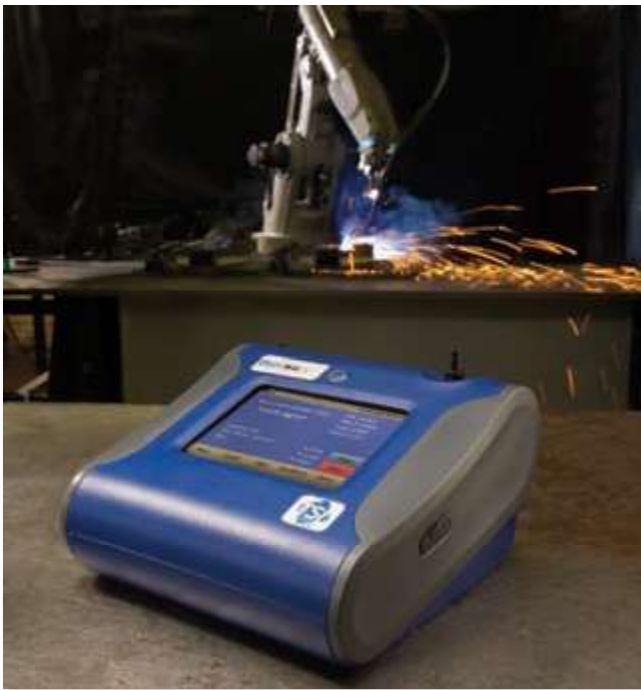
### All Desktop Models

- Hot swappable batteries
- Gravimetric reference sample capability
- Long life 10,000-hour internal pump
- TRAKPRO Data Analysis Software
- Auto zeroing module (optional accessory)
- STEL alarm setpoint

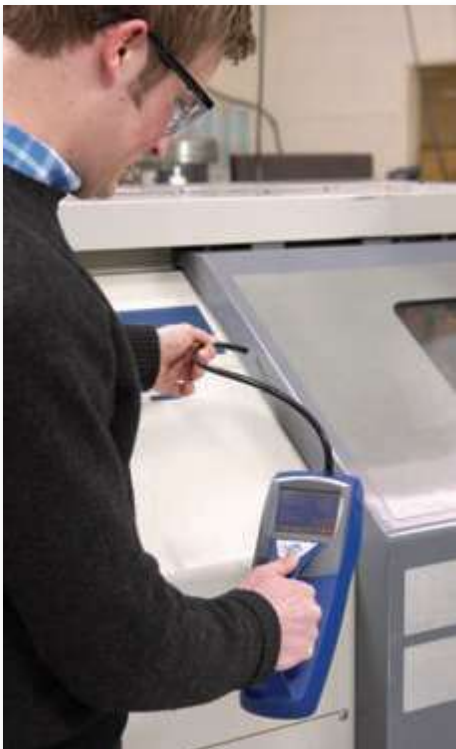
### All Handheld Models

- Long life 2,500-hour internal pump
- Single-point data collection for walk through surveys
- TRAKPRO Data Analysis Software

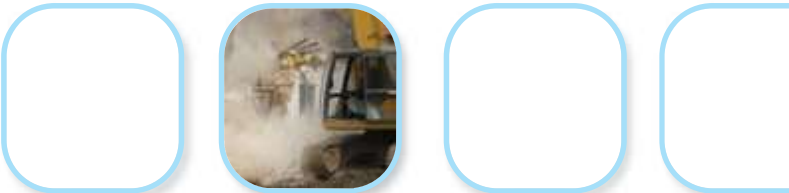
Models 8530/8531 (typical) 6600 mAH Li-Ion Battery Pack (P/N 801680)	1 Battery	2 Batteries
Battery Runtime (hours)	up to 6	up to 12
Charge Time * (hours) in DUSTTRAK	4	8
Charge Time* (hours) in external battery charger (P/N 801685)	4	8

Model 8532 (typical) 3600 mAH Li-Ion Battery Pack (P/N 801681)	Battery
Battery Runtime (hours)	up to 6
Charge Time * (hours) in DUSTTRAK	4
Charge Time* (hours) in external battery charger (P/N 801686)	4

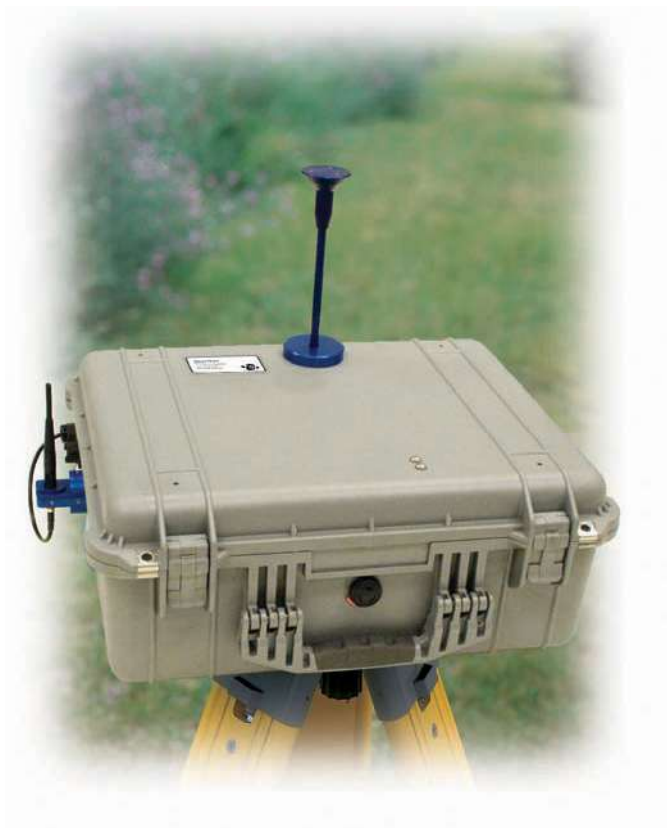
## New Optional Accessories for the DUSTTRAK™ Environmental Enclosure

**Internal Battery System**—this internal power system will provide continuous power to the DUSTTRAK aerosol monitor and the wireless radio modems when dedicated AC power is not available, allowing autonomous, 24-hour operation of the DUSTTRAK Environmental Enclosure. This optional accessory is supplied with two sets of batteries, allowing one set of batteries to be charged while the other is in operation. It includes; two sets of 36 Ah lead acid batteries, and battery charger with universal line cord.

**Solar Power System**—this external power system will provide continuous power to the DUSTTRAK aerosol monitor and wireless radio modem when dedicated AC power is not available for remote, long-term unattended sampling applications. It will power all equipment and charge the external battery during the daytime, and then automatically switches to battery power during the night or in low-light conditions. It includes; two solar panels with stand, weatherproof battery and charge regulator enclosure, charge regulator, extended-life lead acid battery, and DC power cables.
