Hogtown Creek Watershed

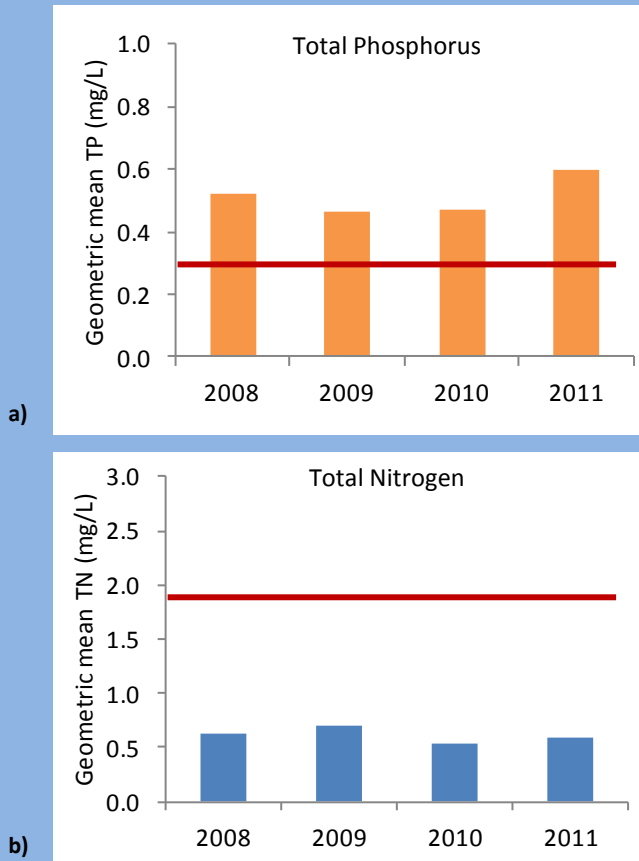
Figure 3. Annual Geometric mean of a) total phosphorus (TP) and b) total Nitrogen (TN) on Hogtown Creek data collected by Alachua County Environmental Protection Department. FDEP nutrient standards for the North Central eco region are represented by the red line a) TP of 0.30mg/L and b) TN of 1.87 mg/L.

Nutrients: The proposed FDEP water quality nutrient standards will be effective in 2012. Total nitrogen concentrations are well below the criteria. Hogtown Creek will be considered impaired for total phosphorus (TP) when this rule becomes effective. Major sources of phosphorus in the watershed include fertilizers in stormwater runoff, as well as naturally occurring phosphorus minerals in the Hawthorn Group formations that are eroded and carried away in high velocity stormwater flows.
