Buck Bay Flatwoods Preserve Management Plan

**Alachua County
Environmental Protection Department
408 W. University Avenue, Suite 106
Gainesville, FL 32601**

version date: 3/3/2015

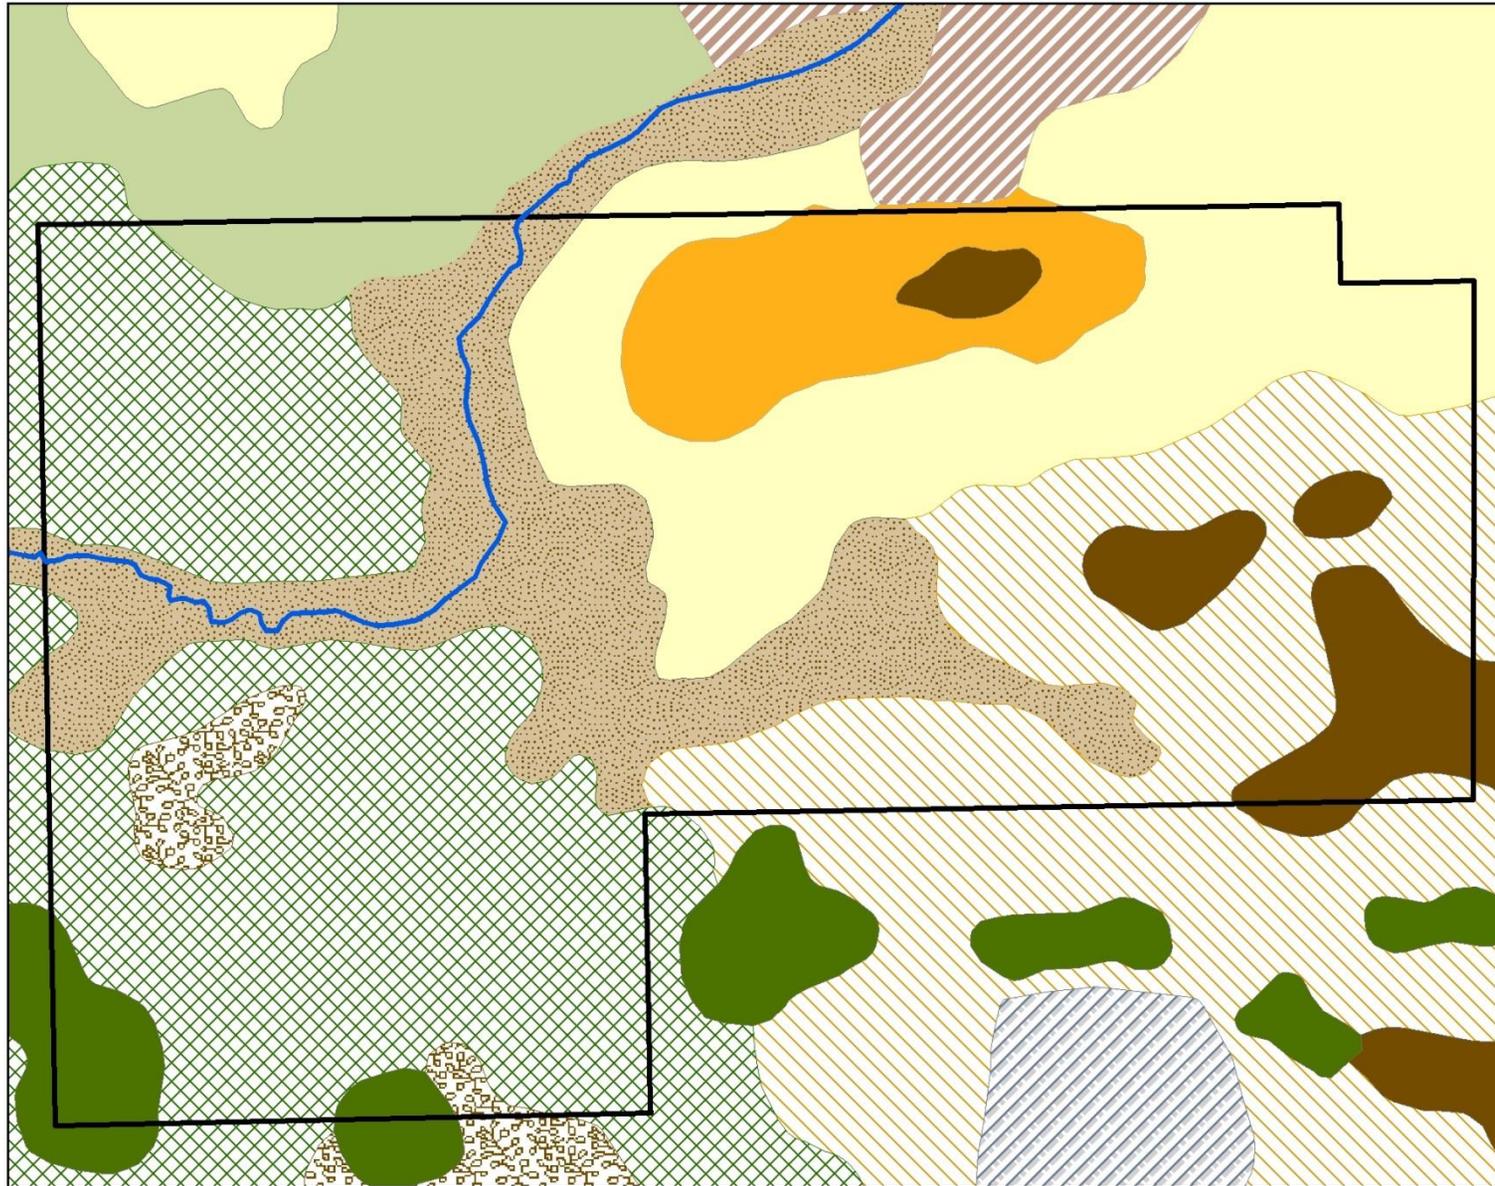
- Preserve Boundary
- Candler fine sand, 0 to 5% slopes
- MWS soils, flooded
- Millhopper sand, 0 to 5% slopes
- Monteocha loamy sand
- Newnan sand
- Pits and Dumps
- Pomona sand
- Pomona sand, depressional
- Surrency sand
- Tavares sand, 0 to 5% slopes
- Wauchula sand
- Hatchet Creek

Nine soil types recognized by the Natural Resources Conservation Service are present within Buck Bay Flatwoods Preserve (Exhibit B) (Thomas et al. 1985). These soils range from well drained to very poorly drained, and are typically sandy in one or more horizons.

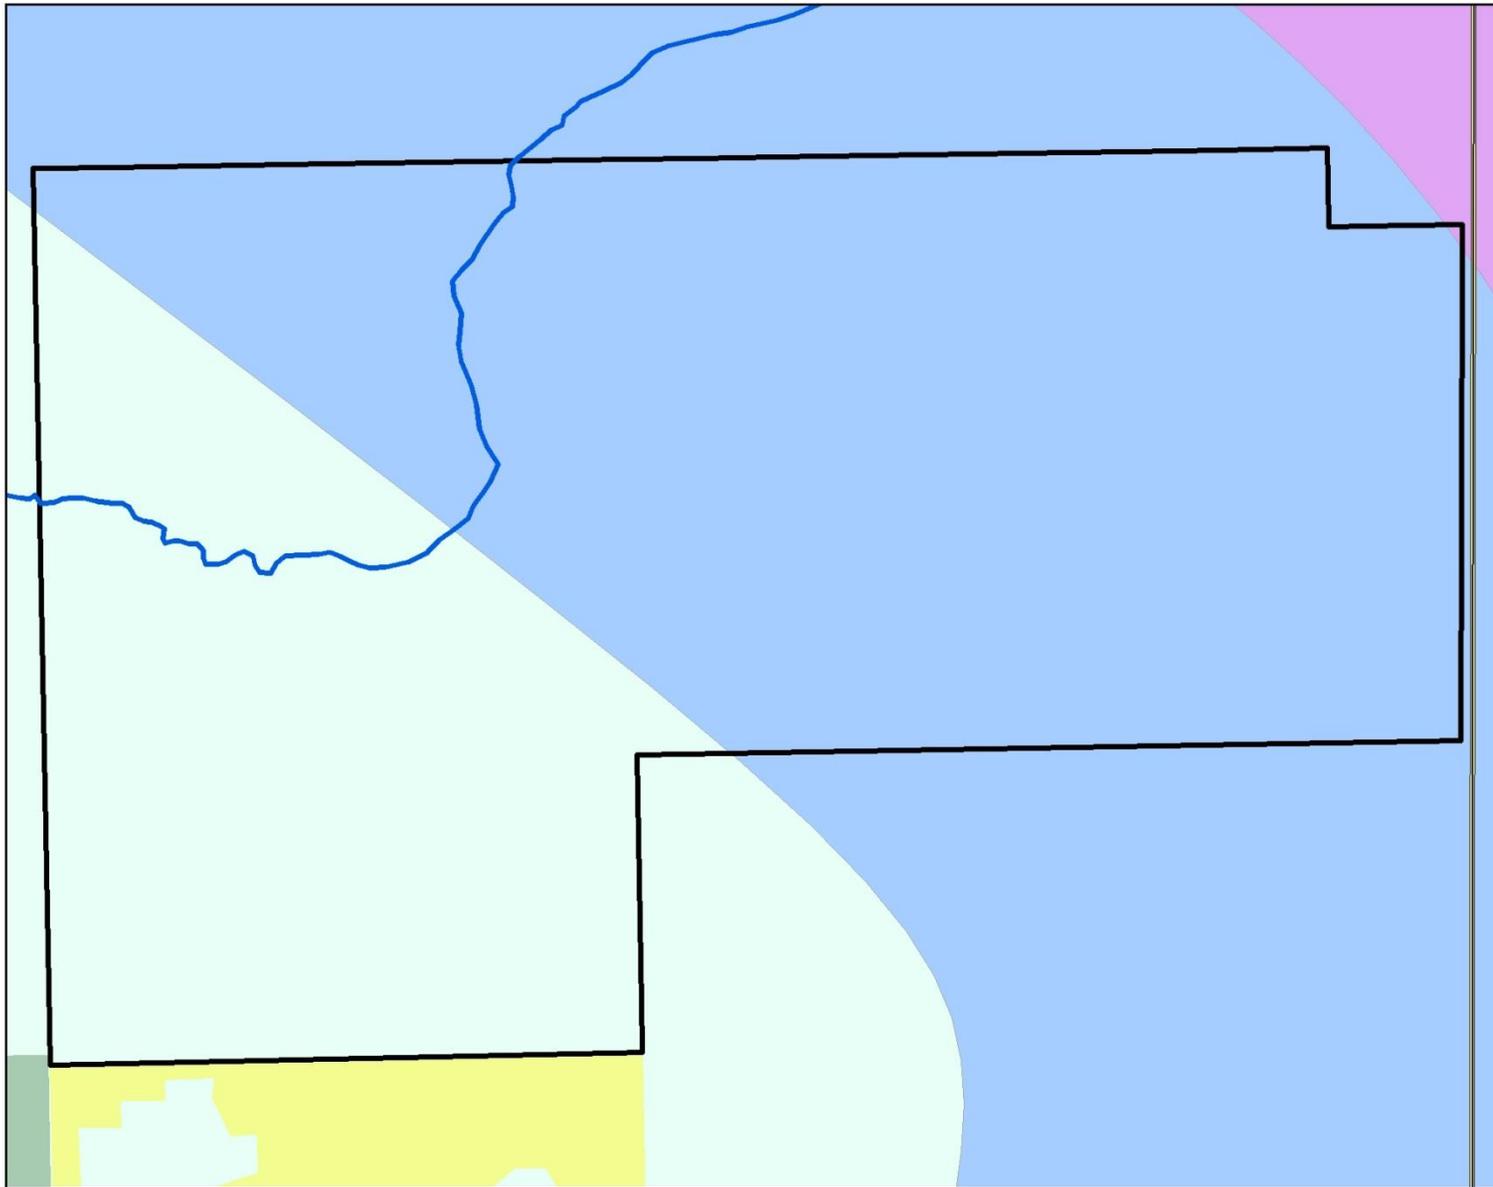
Exhibit C - Buck Bay Flatwoods Preserve Wellfield Protection Zones Map

- Preserve Boundary
- Murphree Water Treatment Plant
- Murphree Solar Park CE
- Hatchet Creek
- Major Roads
- Murphree Well Field Protection Zones**
- Primary Zone (2-yr)
- Secondary Zone (10-yr)
- Tertiary Zone (25-yr)

In addition to the unique surface water features on the property, it is important to note that the Preserve parcels lie within the primary and secondary protection zones of the Murphree Wellfield. This issue is discussed more thoroughly within the Special Management Considerations section (Exhibit C).

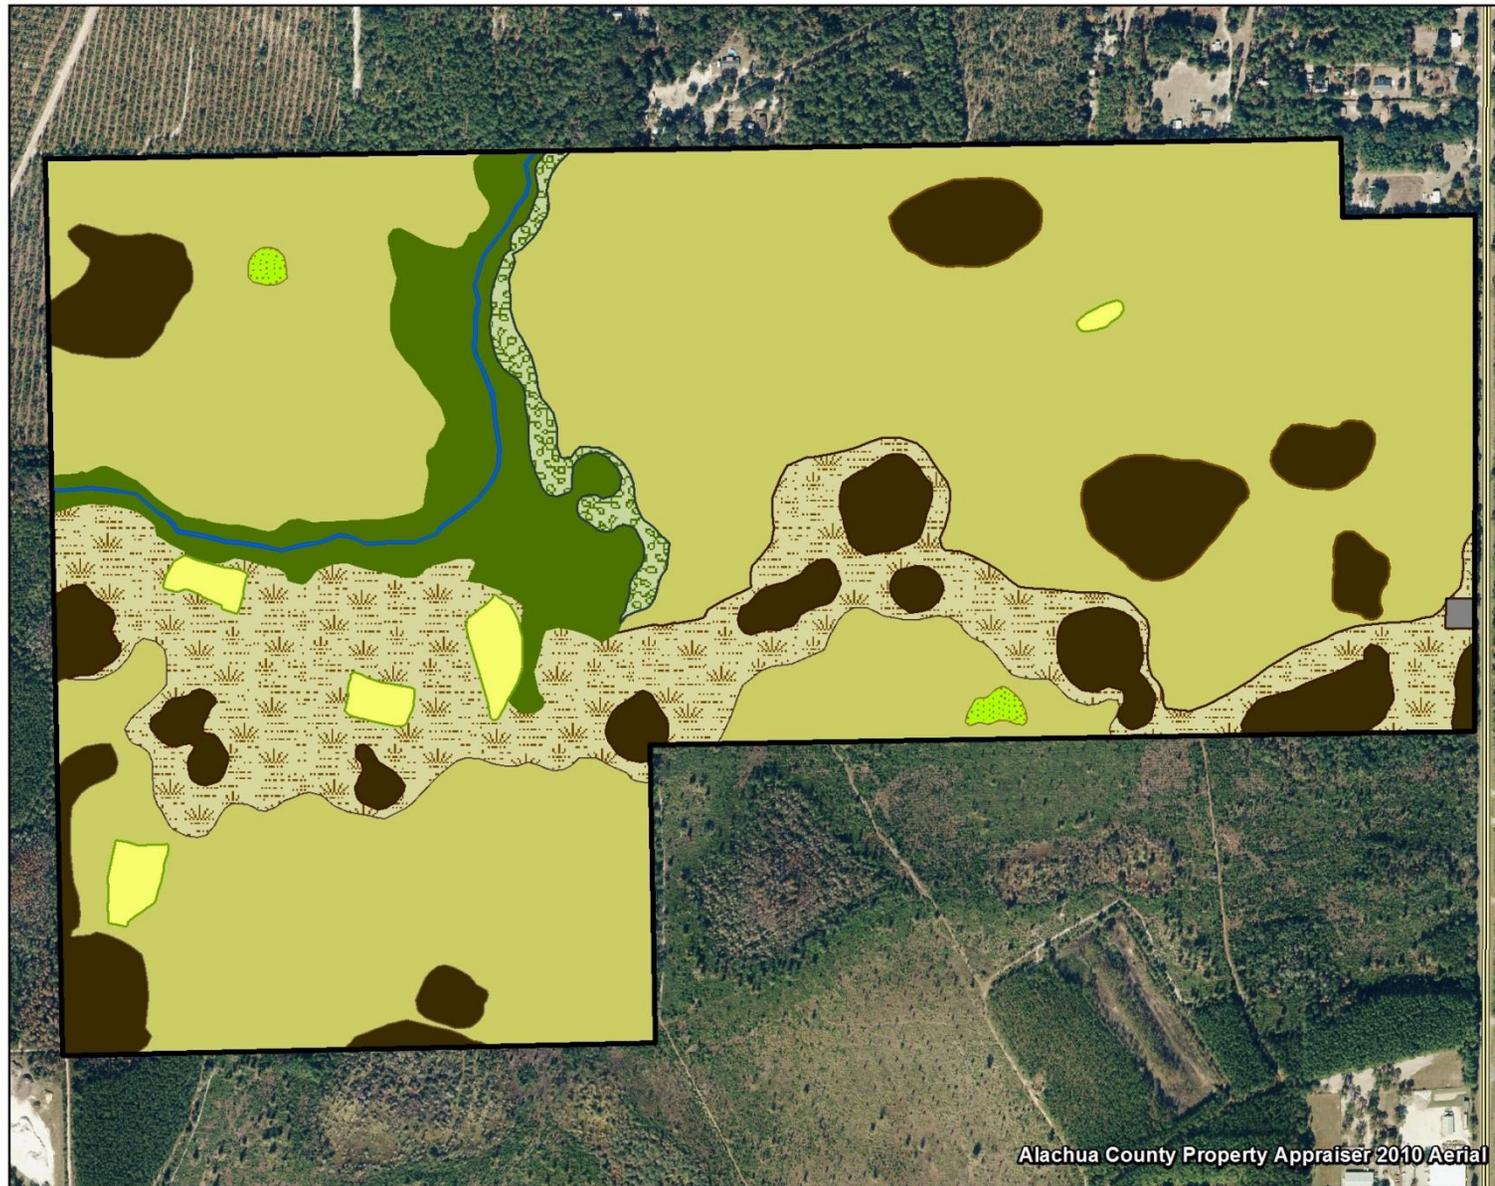
Exhibit D - Buck Bay Flatwoods Preserve Natural Communities Map

- Preserve Boundary
- Blackwater Stream (1.2 ac)
- Borrow Pit (0.4 ac)
- Clearing/regeneration (6.7 ac)
- Depression Marsh (1.4 ac)
- Dome Swamp (51 ac)
- Floodplain Swamp (30.5 ac)
- Mesic Flatwoods (295.1 ac)
- Upland Hardwood Forest (5.7 ac)
- Wet Flatwoods (71.8 ac)

Seven distinct natural communities and two human-altered landcover types (FNAI 2010) exist within Buck Bay Flatwoods Preserve (Exhibit D). The natural communities span a range from upland hardwood forest to the Hatchet Creek blackwater stream. The dominant natural community within the Preserve is mesic flatwoods, which covers approximately 295.1 acres, or 64 percent of the Preserve area.

Several cleared areas exist on the property, five of which are large enough in scale to be included in the natural community map (Exhibit D). The mapped cleared areas total approximately 6.7 acres, and are in good to very good condition. Review of historic aerials indicates the cleared areas were created sometime between 2001 and 2005, following a timber clearcut on the property, and since that time they were maintained and used as food plots to support game hunting. All of the cleared areas show signs of cultivation or harrowing, and two of them contain large push piles of soil, indicating they were scraped. The push pile for one of the scraped areas is very large, and encroaches on the edges of a floodplain swamp community. Remarkably, each of the cleared areas contain abundant native groundcover similar in composition to that growing in the adjacent flatwoods. Species present in the cleared areas include Mohr’s thoroughwort (*Eupatorium mohrii*), Curtiss’ dropseed (*Sporobolus curtissii*), tenangle pipewort, Elliott’s yelloweyed grass, bottlebrush threeawn, blackroot, and Virginia chain fern. As a result of repeated and long-term mowing and clearing, these areas largely lack trees and shrubs, however where they do occur, they are typically slash pine, saw palmetto or gallberry.

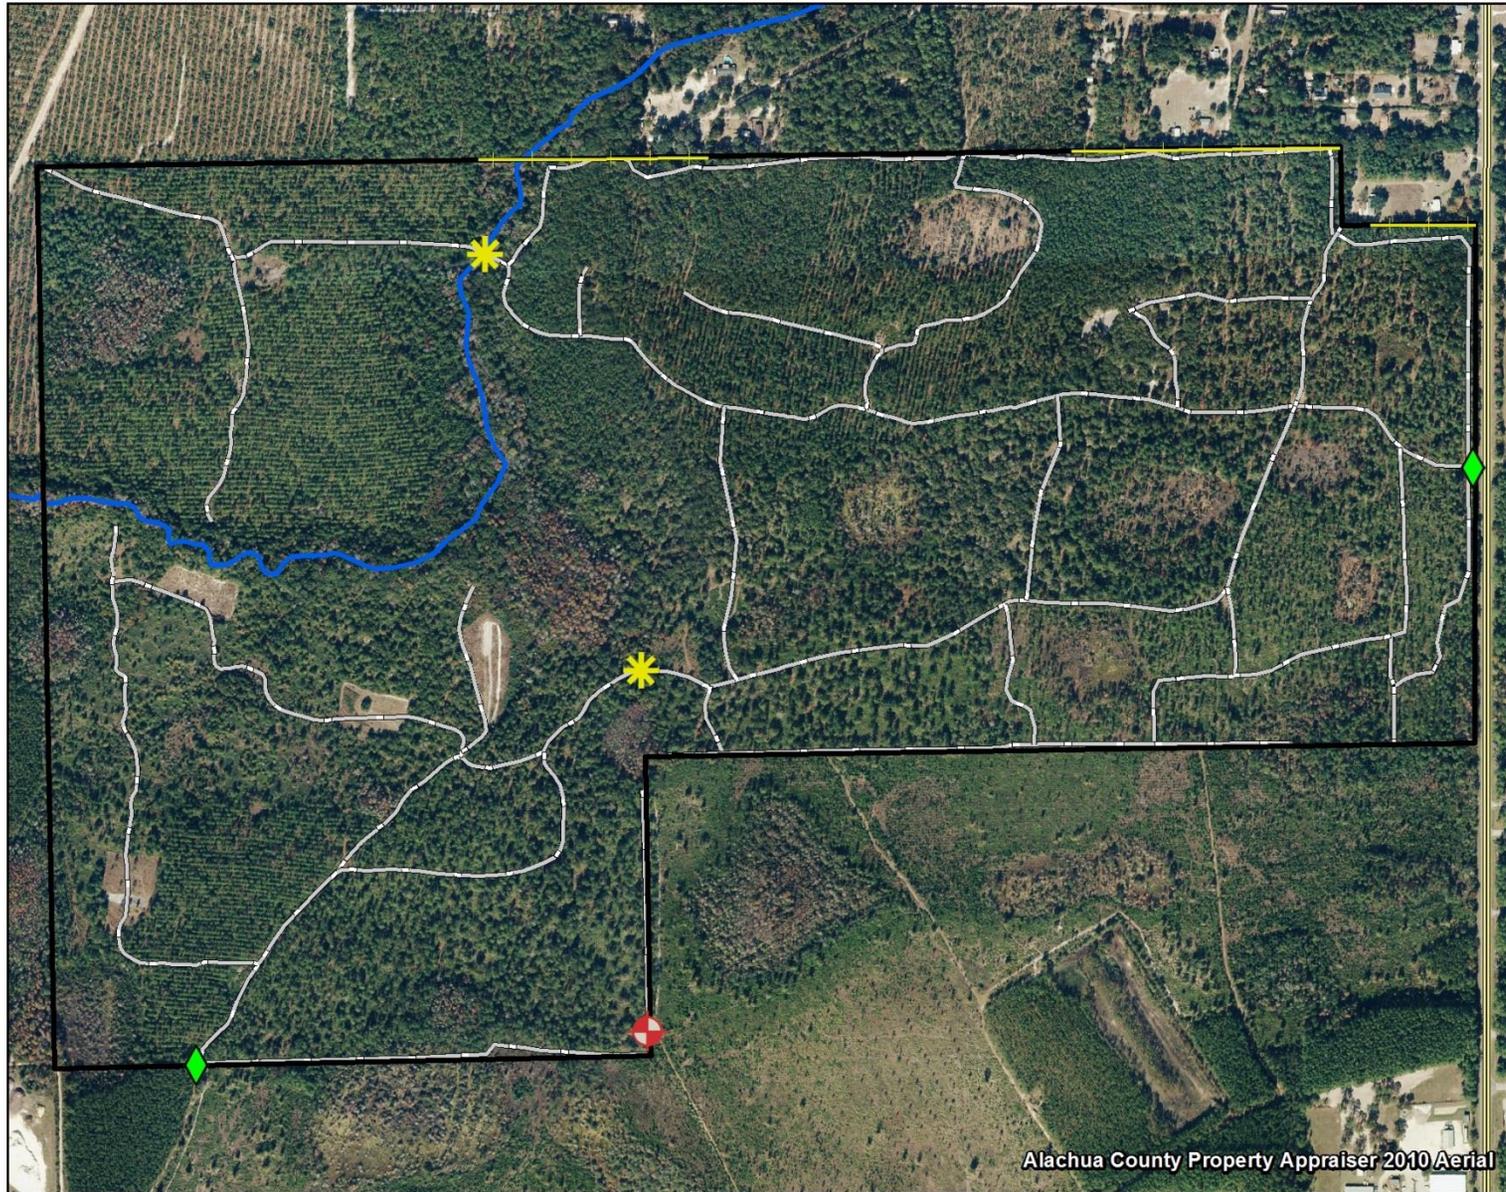
Exhibit G - Buck Bay Flatwoods Preserve Existing Site Improvements

- Preserve Boundary
- Existing Gates
- Existing Roads and Firebreaks
- Existing Low Water Crossings
- Existing Well
- Existing Fences
- Hatchet Creek

Buck Bay Flatwoods Preserve contains approximately 8.7 miles of interior roads and two gates, which were established prior to County ownership (see Exhibit G). A low water crossing exists on the road that crosses Hatchet Creek. The crossing is in very poor condition and consists of assorted riprap and dislodged plastic pipes which may have been utilized as culverts.

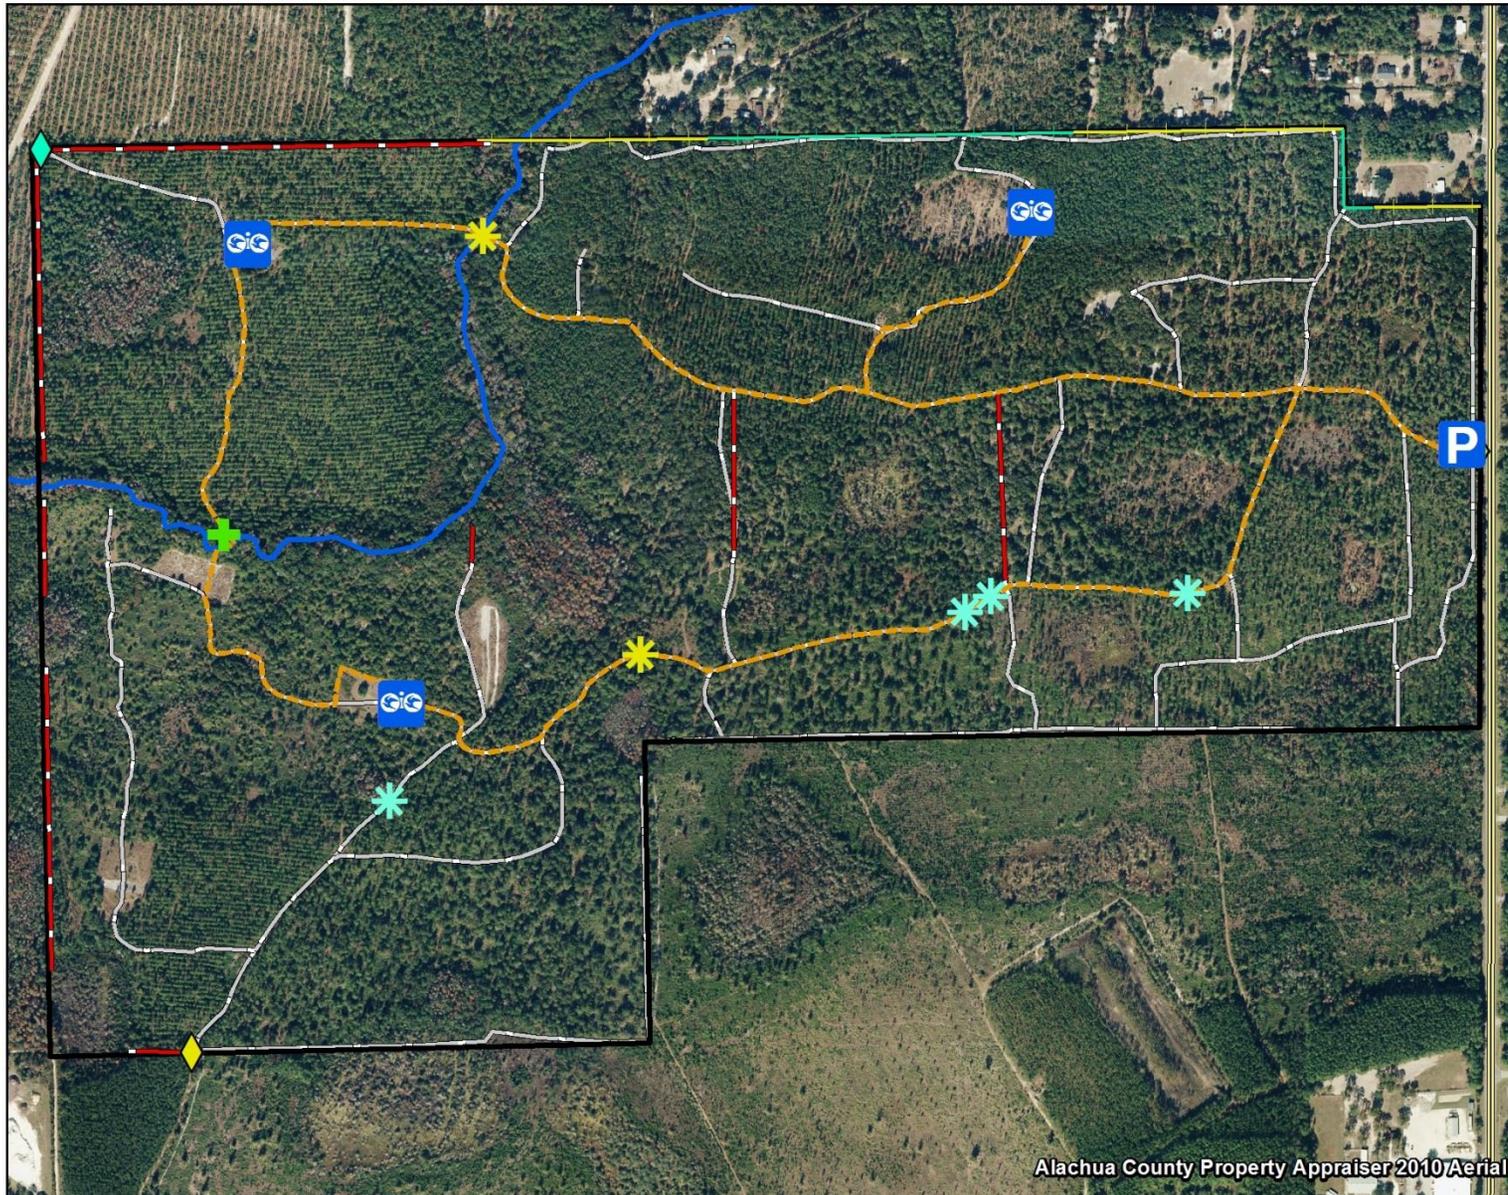
- Preserve Boundary
- Hatchet Creek
- Existing Fences
- New Fences
- Existing Gates
- New Gate
- Existing Roads and Firebreaks
- New Firebreaks
- Existing Low Water Crossings
- New Low Water Crossings
- Parking Area
- Recreational Trail
- Footbridge
- Observation Areas

Two existing low water crossings are planned for reconstruction, and four new low water crossings are planned for new construction to stabilize eroded and flood-prone sections of existing roads within the Preserve. One of the existing crossings planned for reconstruction crosses Hatchet Creek. Construction of low water crossings will entail re-contouring of existing soil within the roadbed, and backfilling with crushed rock or stone to a grade that matches the surrounding conditions. Geotextile fabric may be utilized beneath stone fill as necessary.

A marked trail system will be developed that utilizes existing roads. A small footbridge across Hatchet Creek is anticipated to create a trail loop on the west side of the Preserve. It should be noted that most of the lands within the Preserve are occasionally flooded. This affects access to roads and trails, and will naturally limit use of trail-related improvements. In some instances, trails may be closed to avoid hazardous conditions for visitors, or to minimize negative impacts such as soil erosion.
