8.1 Introduction

The Hatchet Creek Watershed is located in the northeast quadrant of Alachua County. The main channel of the creek flows west to east and empties into Newnans Lake. The watershed is comprised of three sub-basins that encompass approximately 65 square miles of rural land (Figure 8.1). The majority of the watershed is located outside the Gainesville city limits. It begins just west of SR 121 in Gainesville and continues east to SR 26, and south to Newnans Lake. Land surface elevation ranges from 165 feet in the upper basin to 75 feet (NGVD) near Newnans Lake.

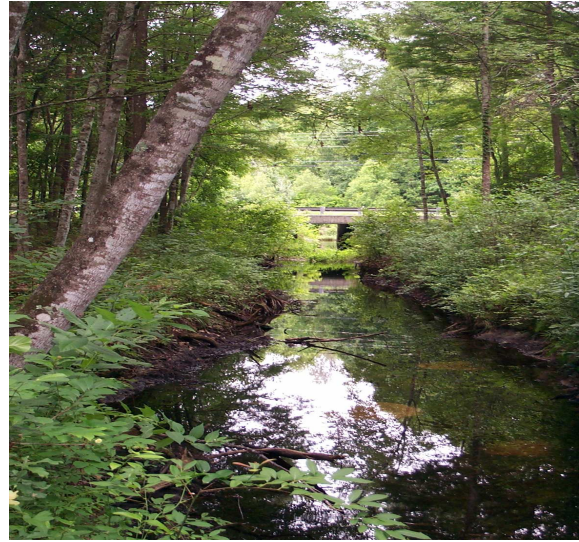
Hatchet Creek at CR 225

8.3.3 Hatchet Creek at CR 225

In 2001, ACEPD and WAV personnel performed a Rapid BioRecon on Hatchet Creek at CR 225 (Table 8.1). It received a 110 out of 160, or 69%, on the Habitat Assessment. Considerable point deductions were made in both the water velocity and habitat smothering categories. Despite these deductions, this site was rated healthy by the BioRecon surpassing all three metric target values.

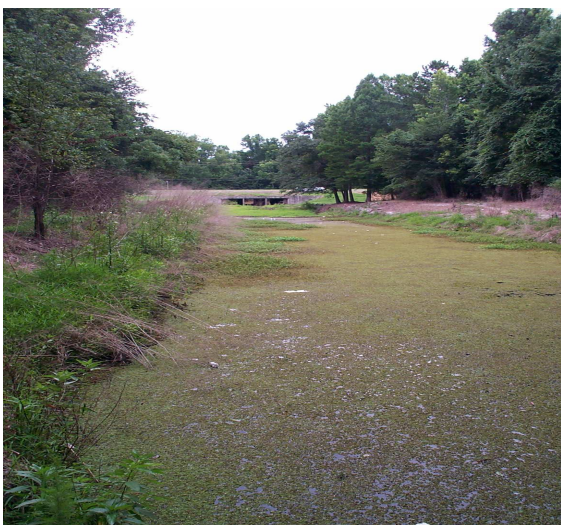
Dredged portion of Hatchet Creek at Waldo Road (SR24)

areas, and farmland. Only about 10% of the stream length has been channelized and these areas tend to be near major roadways. These areas are subject to sand smothering due to the channelization.

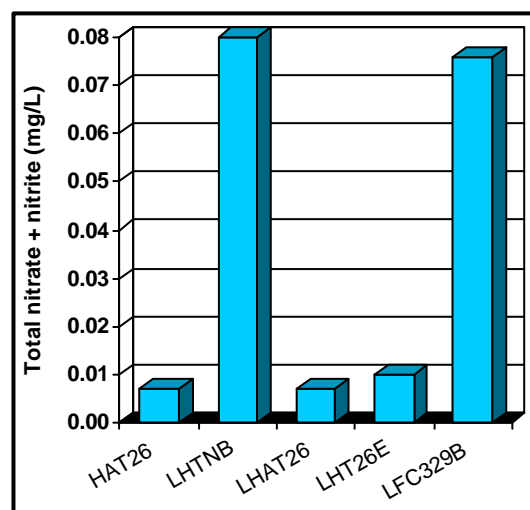
Figure 8.3 Comparison of total nitrate plus nitrite ($\text{NO}_x\text{-T}$) among the tributaries of Newnans Lake

Total nitrate plus nitrite ($\text{NO}_x\text{-T}$) concentrations are quite low in Hatchet Creek (median of 0.007 mg/L), while Total Kjeldahl Nitrogen (TKN-T) concentrations are elevated (median of 1.11 mg/L) compared to streams flowing through

more urbanized watersheds (Figure 8.3). This suggests significant organic matter breakdown and bacterial/fungal metabolism in the stream, which transforms the available $\text{NO}_x\text{-T}$ into organic nitrogen compounds. Similar results were observed at Little Hatchet Creek sites near the Newnans Lake Conservation Area.

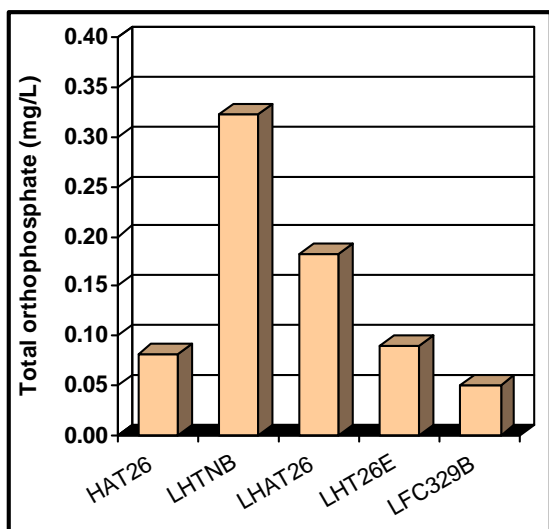
Figure 8.4 Comparison of total orthophosphate ($\text{PO}_4\text{-T}$) among the tributaries of Newnans Lake

Total phosphorus (TP-T) and total orthophosphate ($\text{PO}_4\text{-T}$) concentrations in Hatchet Creek (median concentrations of 0.123 mg/L and 0.082 mg/L respectively) were similar to those in the upper reaches of Sweetwater Branch and the lower reaches of Tumblin Creek (Figure 8.4). These concentrations were also similar to those in the East Branch of Little Hatchet Creek near the Newnans Lake Conservation Area and at Lake Forest Creek just downstream from its forested wetland.

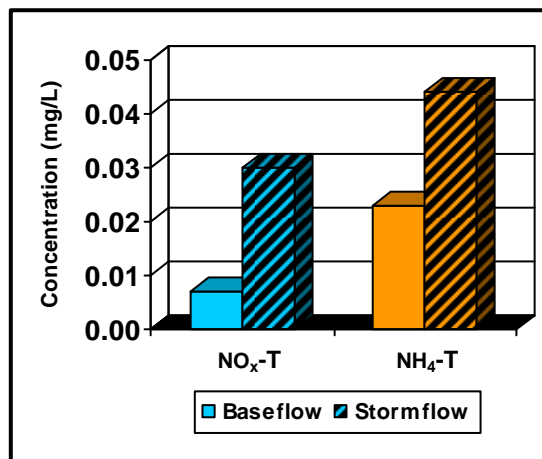
Figure 8.5 Increase in nitrate plus nitrite ($\text{NO}_x\text{-T}$) and total ammonia ($\text{NH}_4\text{-T}$) under stormflow conditions compared to baseflow at Hatchet Creek (HAT26)

Stormwater samples were collected from Hatchet Creek in the summers of 2000 and 2001. Organic carbon and nitrogen species showed noteworthy changes during storm flow conditions compared to baseflow conditions. Total organic carbon (TOC) concentrations increased 84% during stormflow (from a median baseflow value of 36.92 mg/L to 67.81 mg/L). Median $\text{NO}_x\text{-T}$ concentrations increased 329% during stormflow (from a median baseflow value of 0.007 mg/L to 0.030 mg/L) (Figure 8.5). Only the West Branch of Little Hatchet Creek showed a greater increase. Total ammonia ($\text{NH}_4\text{-T}$) concentrations increased 91% during stormflow conditions (from 0.023 mg/L at baseflow to 0.044 mg/L), which was the second smallest increase of all streams monitored in this study. Total Kjeldahl Nitrogen (TKN-T) concentrations

increased by 47% (from a baseflow value of 1.110 mg/L to 1.630 mg/L); only the West Branch of Little Hatchet Creek and Lake Forest Creek had smaller increases. Median total orthophosphate ($\text{PO}_4\text{-T}$) concentrations increased from 0.082 mg/L during baseflow to 0.093 mg/L (13% increase) during stormflow, which was similar to the 11% increase observed in the East Branch of Little Hatchet Creek.

The noteworthy increases in nutrient concentrations, specifically TOC and $\text{NO}_x\text{-T}$, during stormflow conditions in streams flowing through forested wetlands can be difficult to qualify. Increases in TOC indicate there is more organic material within the stream flow. This likely results from increased areas of sheet flow during storm events which collect and transport decaying organic matter from the forested wetland floor. Storm related increases in $\text{NO}_x\text{-T}$ can be the result of several factors. First, runoff from agricultural and residential areas has the potential to contain NO_x from fertilizer application. Second, NO_x is present in rainfall due to naturally occurring atmospheric deposition. In addition, $\text{NO}_x\text{-T}$ levels can fluctuate in streams flowing through forested wetlands as the amount of oxygen within the water changes. Under aerobic conditions, which may occur during stormflow, NH_4 is converted to NO_x by bacteria. Under anaerobic conditions, which occur more often during baseflow, NO_x is converted to NH_4 , thus decreasing $\text{NO}_x\text{-T}$ levels while increasing $\text{NH}_4\text{-T}$ levels. In summary, it can be difficult to explain changes in nitrogen species in forested wetlands during storm conditions due to the number of factors influencing concentrations.

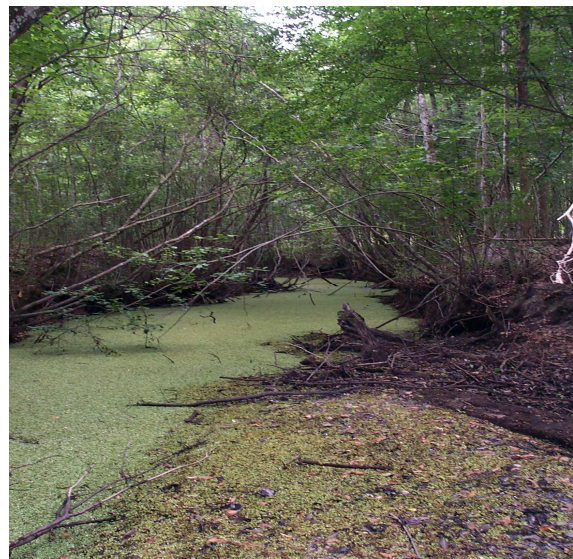
Salvinia sp. and duckweed in Hatchet Creek
