# Poe Springs County Park EPD Restoration Efforts

## Riparian Buffer at the Lodge

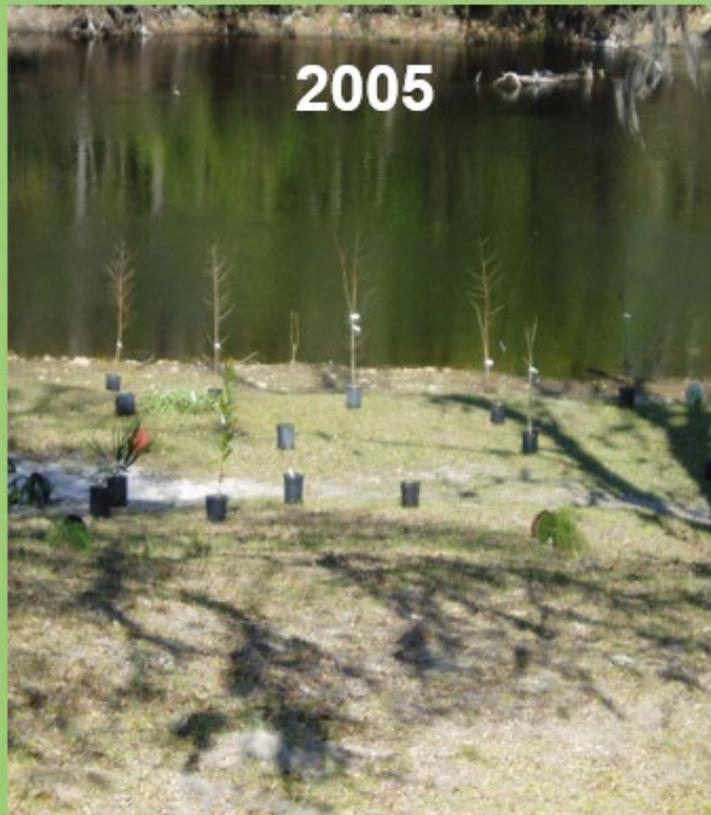
**Left:** The river front behind the Lodge was historically mowed to the water's edge, which contributed to erosion and provided minimal habitat for wildlife. Native vegetation was planted through a series of workshops in 2005.

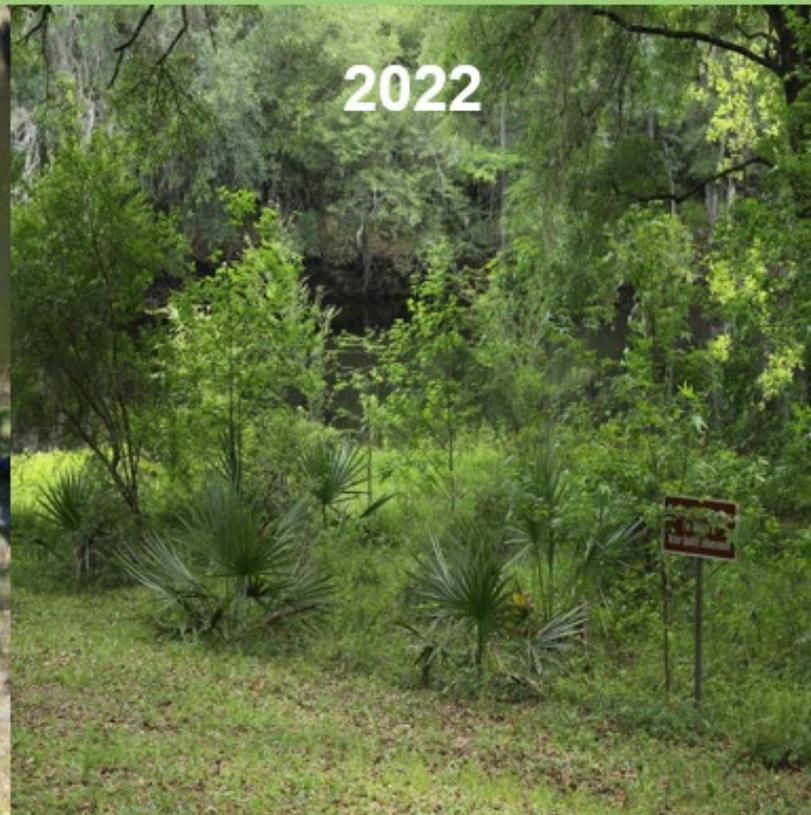
**Right:** A healthy vegetative buffer now provides habitat and prevents soil erosion.

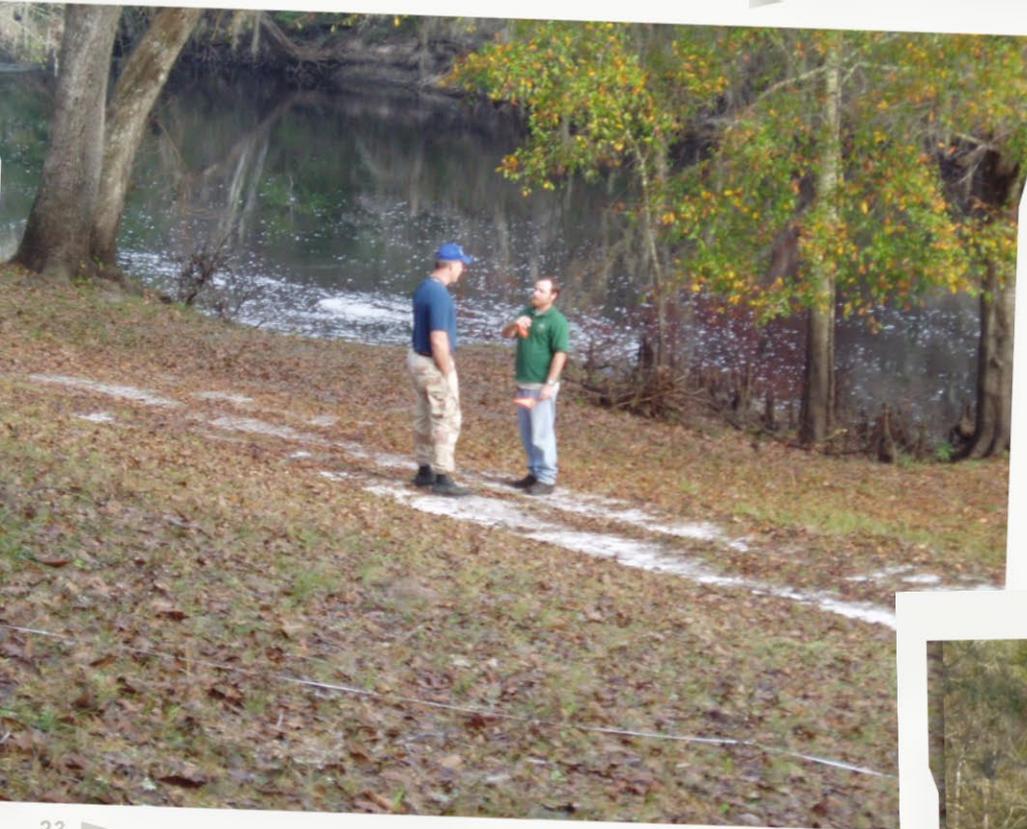
LEFT: TRAIL BETWEEN LODGE AND BOAT RAMP WITH NO BUFFER IN 2005!

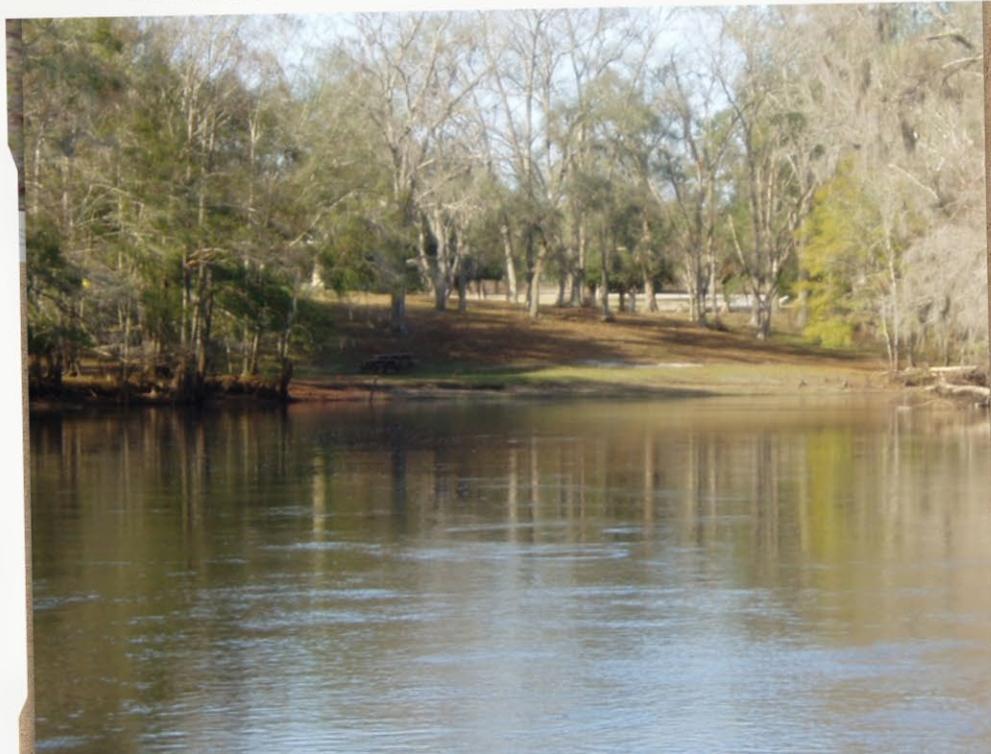
RIGHT: LOOKING TOWARDS THE LODGE FROM THE RIVER IN 2005- YOU CAN SEE THE ROAD TO THE BOAT RAMP!

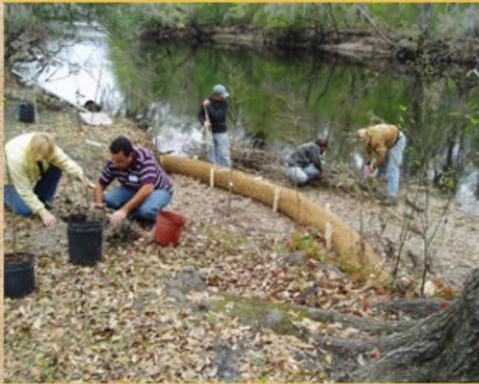
This picture shows the Santa Fe River upstream of the spring run and illustrates erosion and the lack of vegetation along the river in 2005. This area now has healthy trees and shrubs that provide habitat and shade.

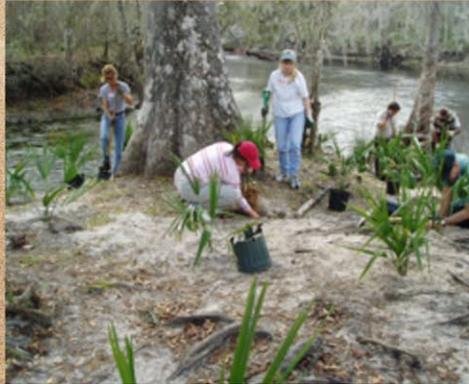
Over the course of three workshops, community members helped place biologs and downed tree branches along the river's edge to prevent erosion. Native vegetation was planted on the bank to establish a healthy root system that helps keep soil and biologs in place.

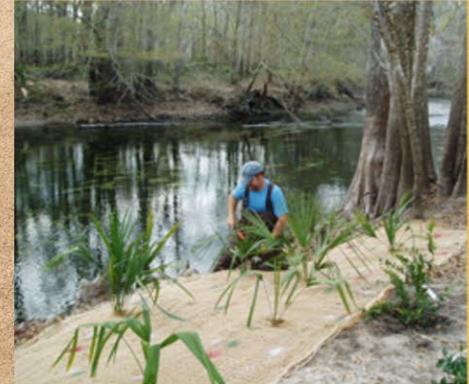
Native vegetation was strategically planted to direct people towards designated entry and exit points along the river. This limits erosion and reduces impacts from recreation.

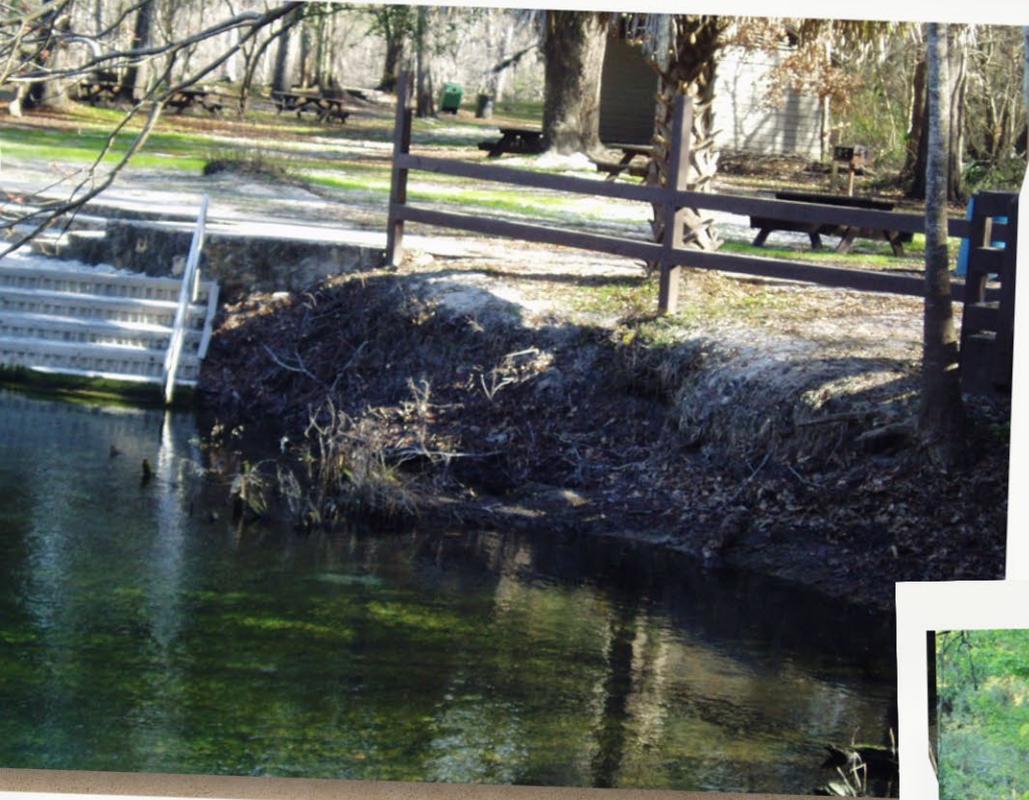
LEFT: ERODED POINT BY SPRING ENTRANCE IN 2005

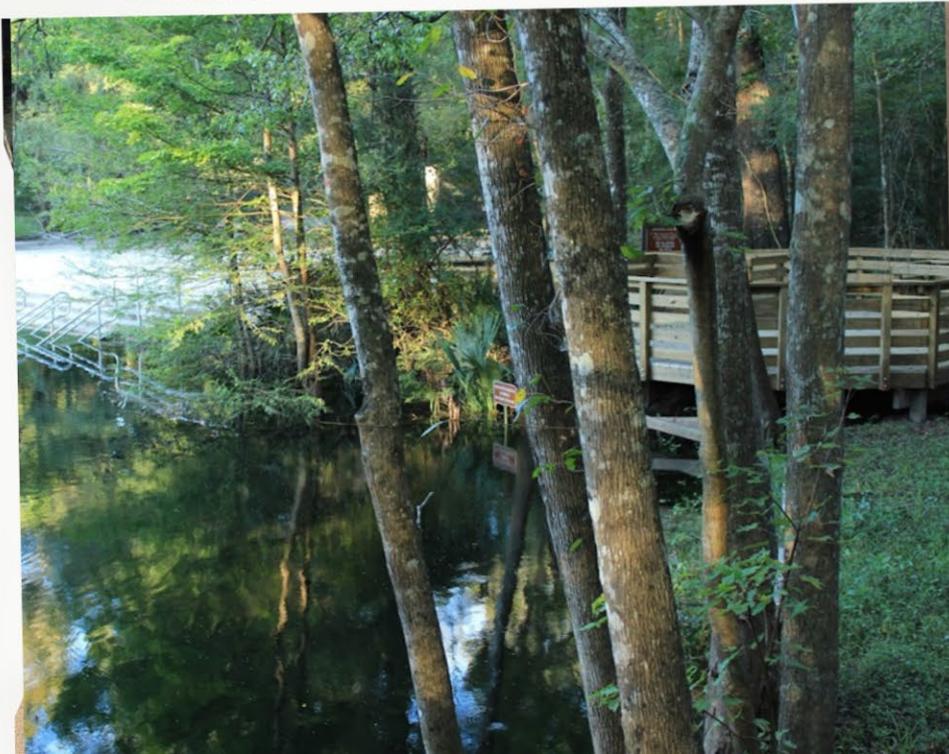
RIGHT: HERE IS THE POINT IN 2022 AFTER PALMETTOS, CYPRESS, AND OTHER VEGETATION WAS USED TO STABILIZE IT IN 2005.

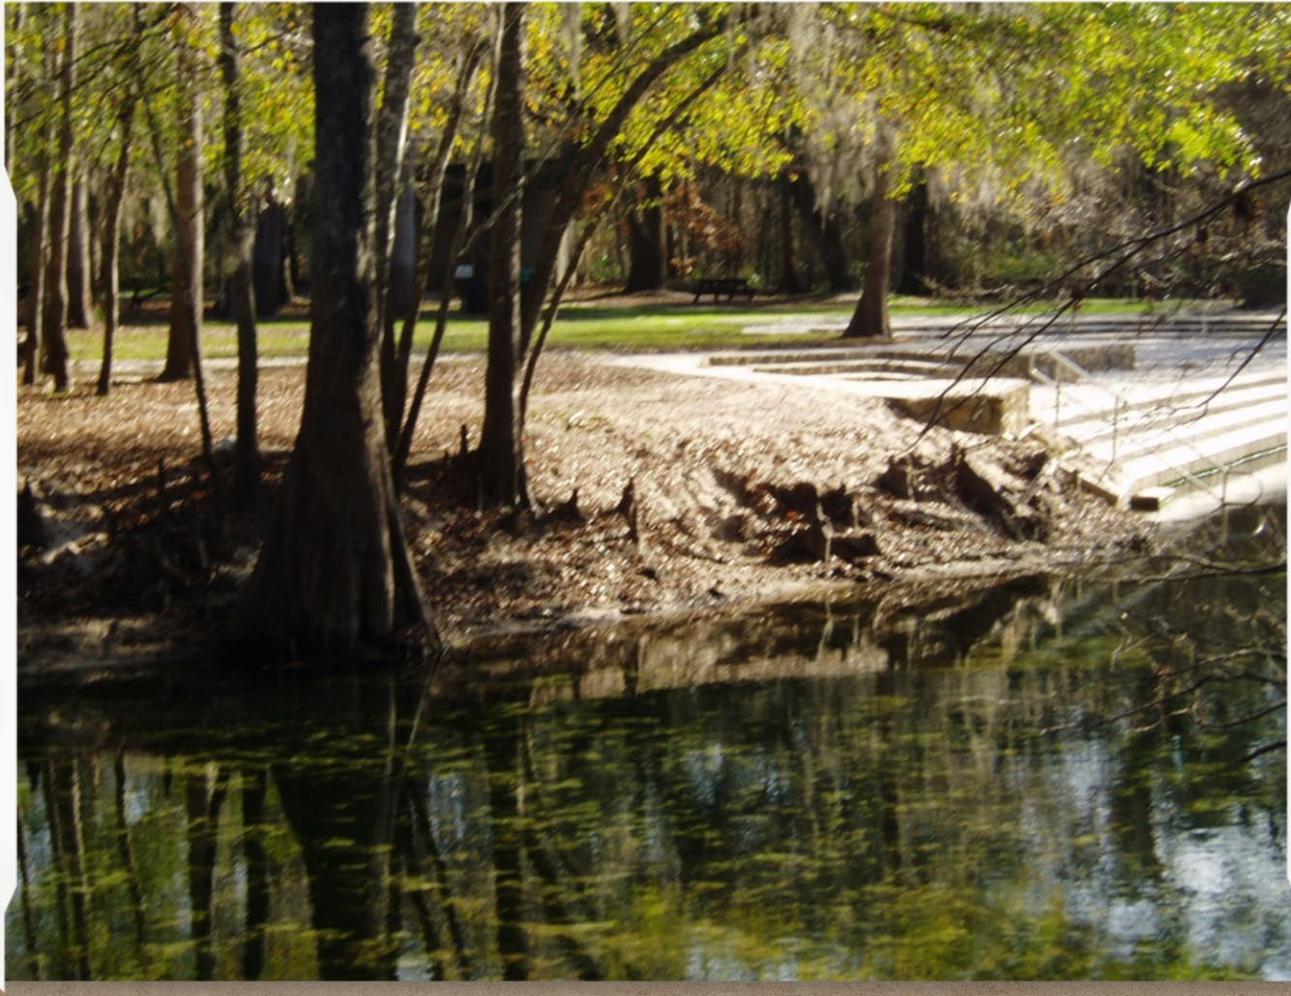
Eroded bank on spring run in 2005. This is where the new "Low Dissolved Oxygen Springs" sign is today.

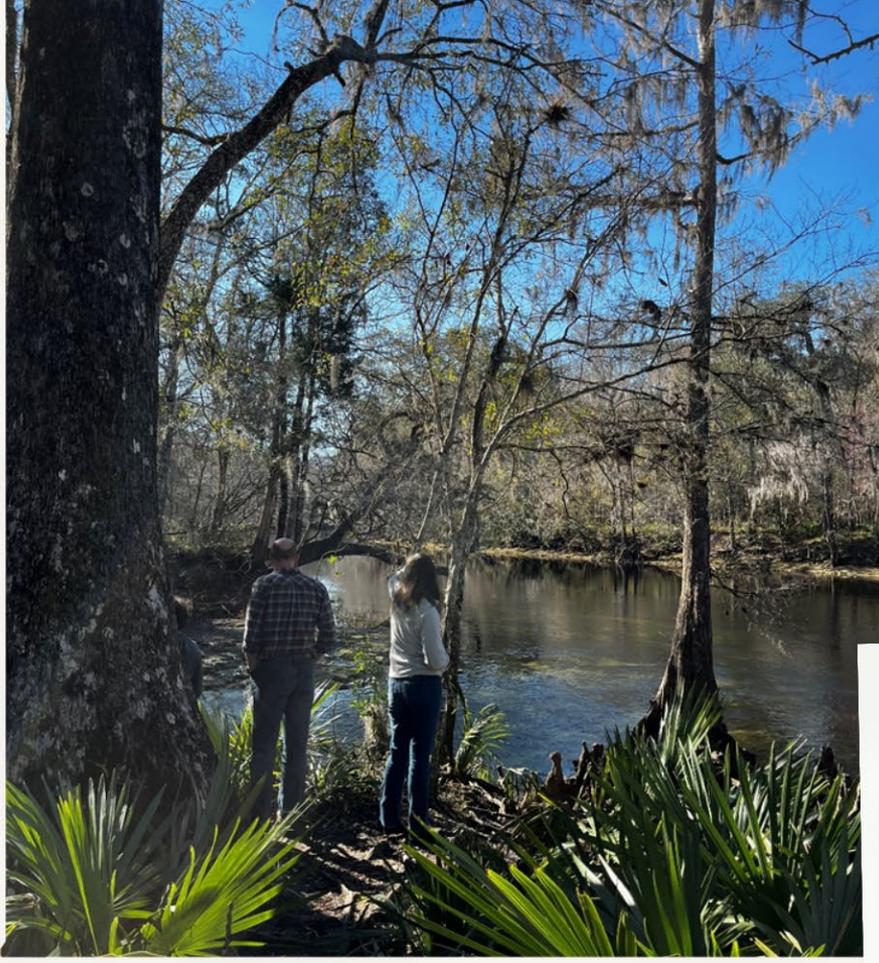
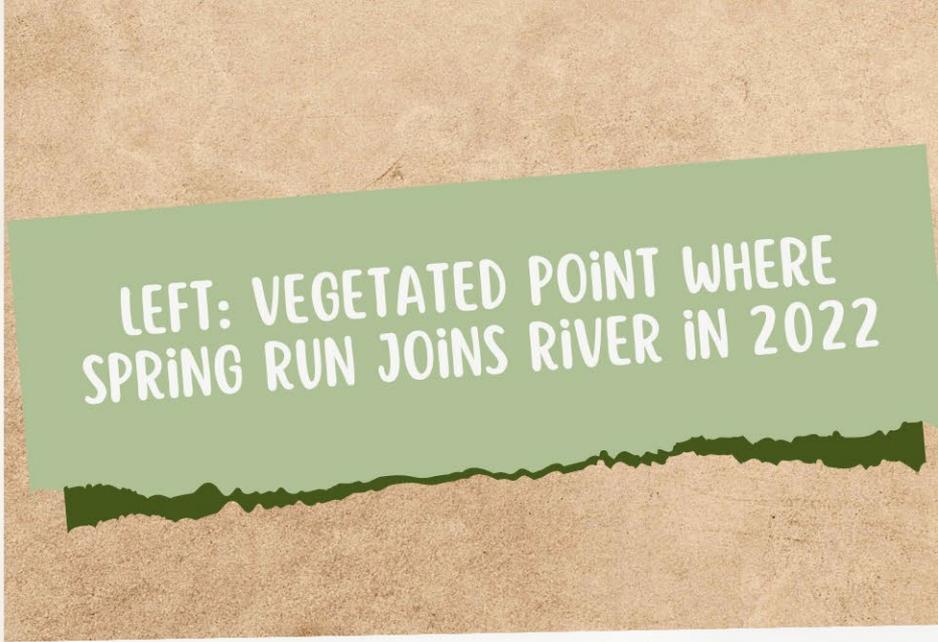
LEFT: VEGETATED POINT WHERE  
SPRING RUN JOINS RIVER IN 2022

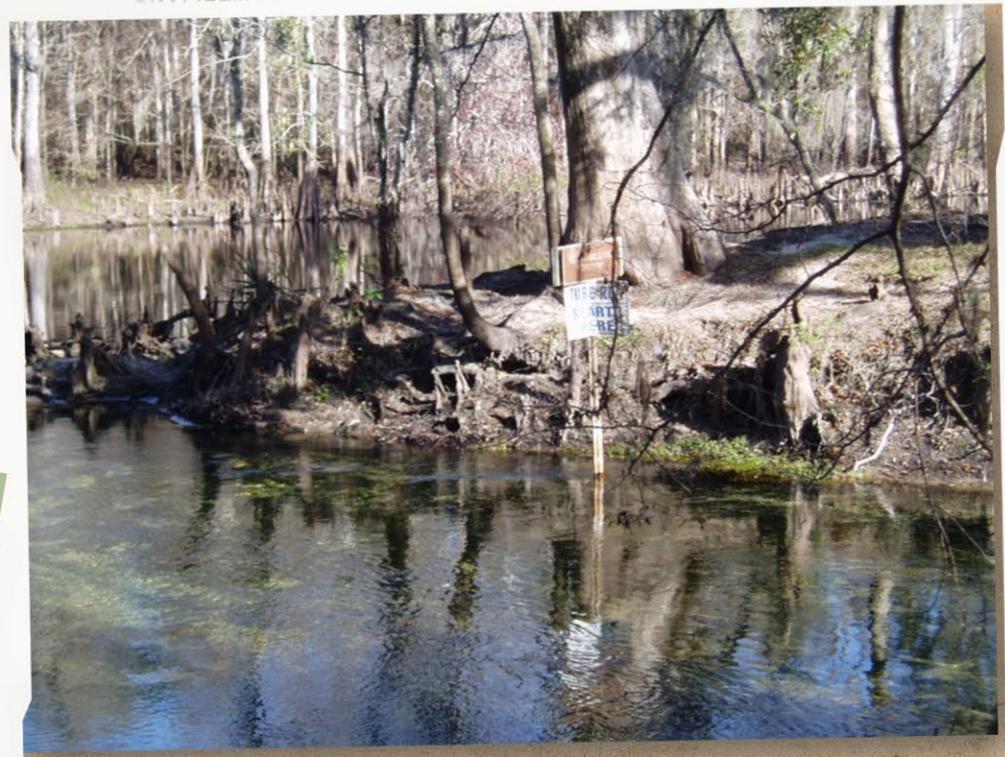
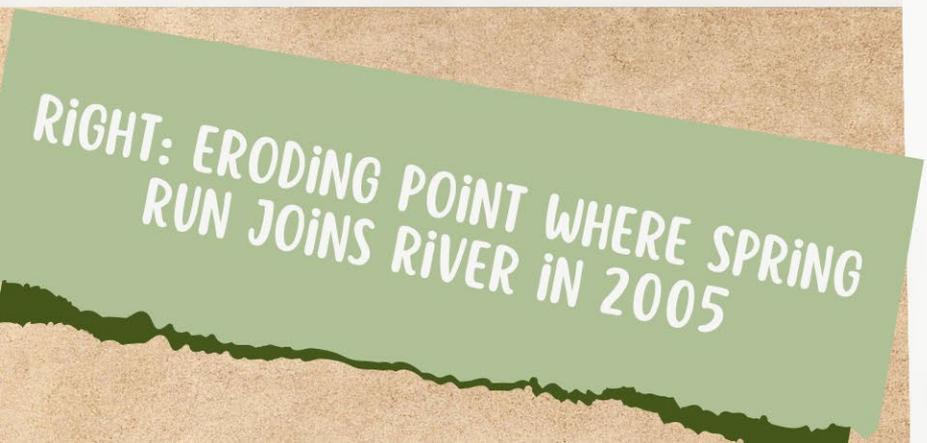
RIGHT: ERODING POINT WHERE SPRING  
RUN JOINS RIVER IN 2005

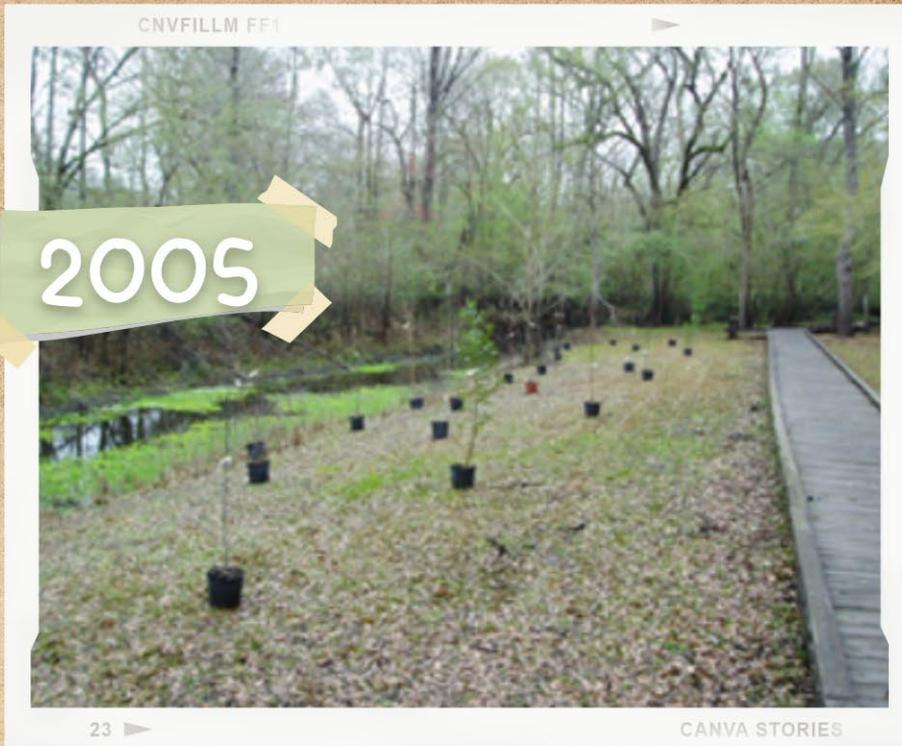
Left: During the 2005 workshops, native trees and shrubs were planted along the boardwalk to provide shade. This reduces water temperatures, shades out algae, and creates habitat.

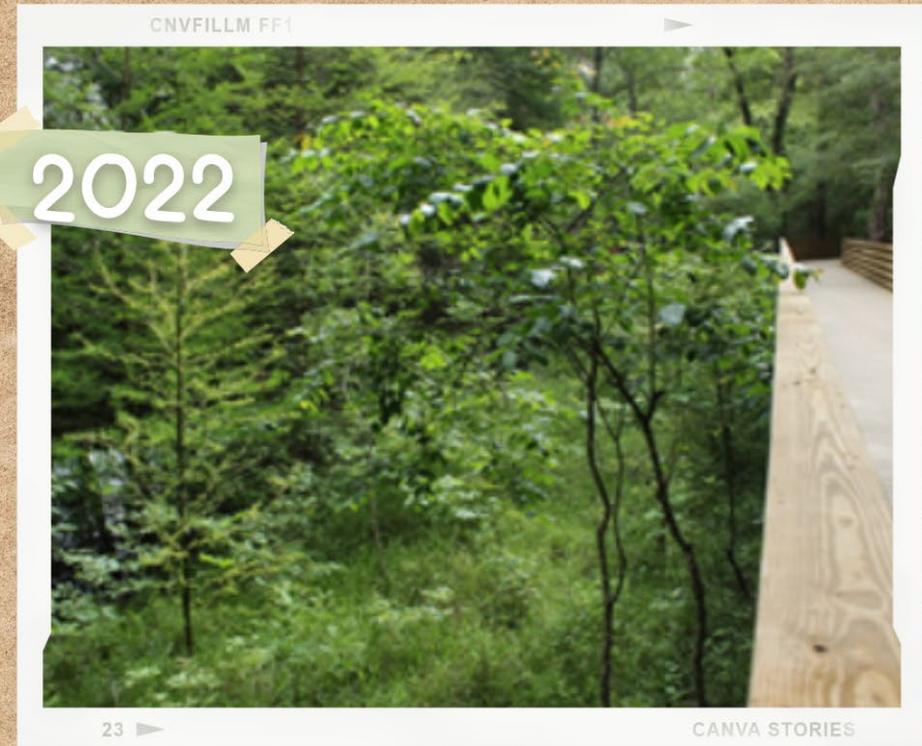
Right: The plantings have flourished and new species continue to "volunteer" in this area, creating a diverse forested wetland community. The boardwalk was replaced in 2021 and is now elevated to allow floodwaters to freely flow into this wetland and help alleviate flooding.

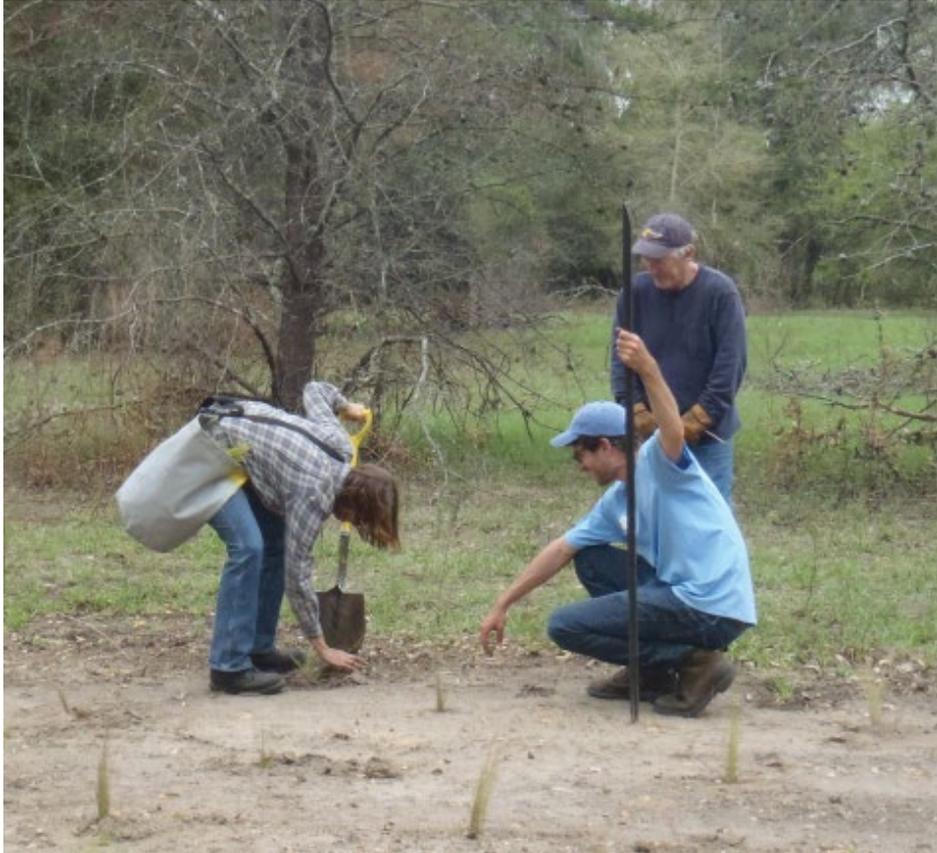
- Longleaf pines were planted in 2011 and 2012.
- In March 2014 a three acre portion of the area was planted with Longleaf pines and Wiregrass.

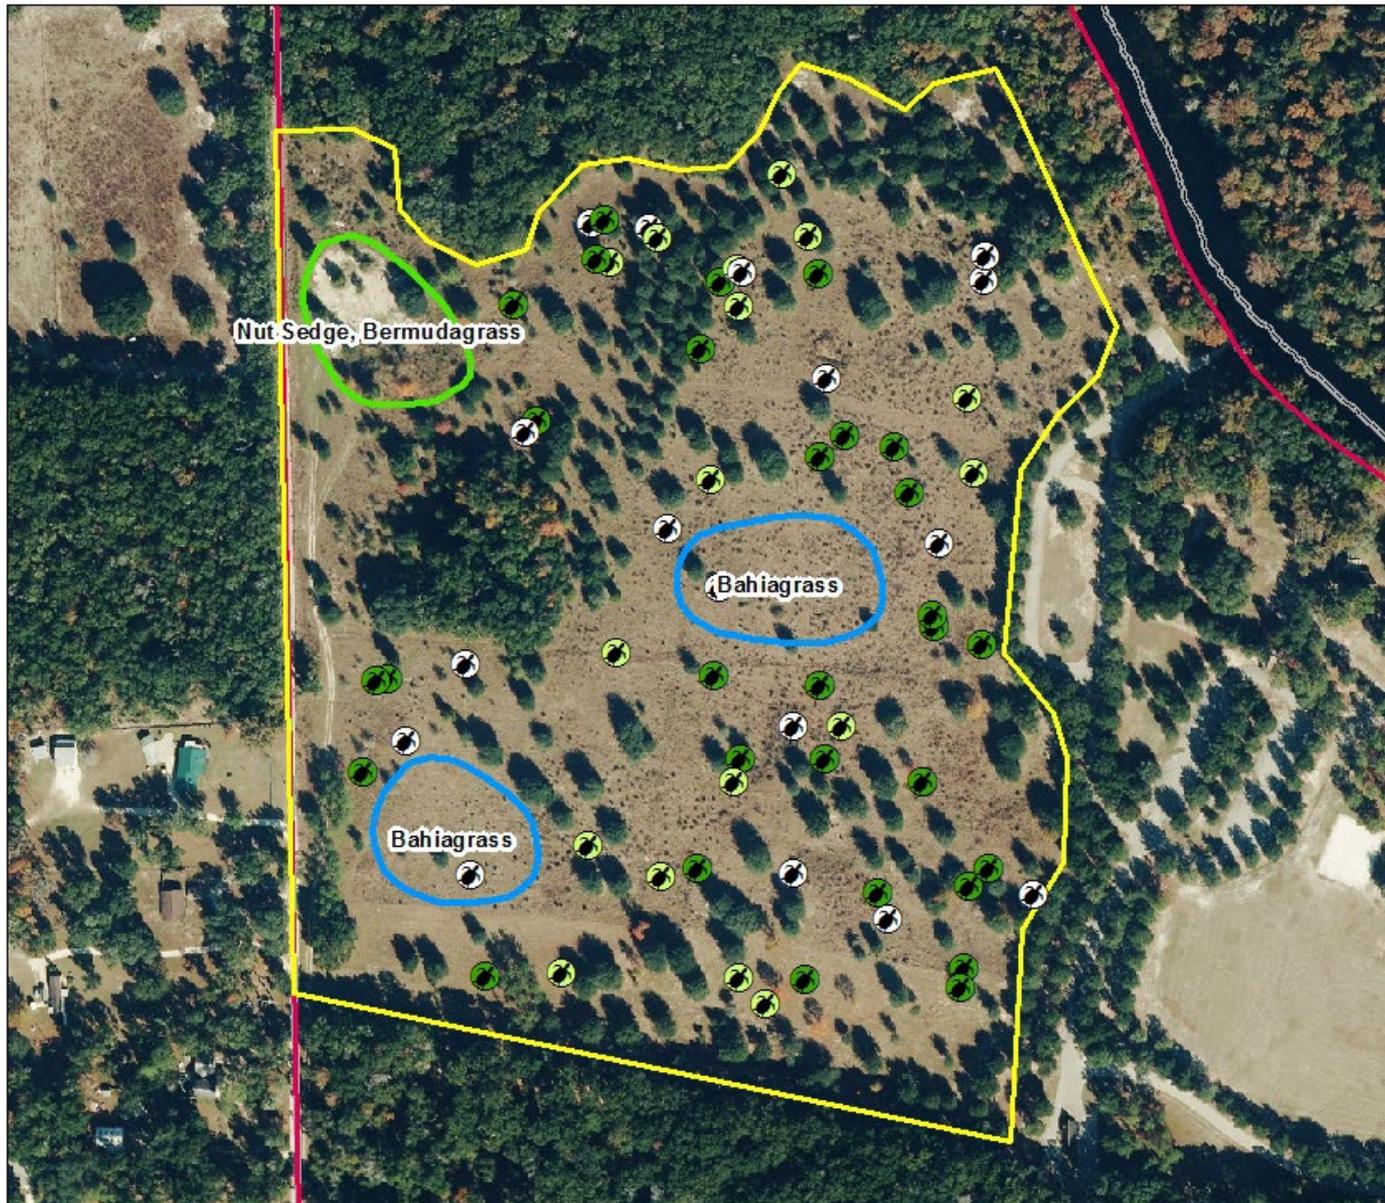
# Gopher Tortoise Habitat Management Area at Poe Springs Park

## Treatment Areas

Bahia grass

Nut Sedge, Bermudagrass

## Gopher Burrows

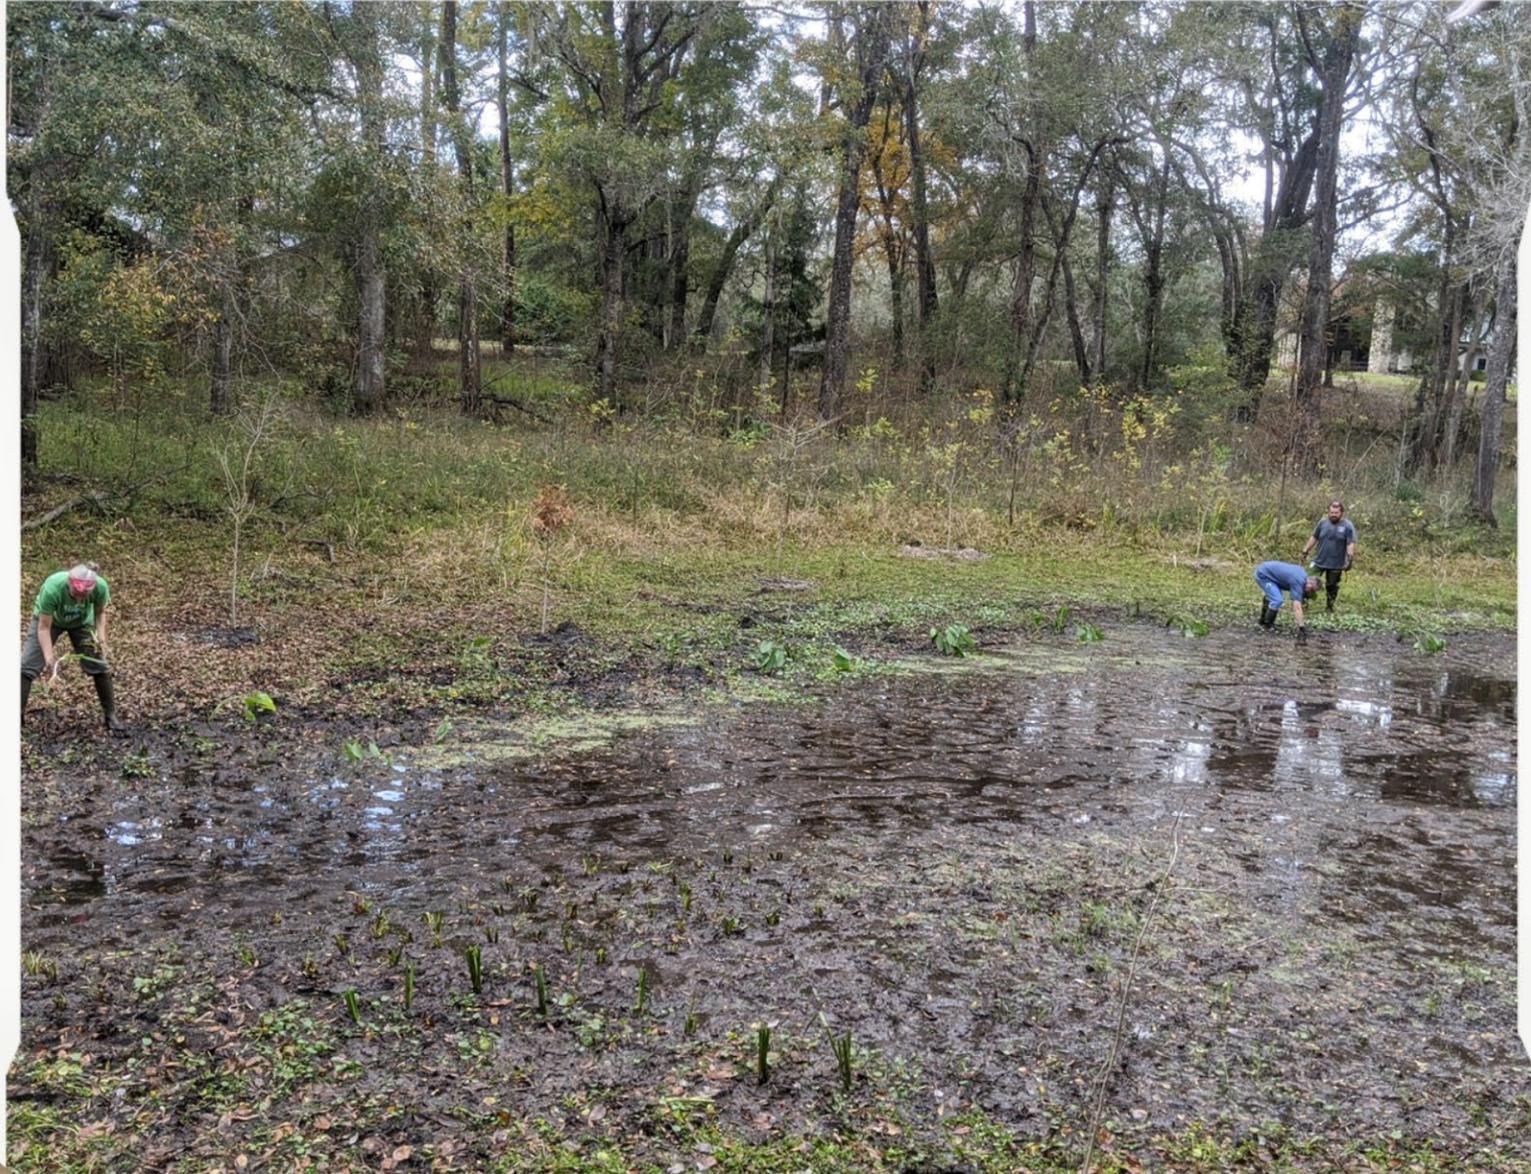
## Watermelon Springs Re-vegetation

### Legend

Planted Area
-

Native Trees
-

Native Shrubs  
and Palms
-

Native Wetland  
Herbaceous Plants

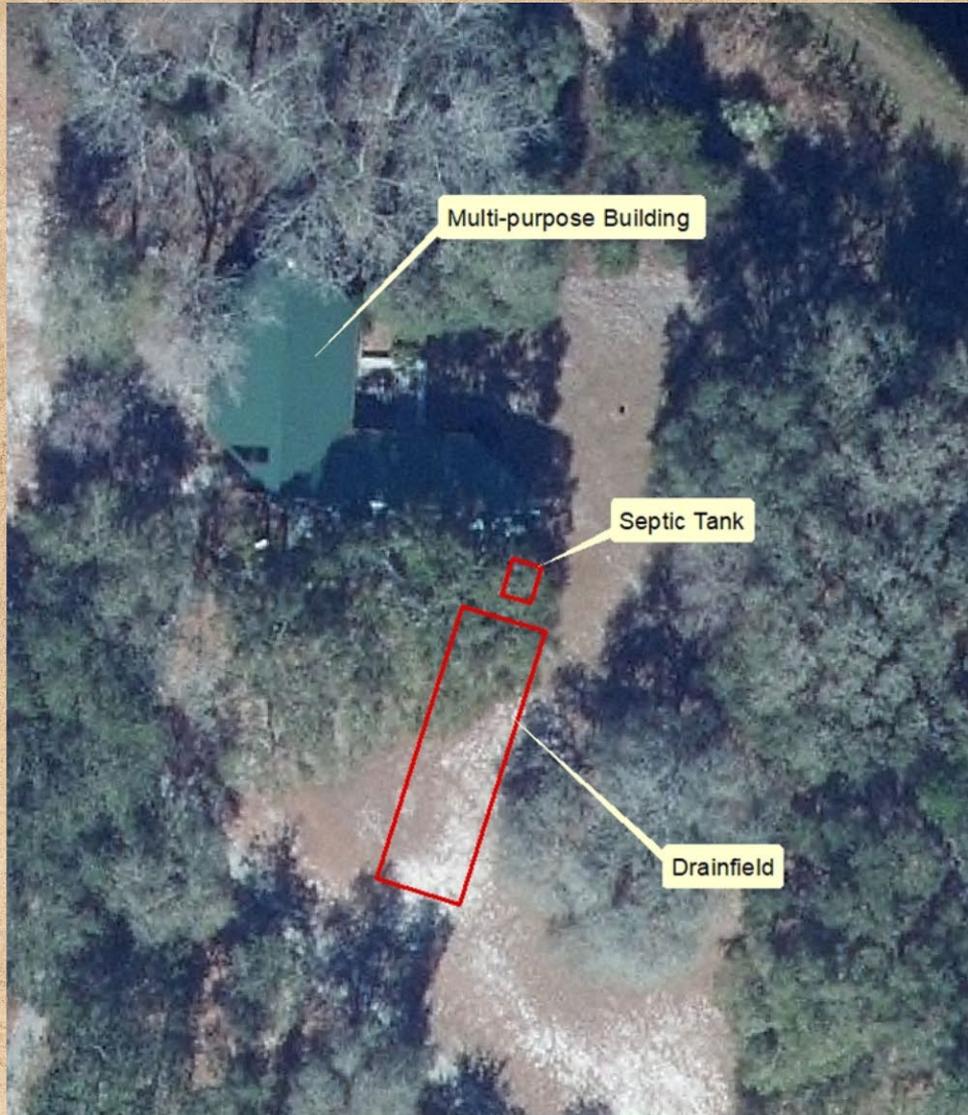
THE SEPTIC SYSTEMS  
AT THE LODGE AND  
CONCESSION WERE  
UPGRADED TO  
NUTRIENT REDUCING  
SYSTEMS THANKS TO  
GRANT FUNDS FROM  
SRWMD IN 2019 INTO  
2020.

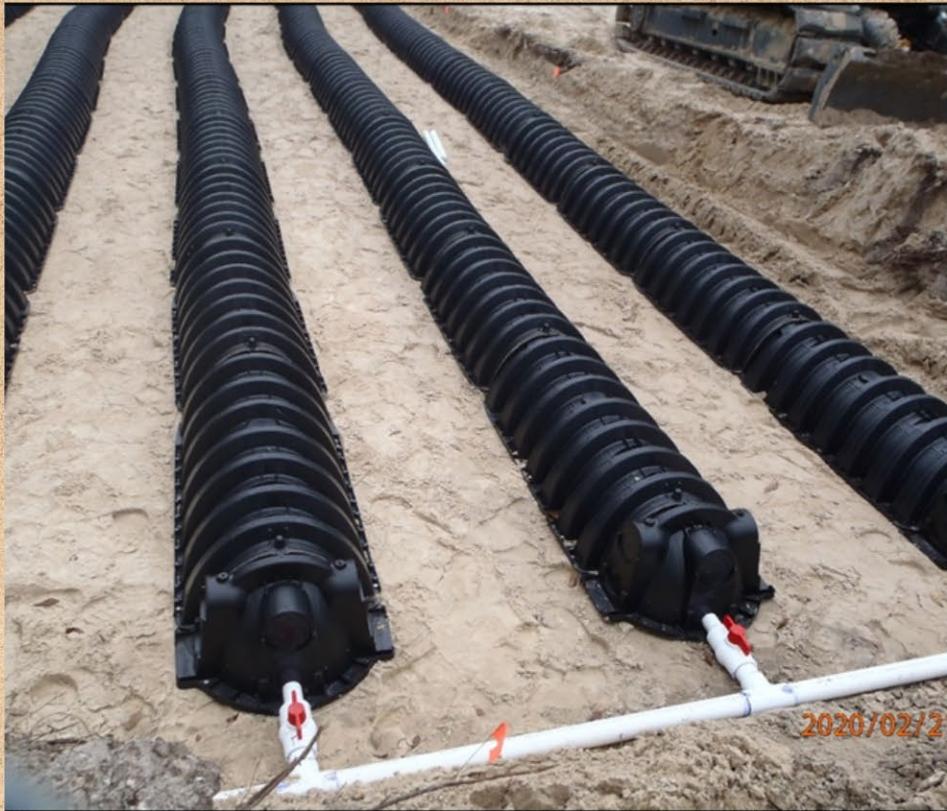
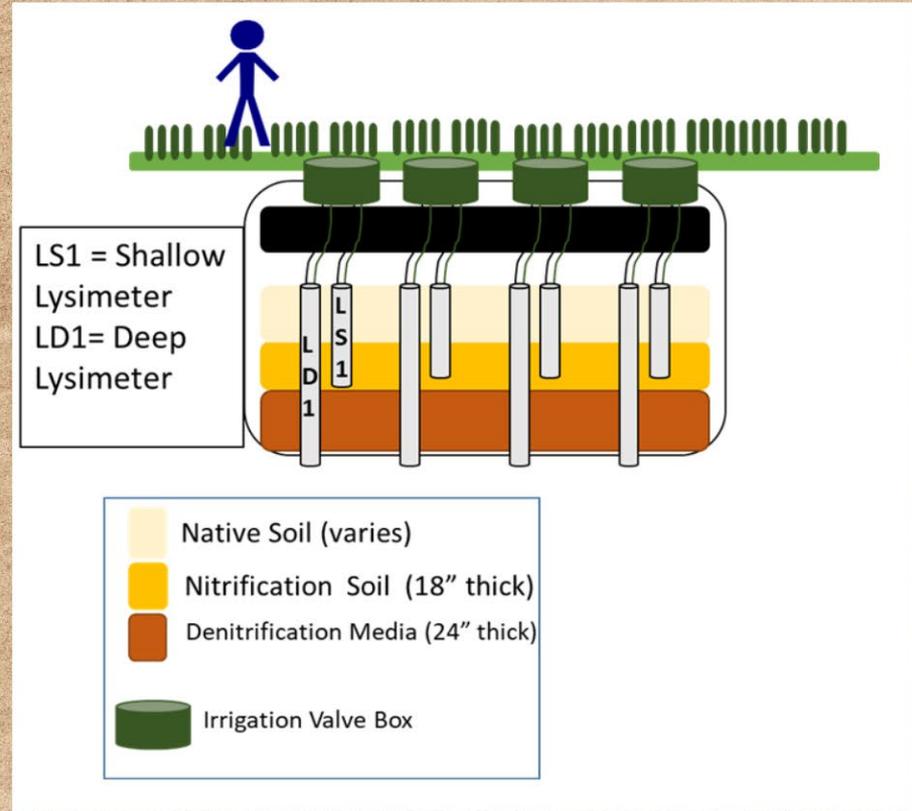
LS1 = Shallow Lysimeter  
LD1 = Deep Lysimeter

- Native Soil (varies)
- Nitrification Soil (18" thick)
- Denitrification Media (24" thick)
- Irrigation Valve Box

Piping installation for Drainfield Infiltration Chambers for the Concession Building OSTDS

The drainfields at Poe have been updated to In-ground Nitrogen Reducing Biofilter (INRB) systems. The INRB includes a sand layer where oxygen is present and a second layer of finer sand and wood chips that stays wet and un-oxygenated. INRB systems reduce nitrogen by facilitating the nitrogen cycle and turning the nitrate pollution into harmless nitrogen gas. This protects our water by reducing the amount of nitrogen that reaches the aquifer below, and which flows to the
