# Hornsby Springs Restoration Project

# Hornsby Spring Restoration Project

## **\$423,480 Springs Grant Funding for a Two Phased Project**

# Phase I Aeration Pilot Project Experiment

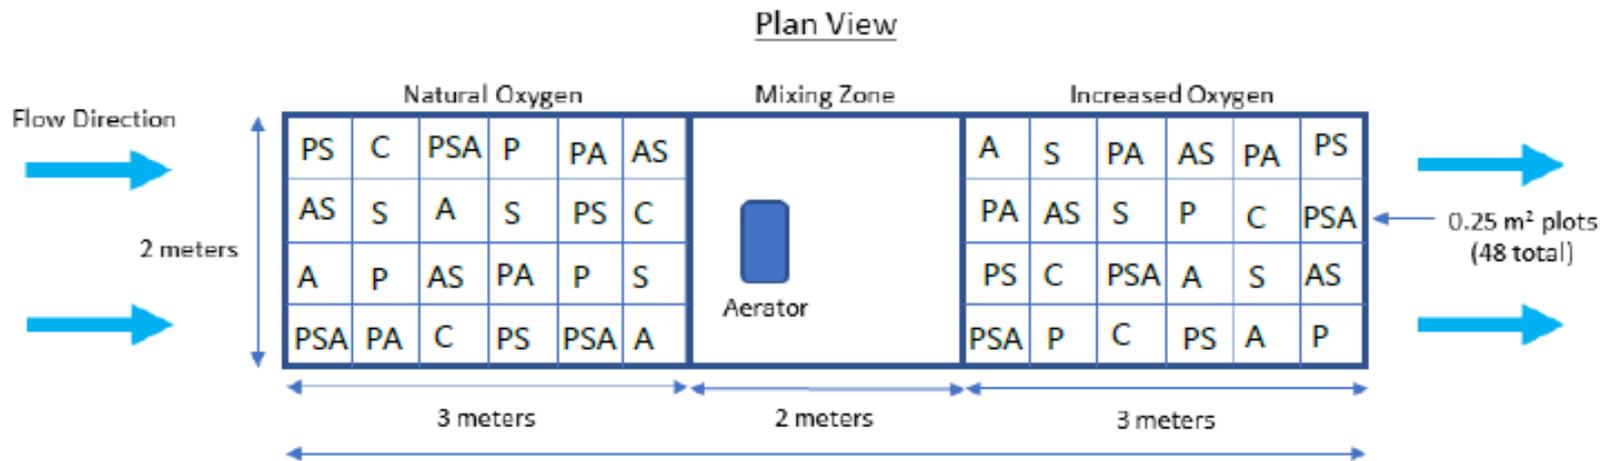
# Variables: Plants (P), Snails (S), Removal of Algae (A), and Control (C)

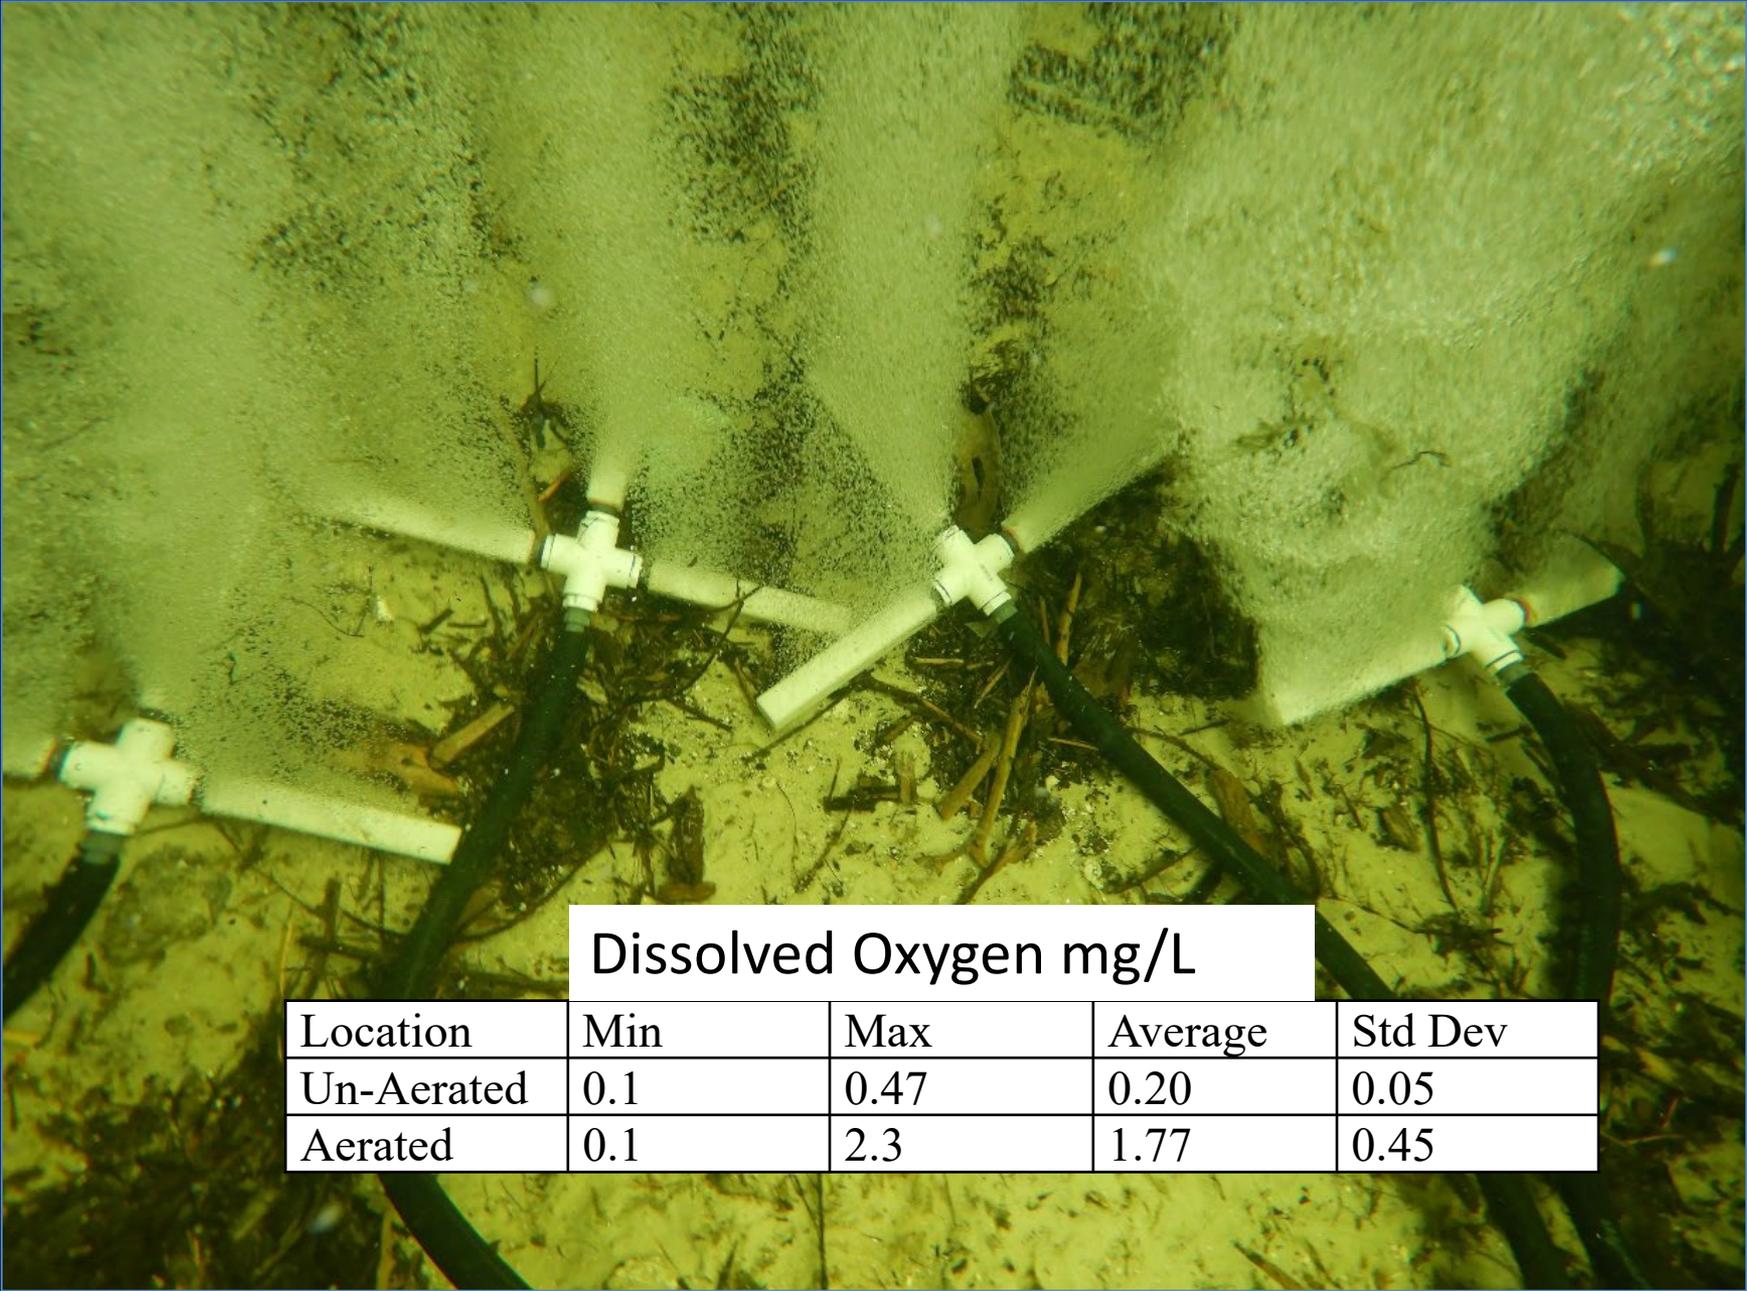
16 total treatments, 3 replications

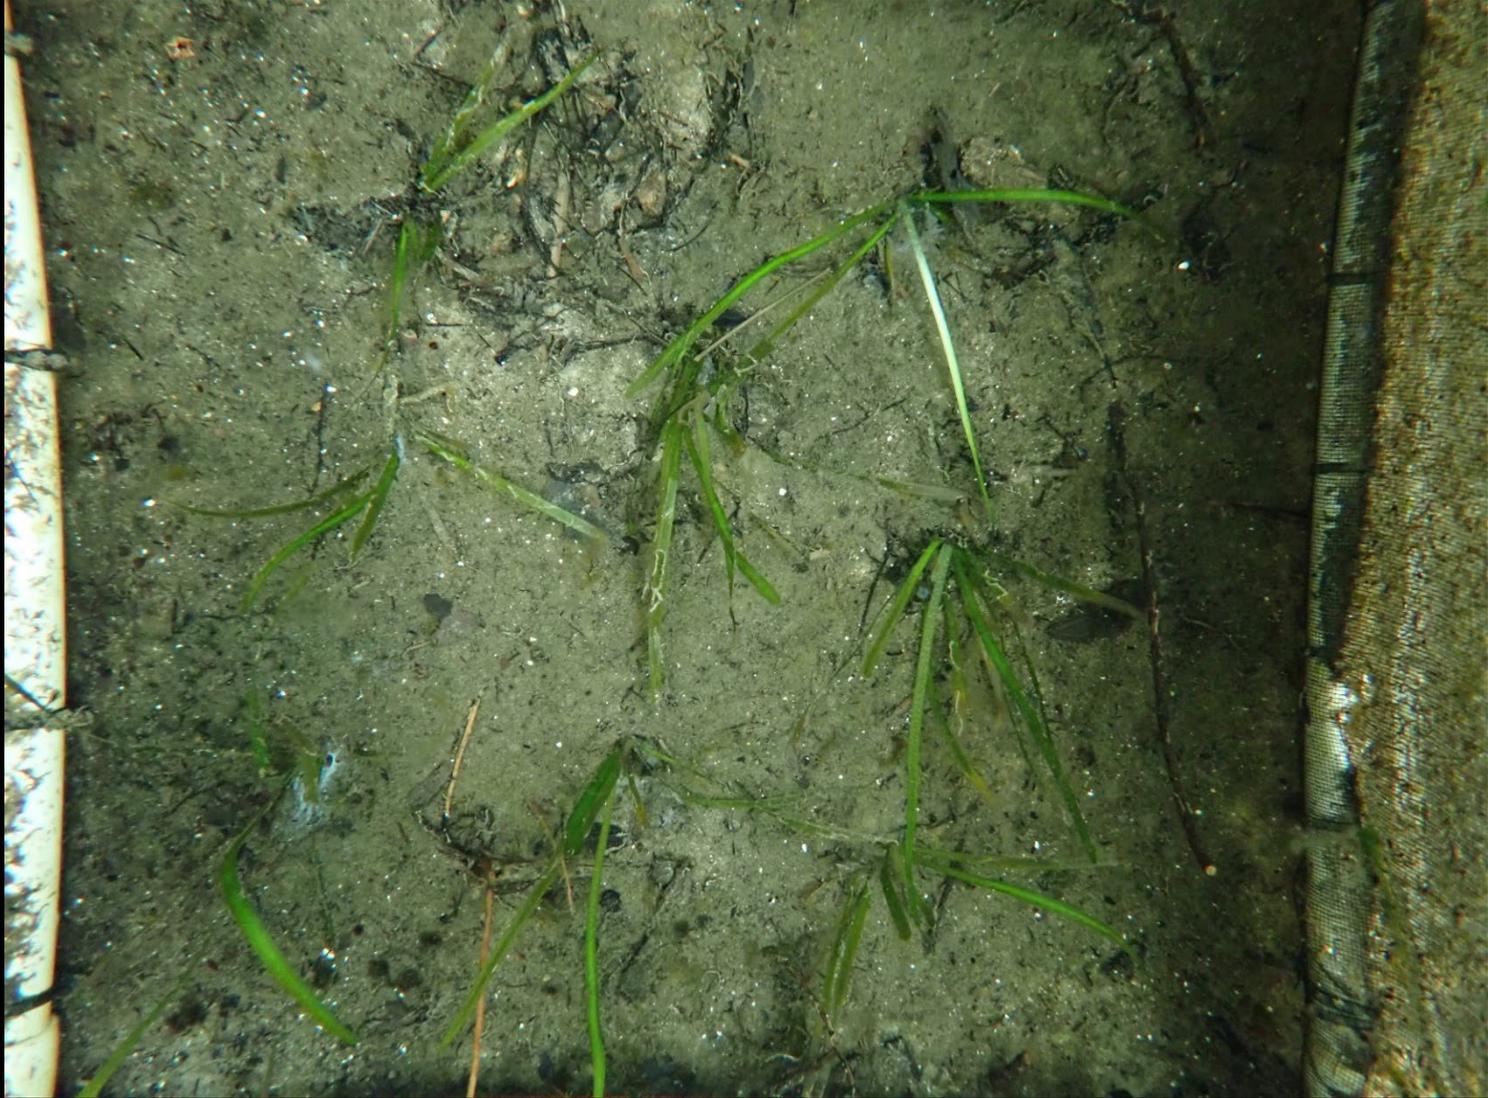
Unaired PSA 11 days

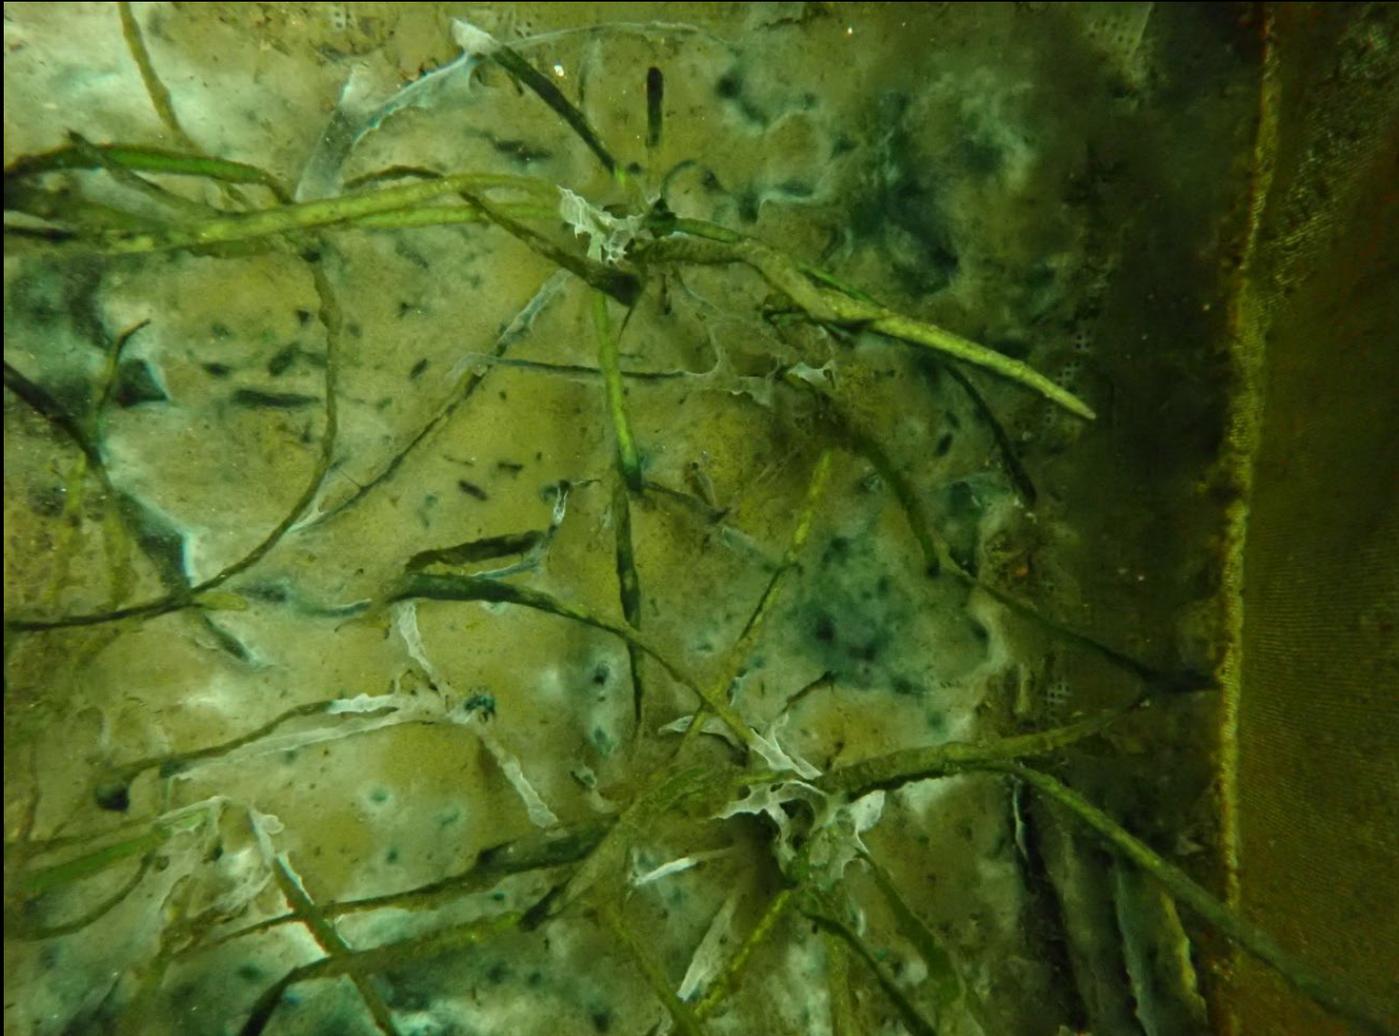
Unaerated PSA 25 days

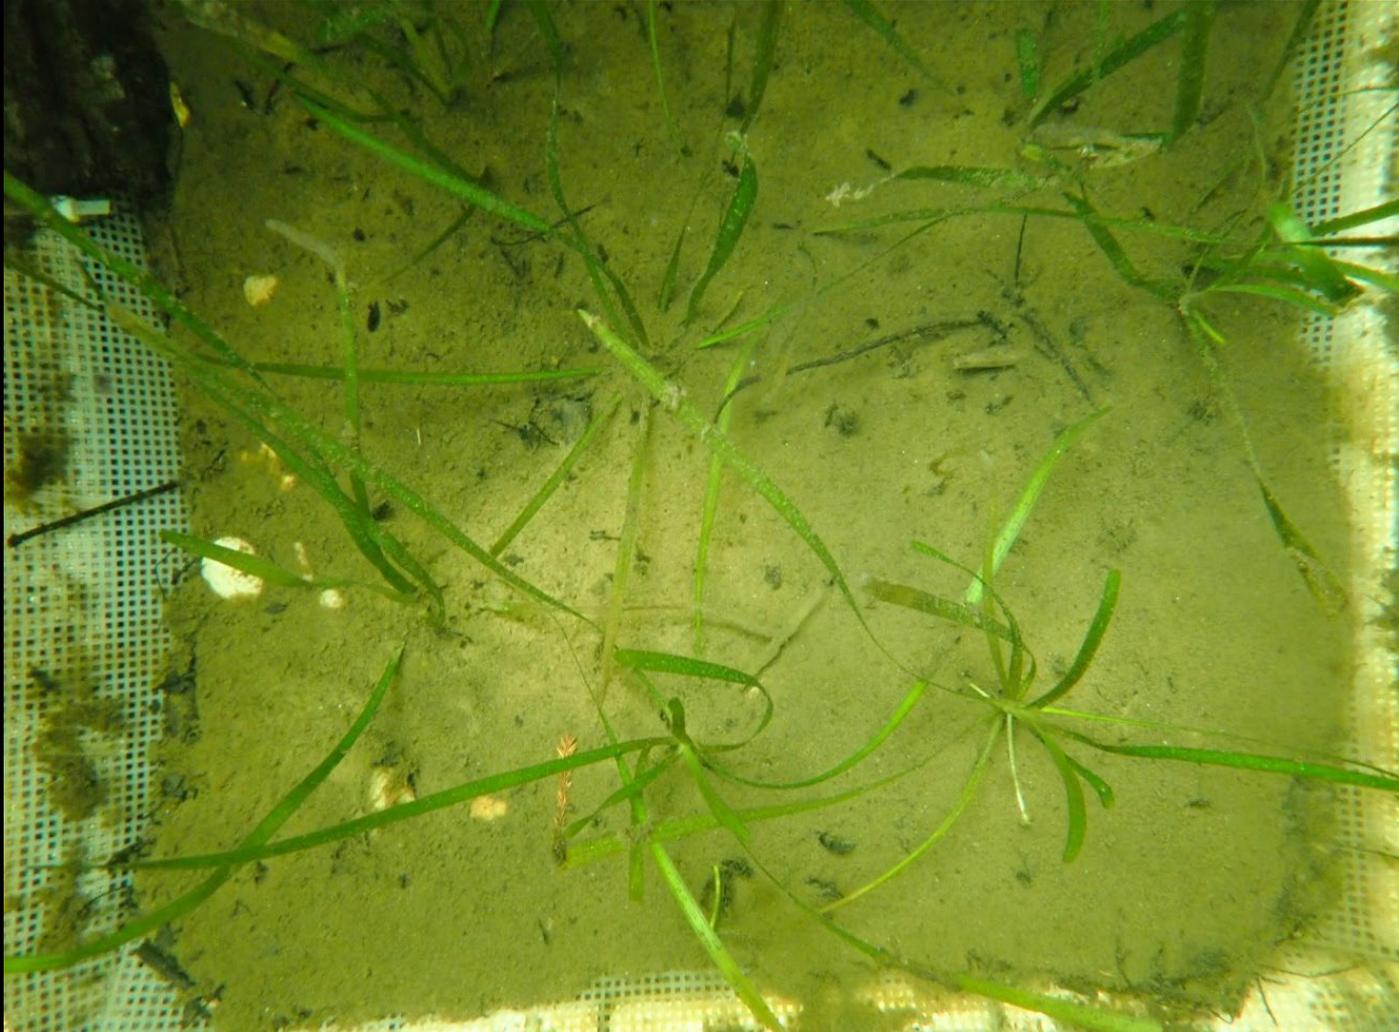
Unaerated PSA 57 days

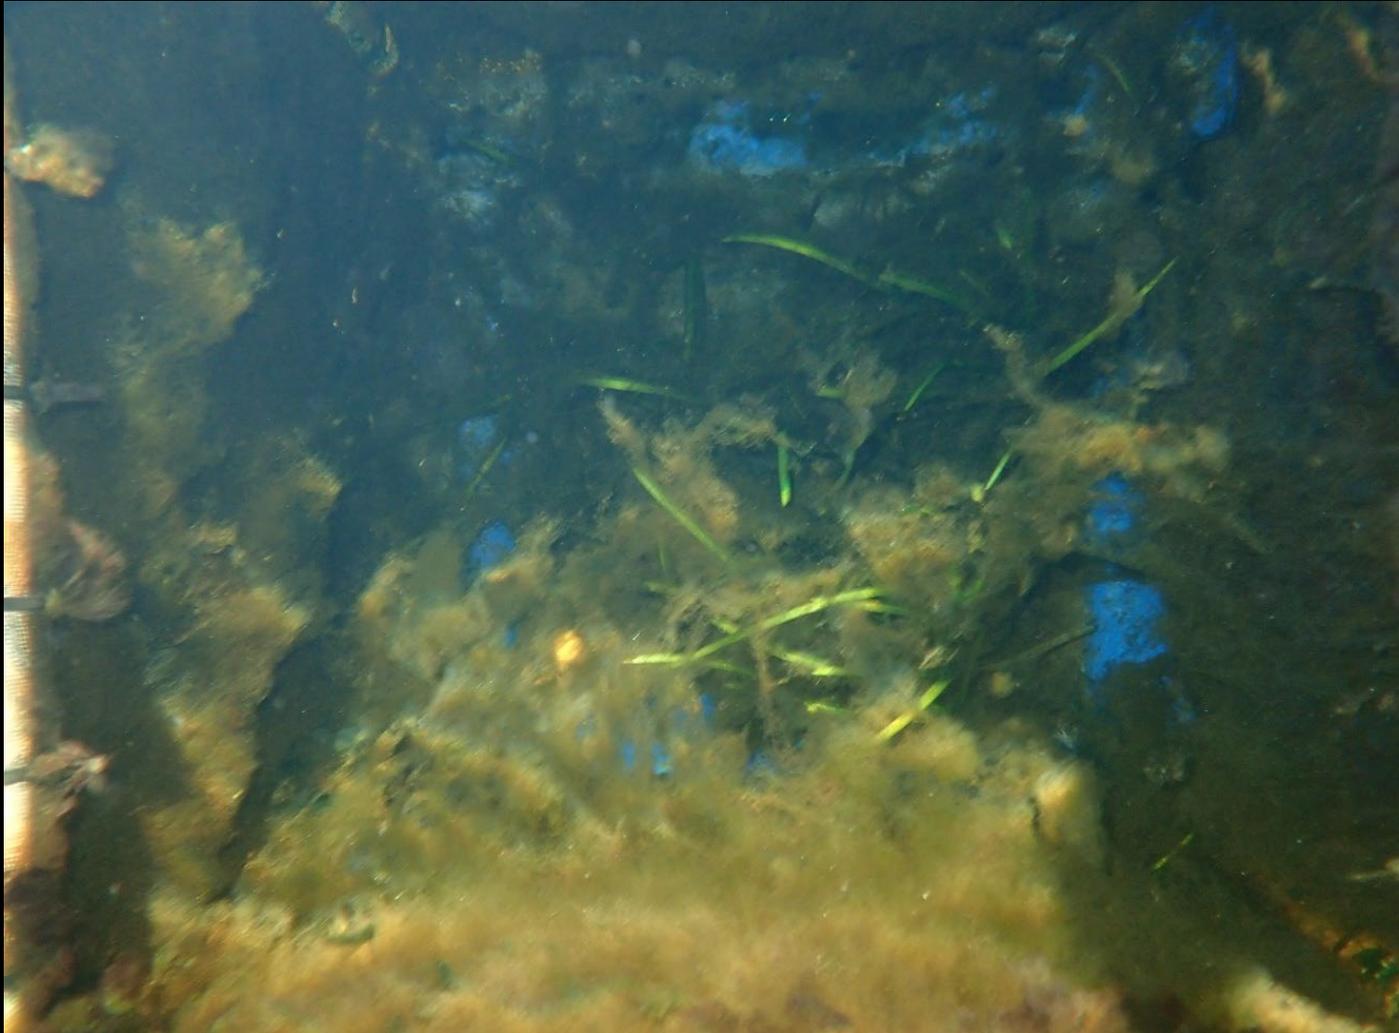
Unaerated PSA 102 days

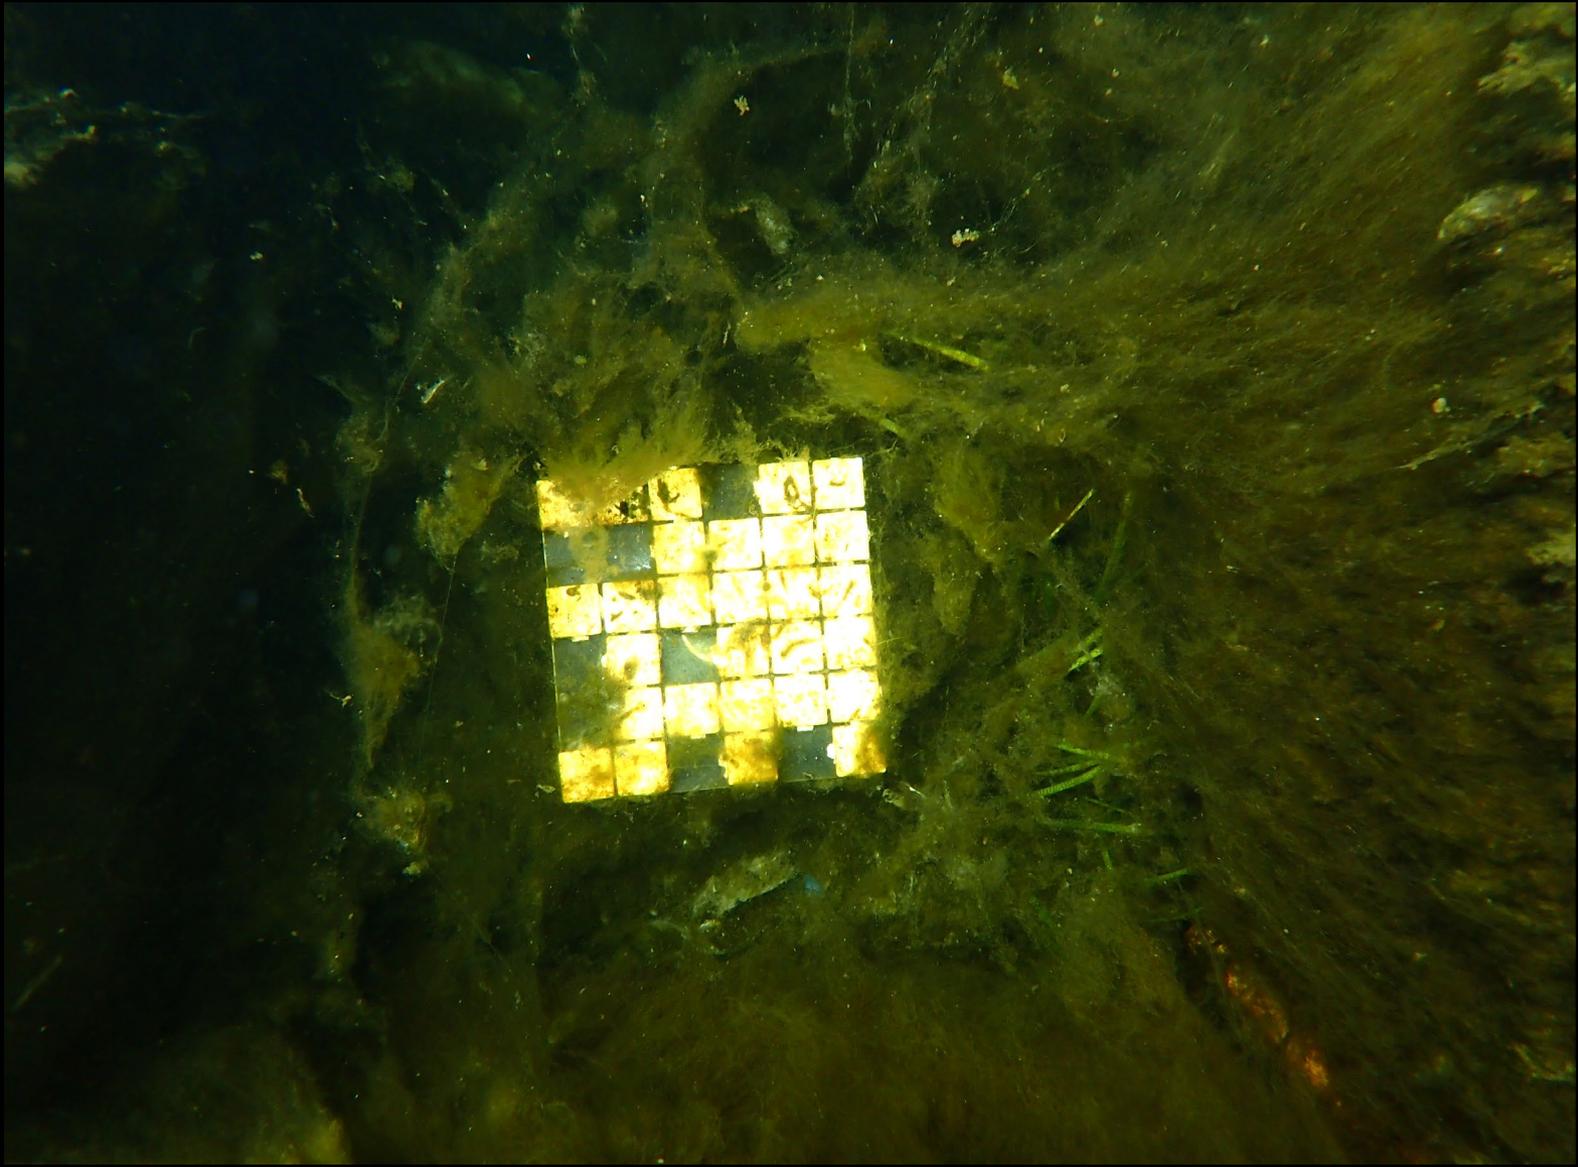
Unaerated PSA 340 days

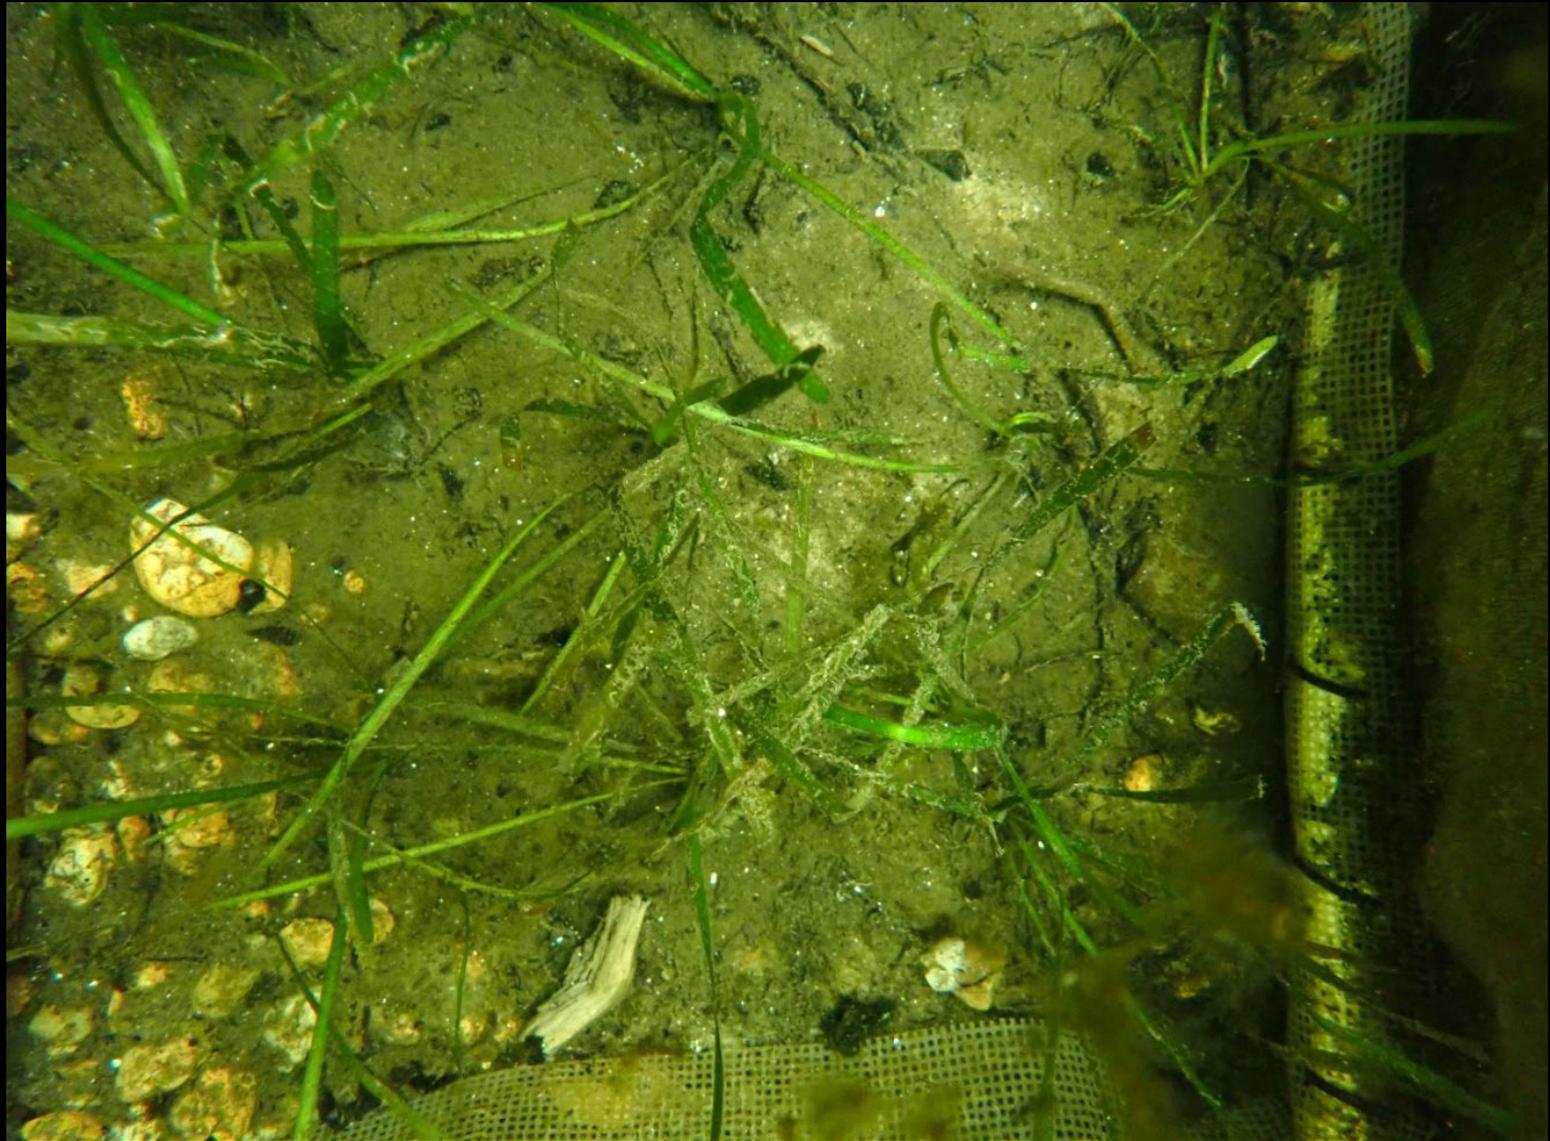
Aerated PSA 11 days

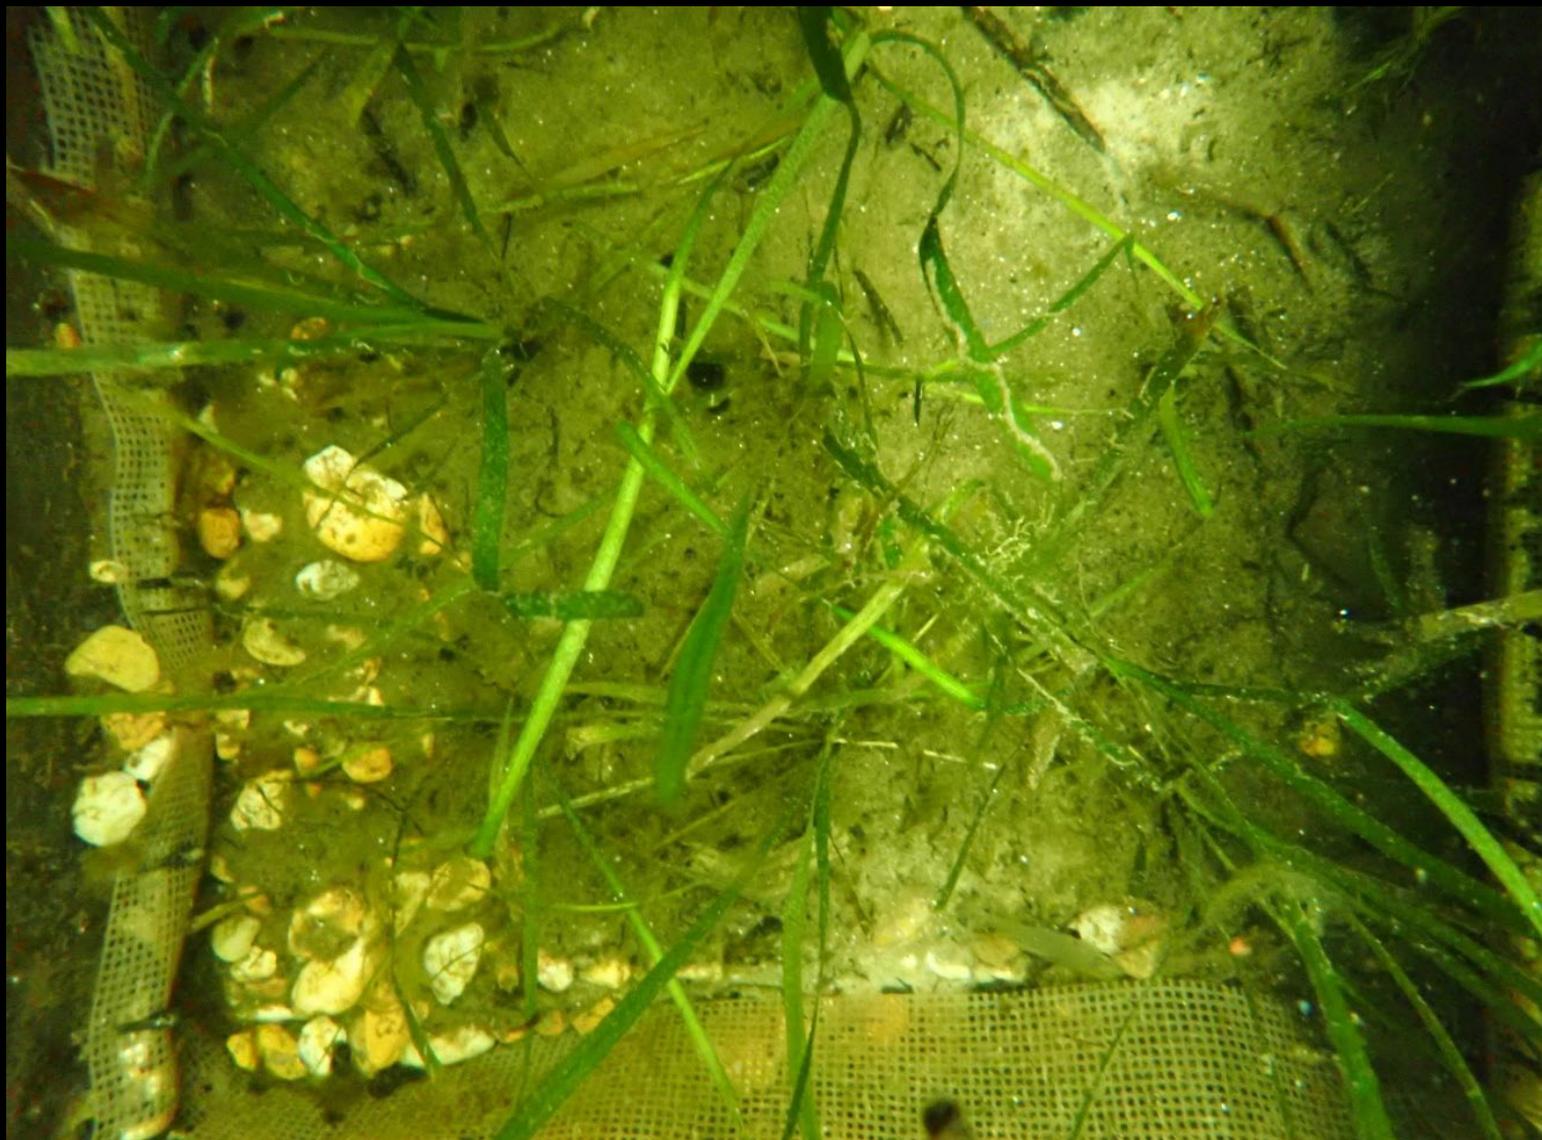
Aerated PSA 25 days

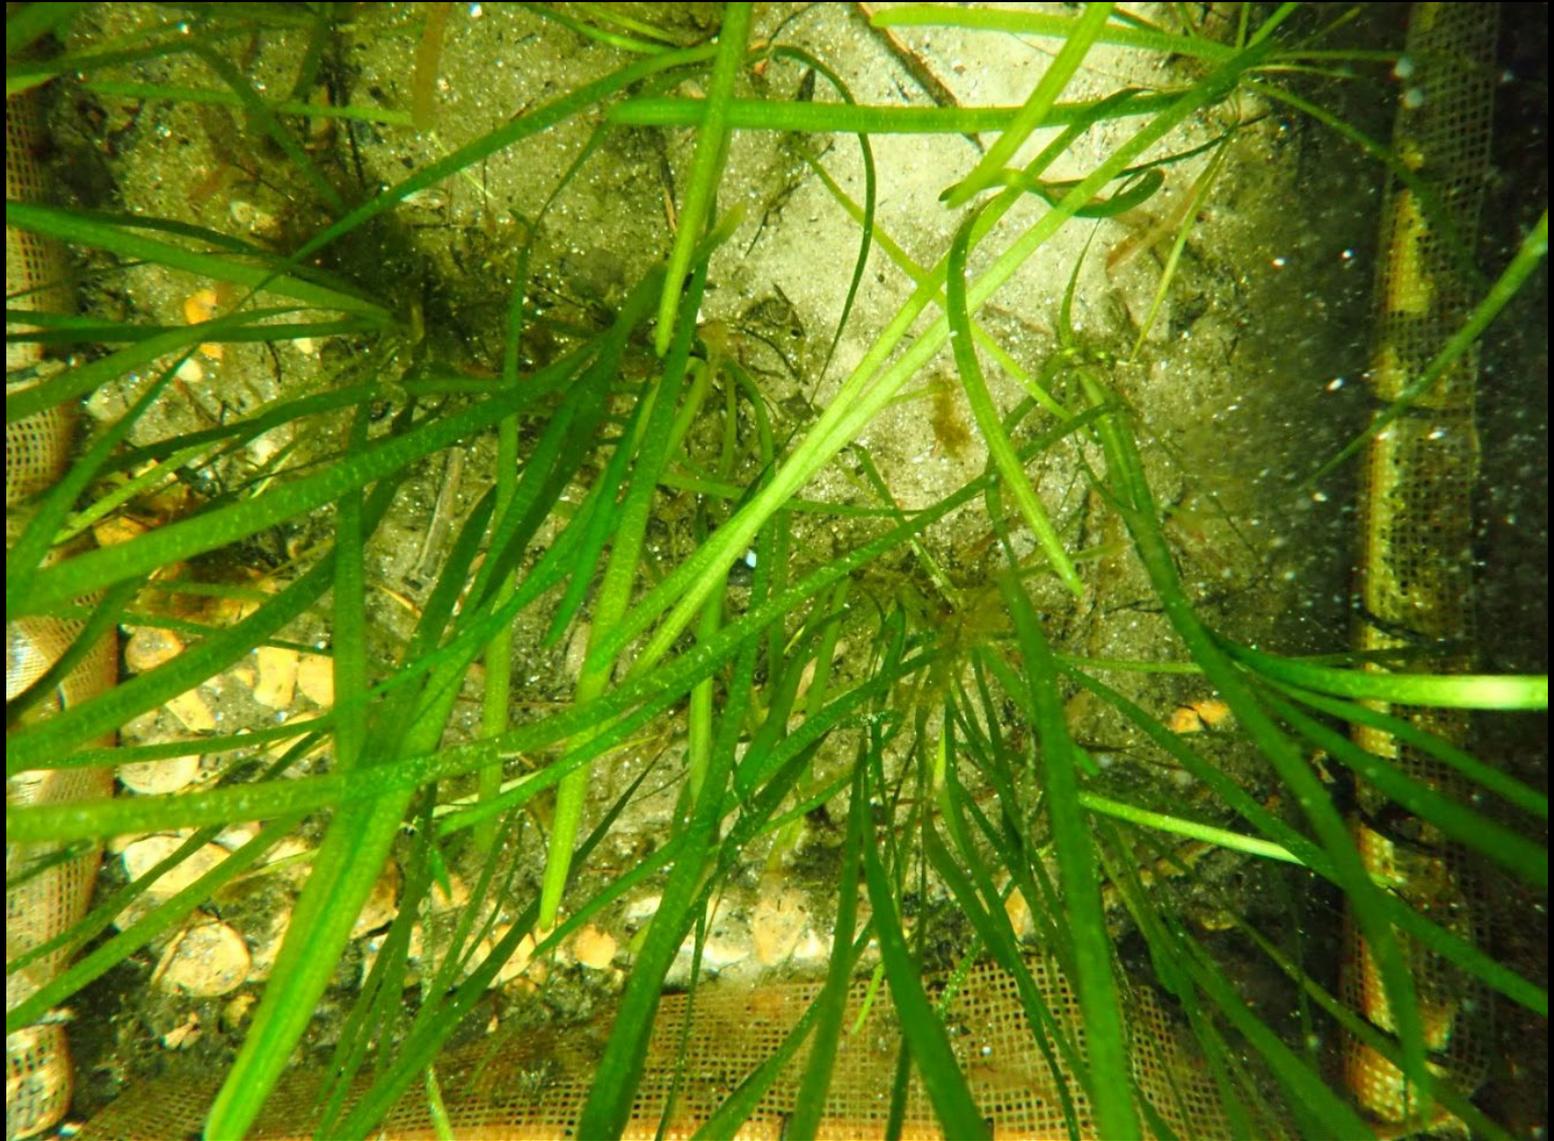
Aerated PSA 57 days

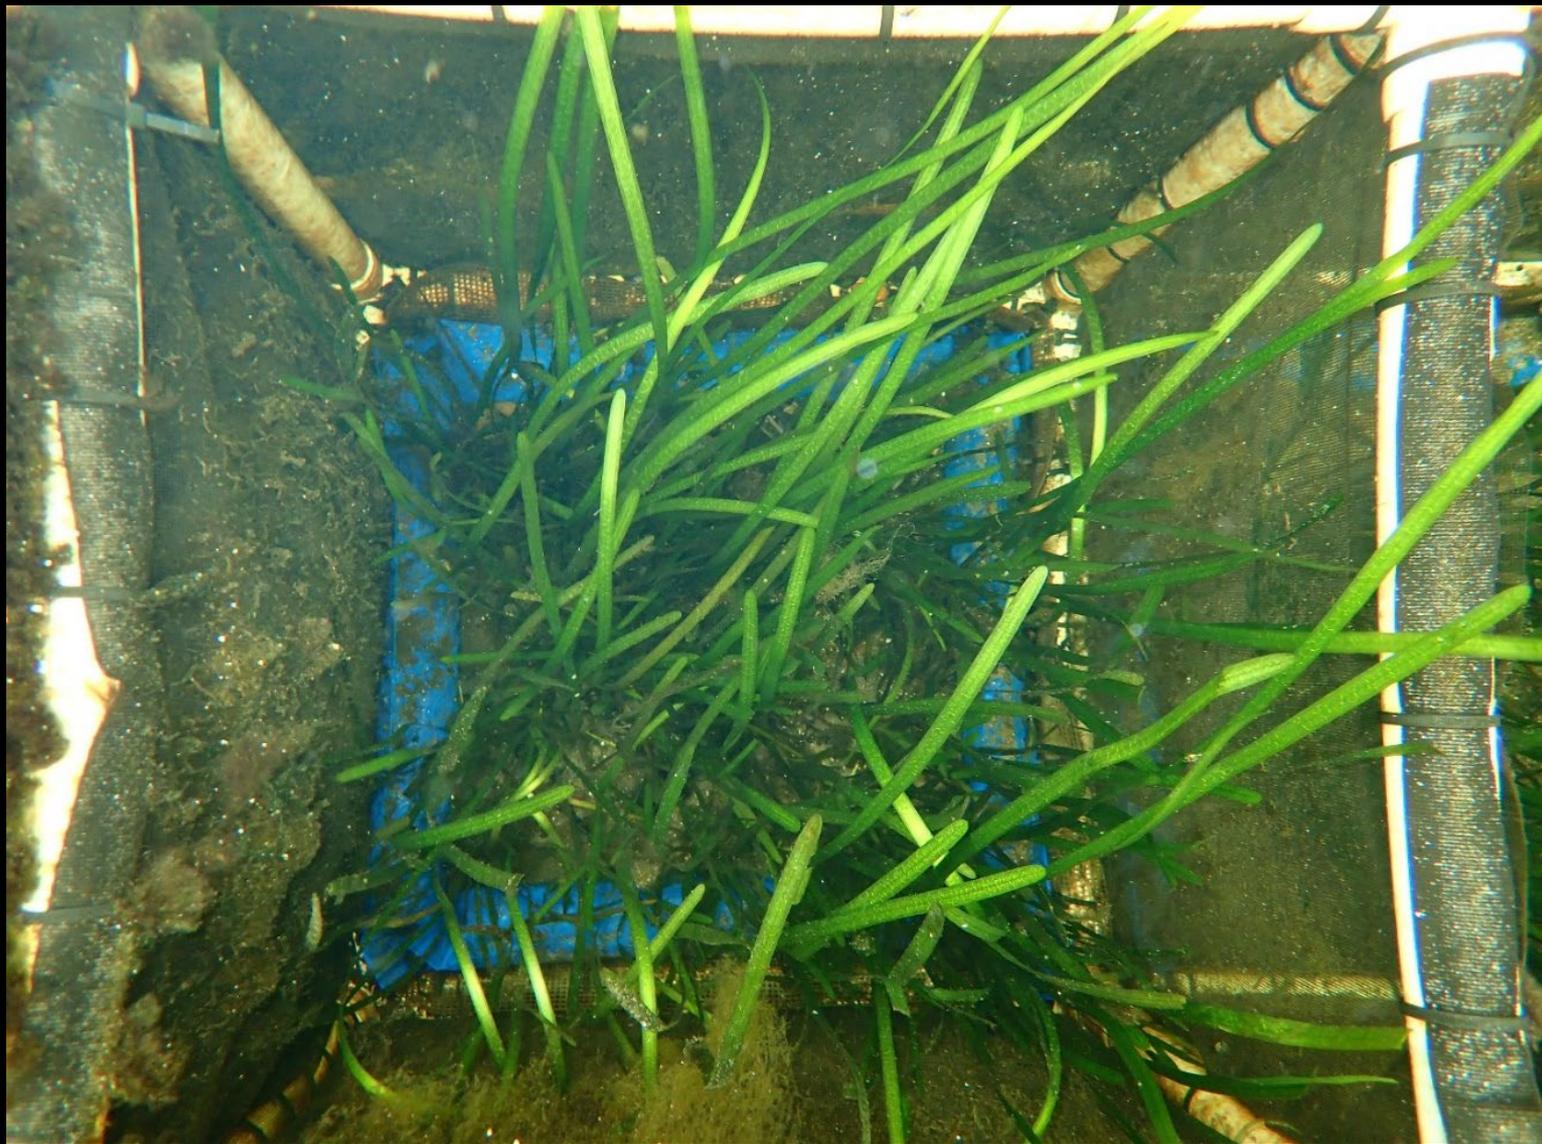
Aerated PSA 102 days

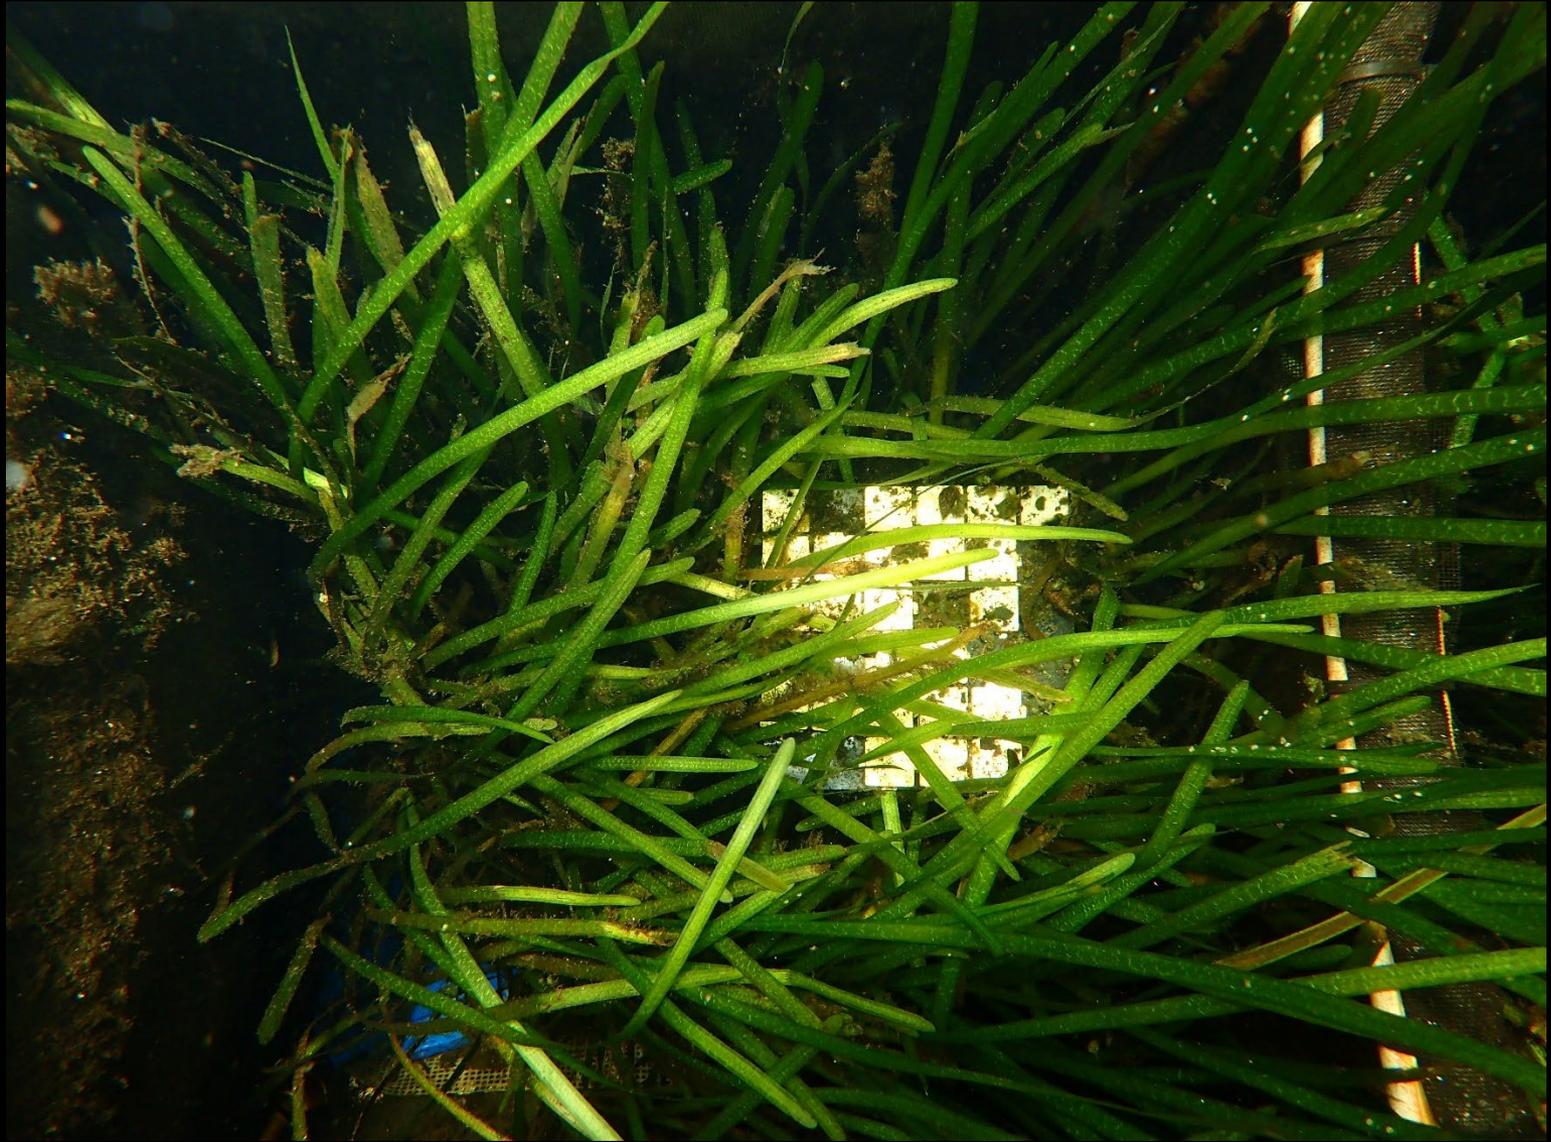
Aerated PSA 340 days

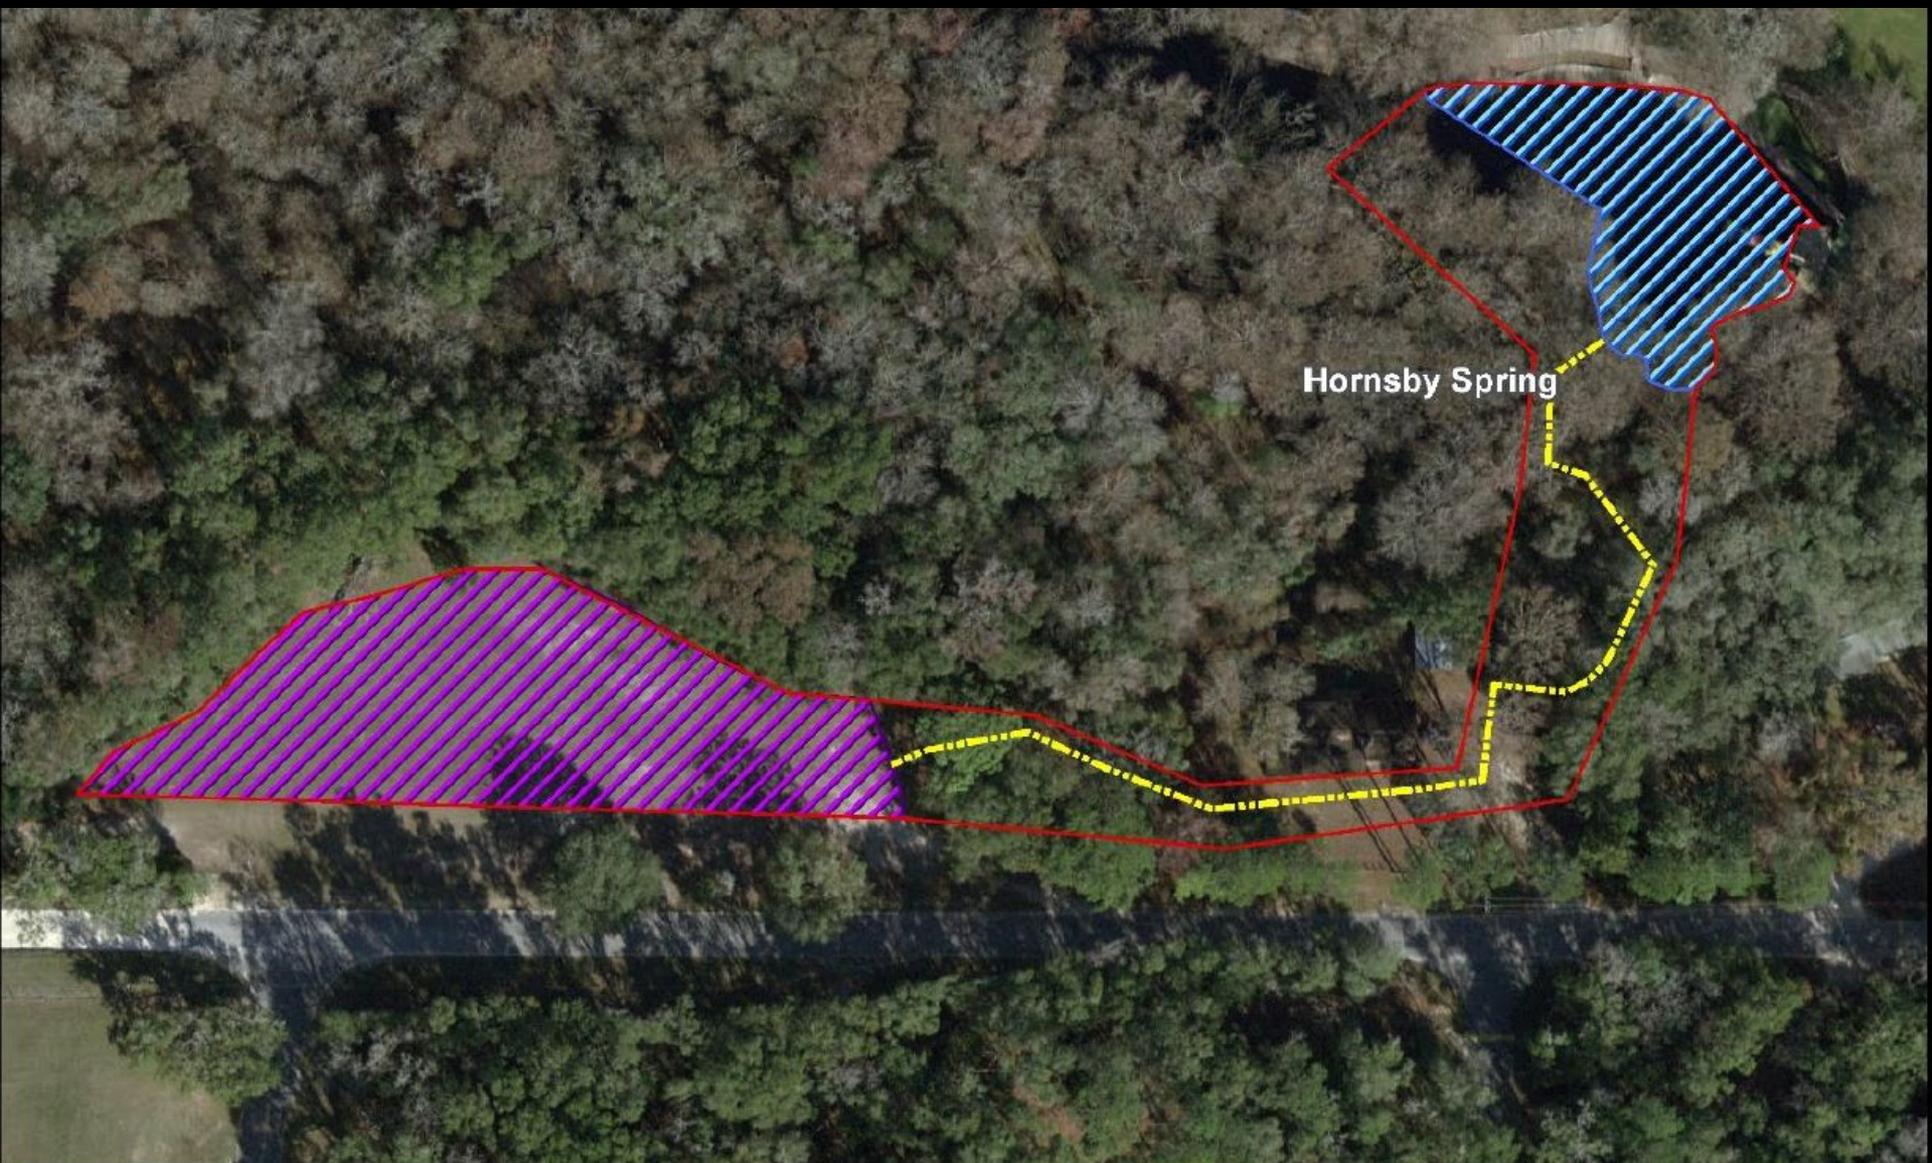
Hornsby Spring

Project Area
-

Muck/Algae Removal Area
-

Staging/Dewatering Area
