# Hornsby Springs Restoration Project

# Hornsby Spring Restoration Project

## **\$423,480 Springs Grant Funding for a Two Phased Project**

# Phase I Aeration Pilot Project Experiment

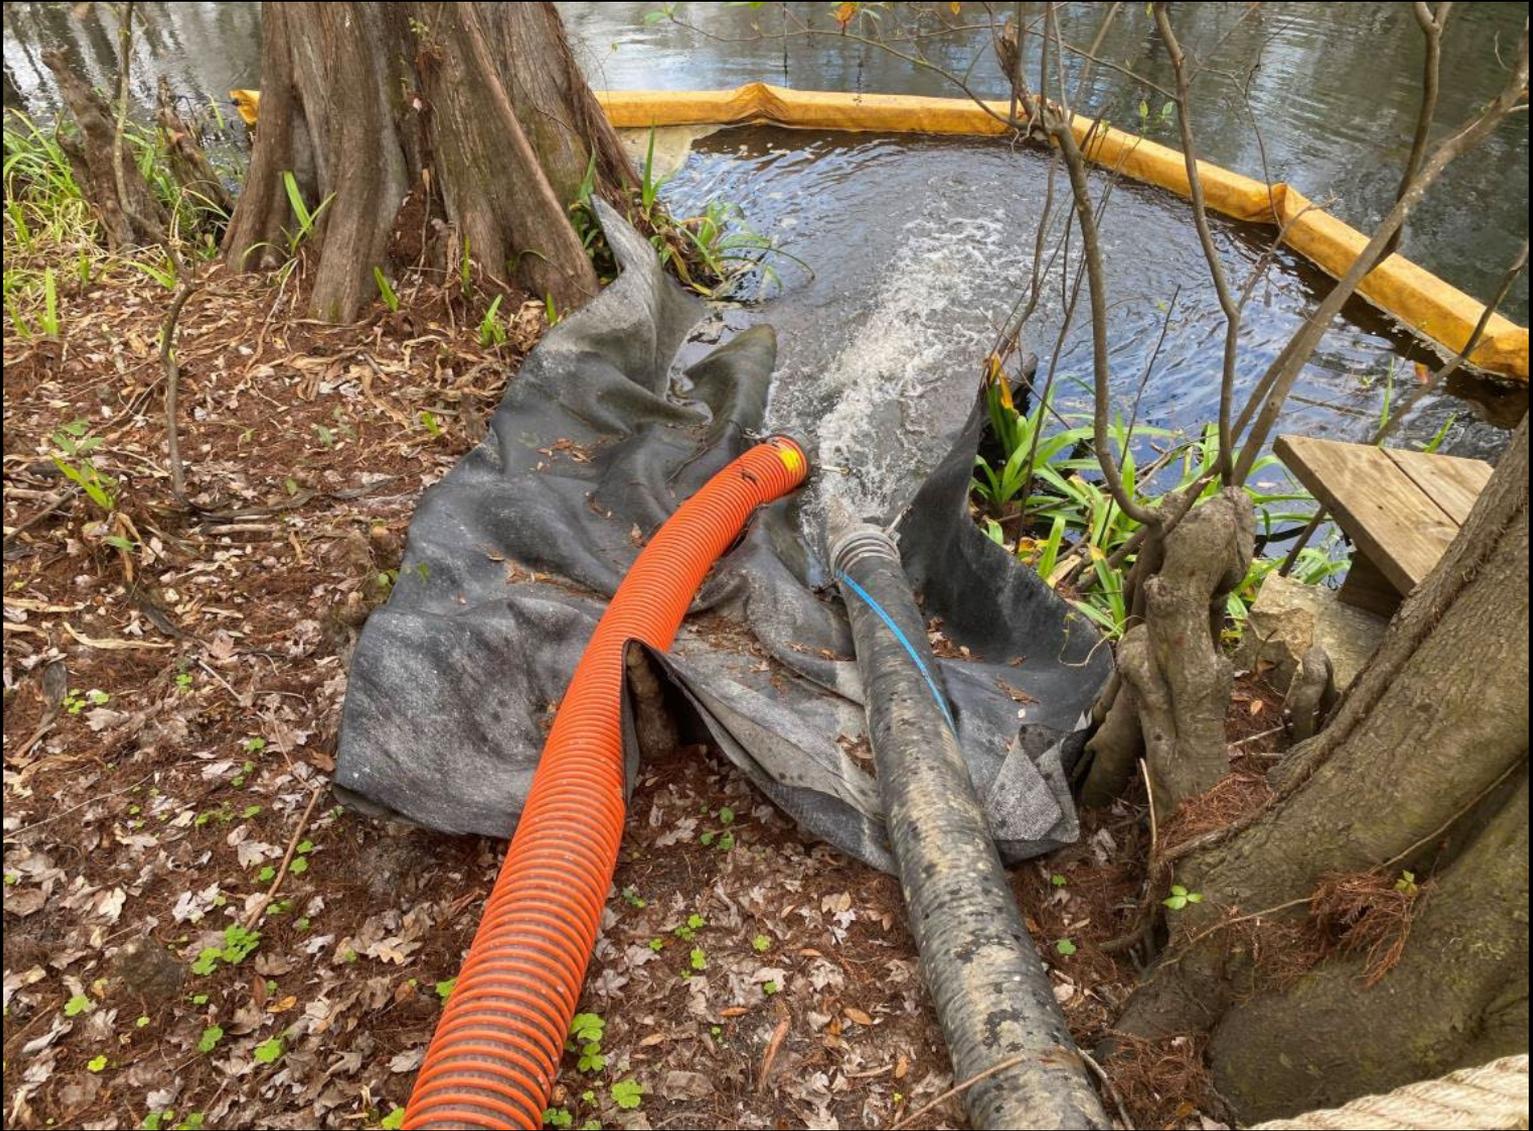
Water Return with Erosion Controls

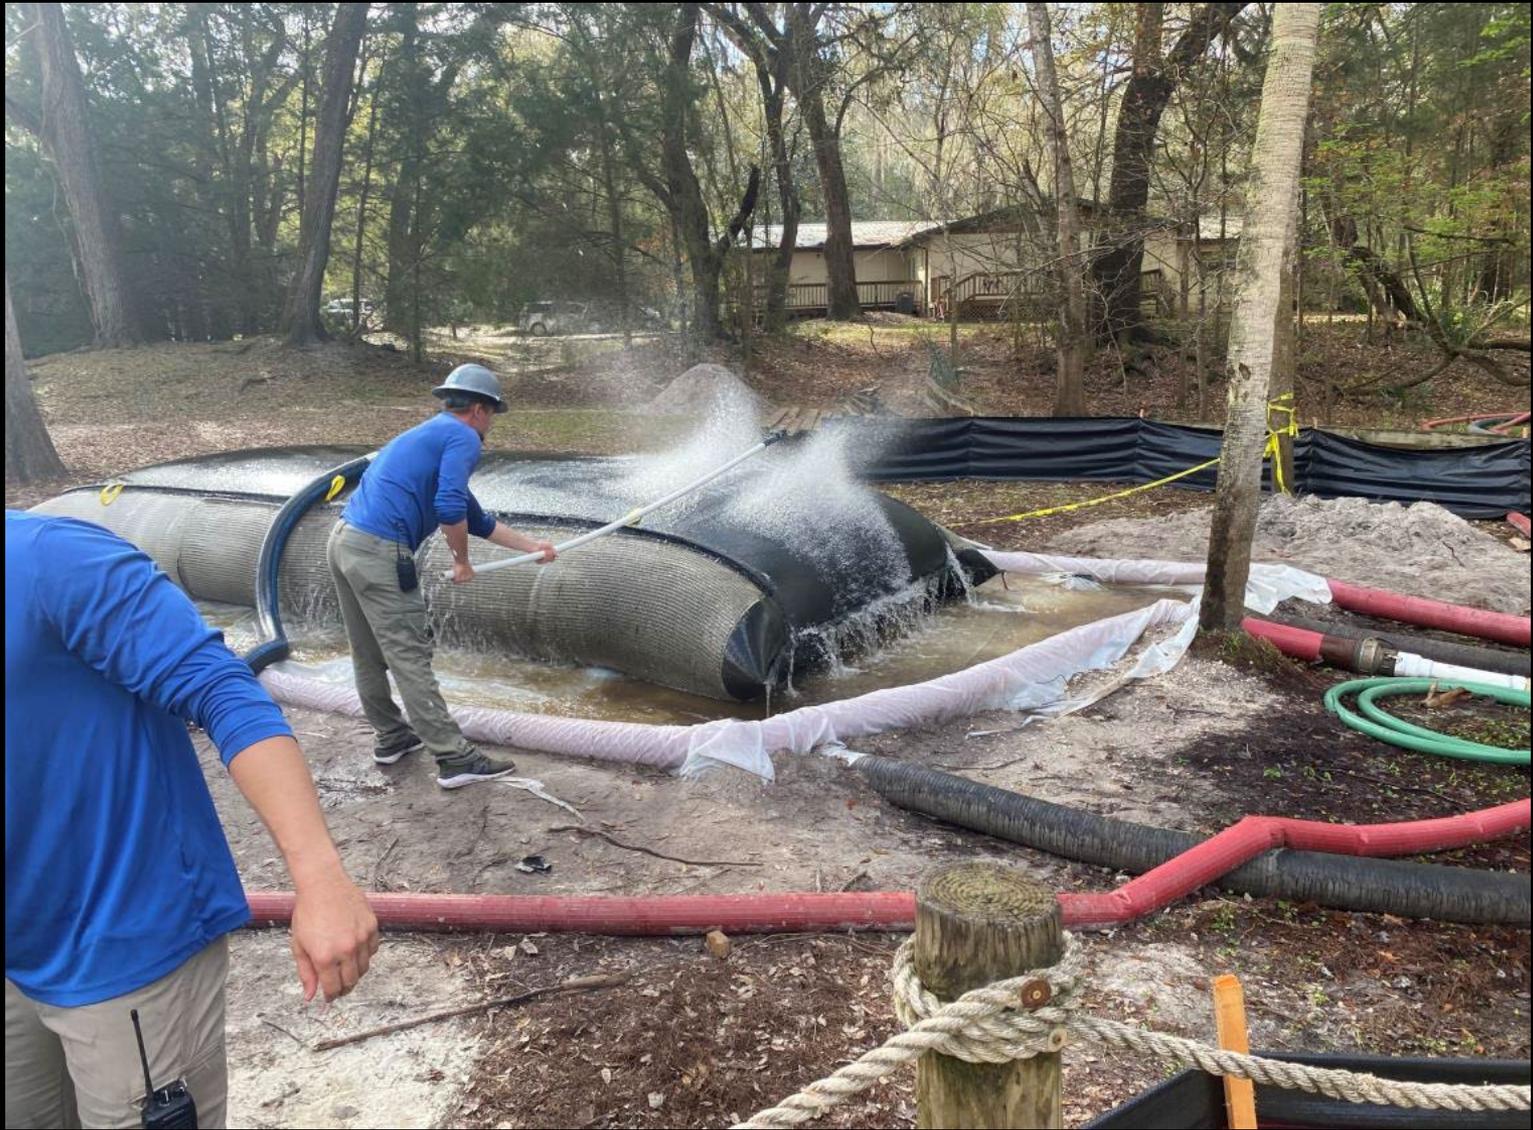
Geotube Bag to Prevent Turbidity of Return Water

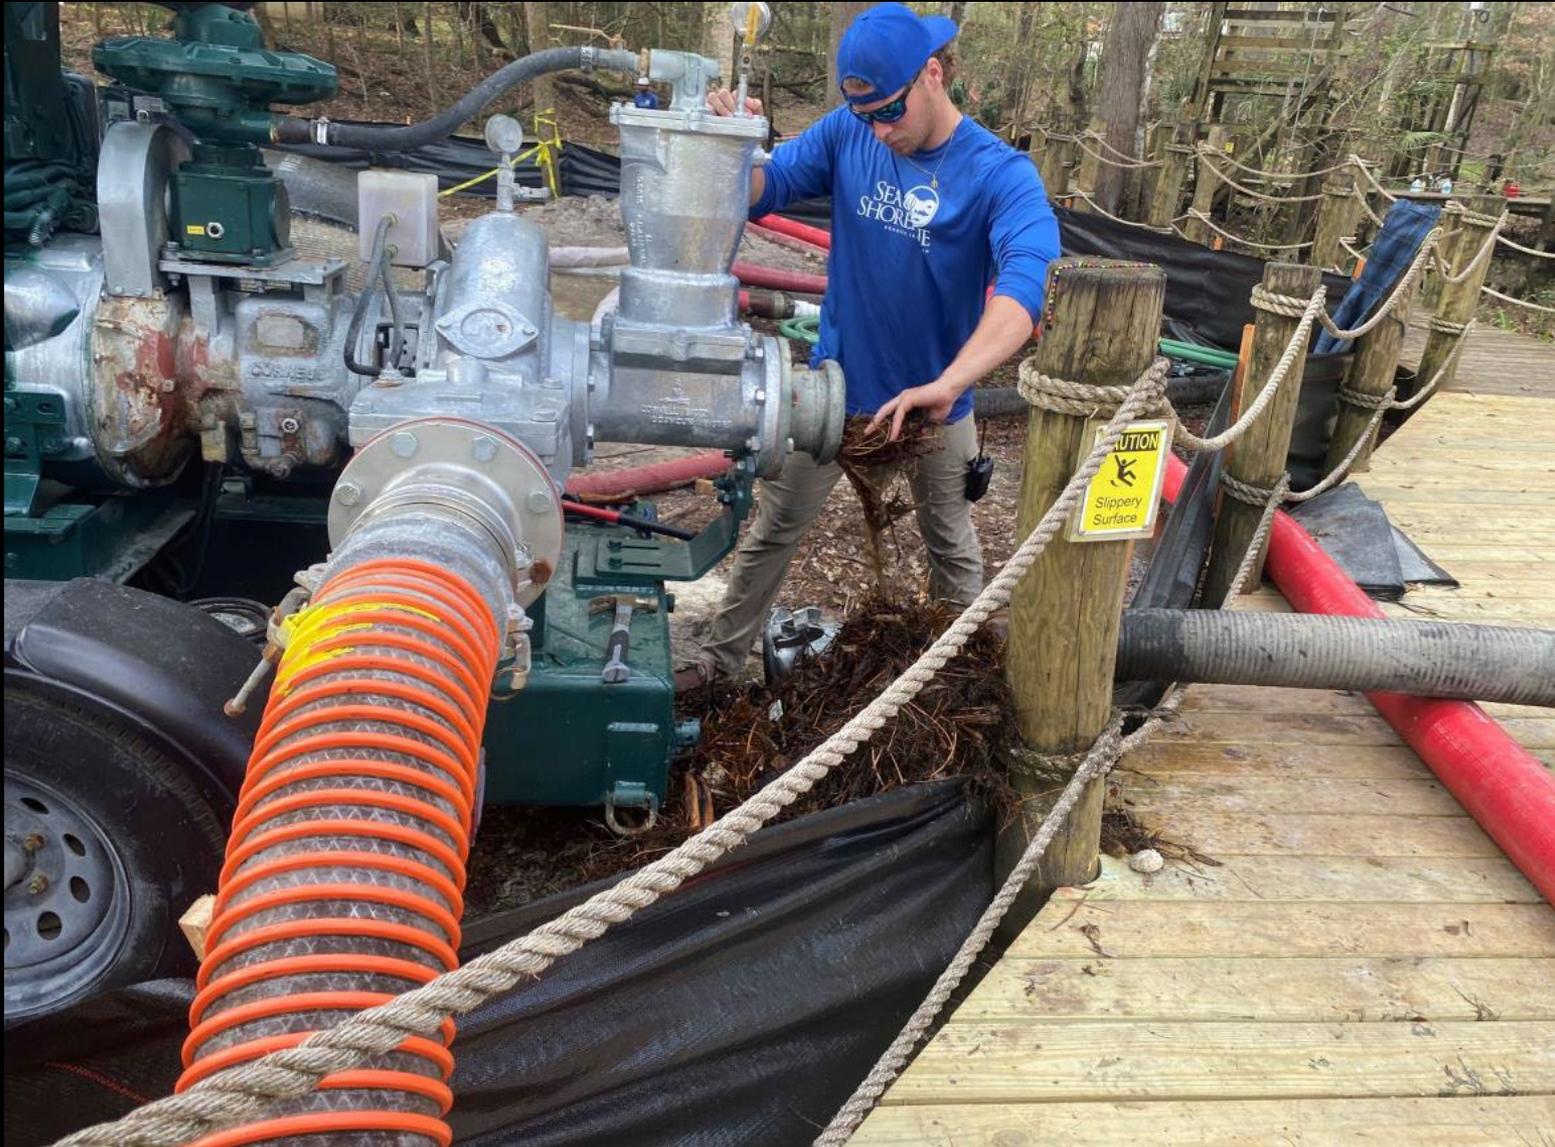
Debris Being Removed from Pump

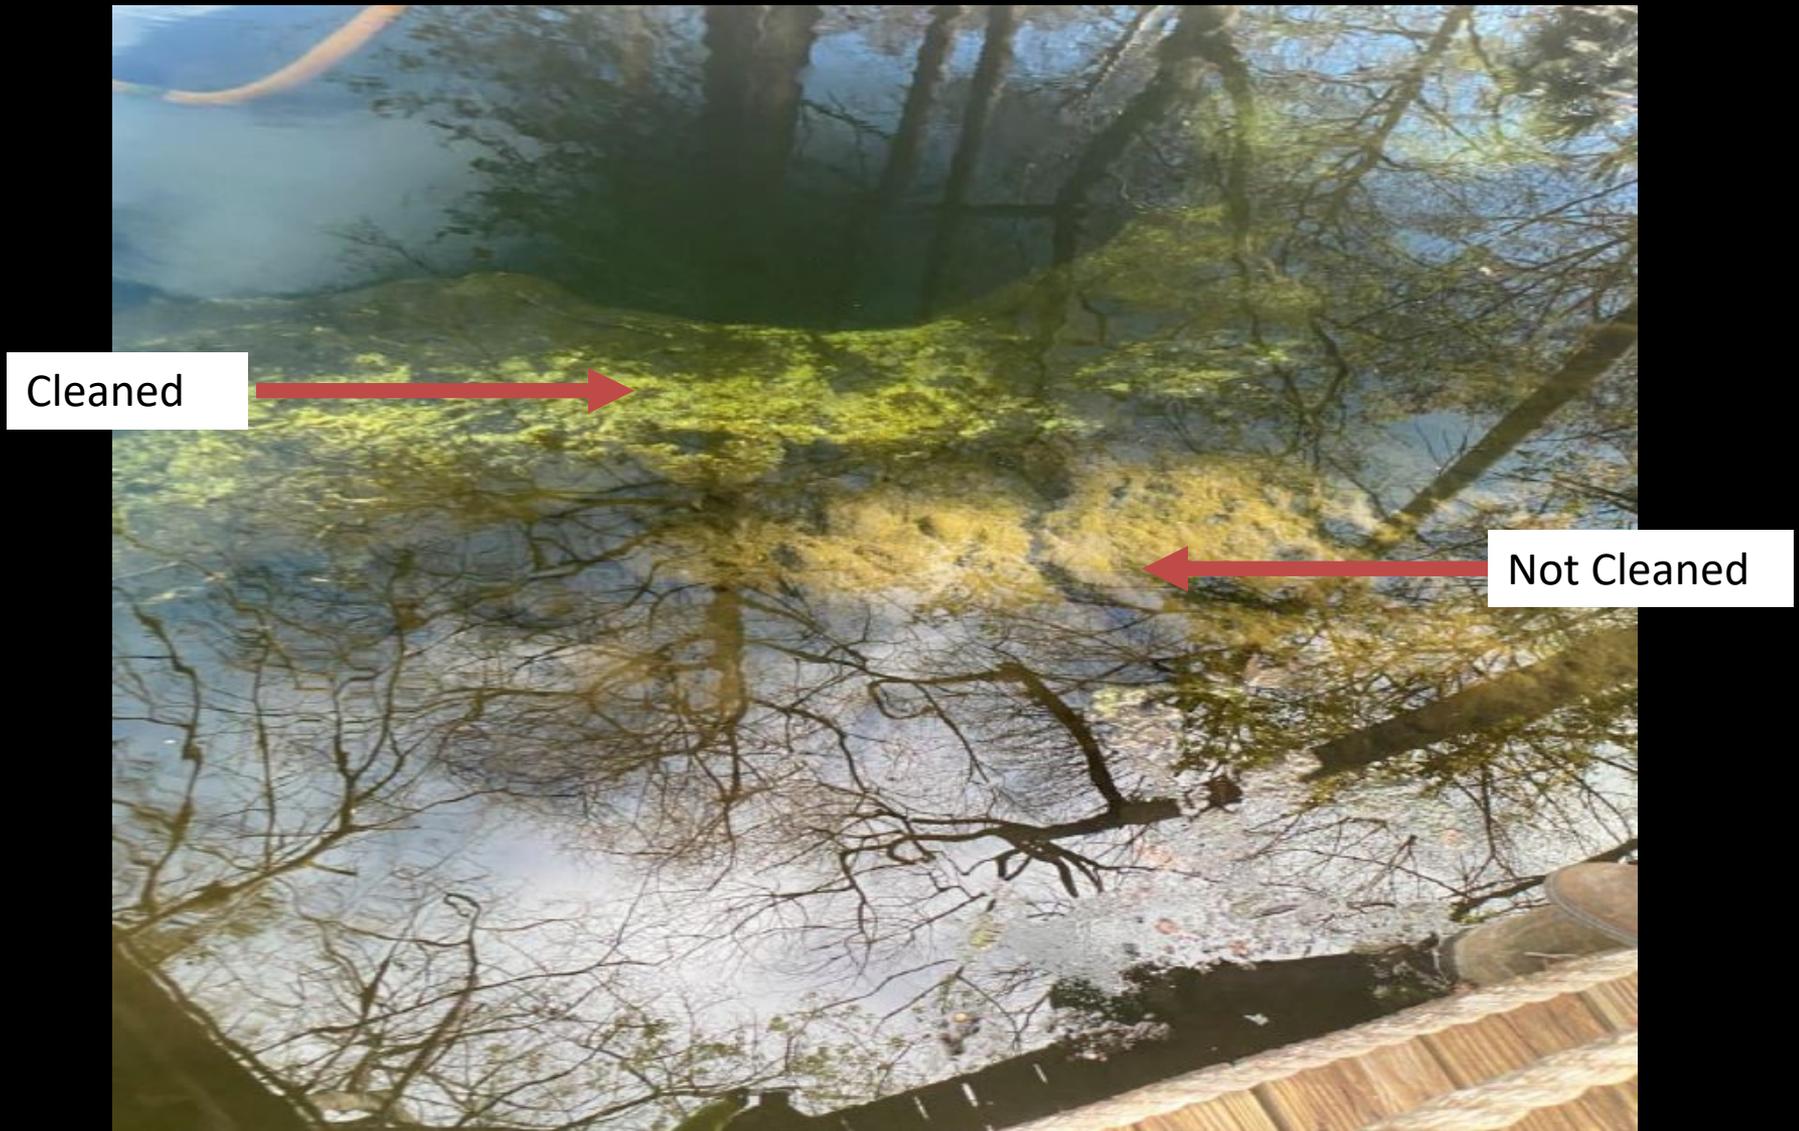
Removal Area Comparison of Cleaned vs Uncleaned

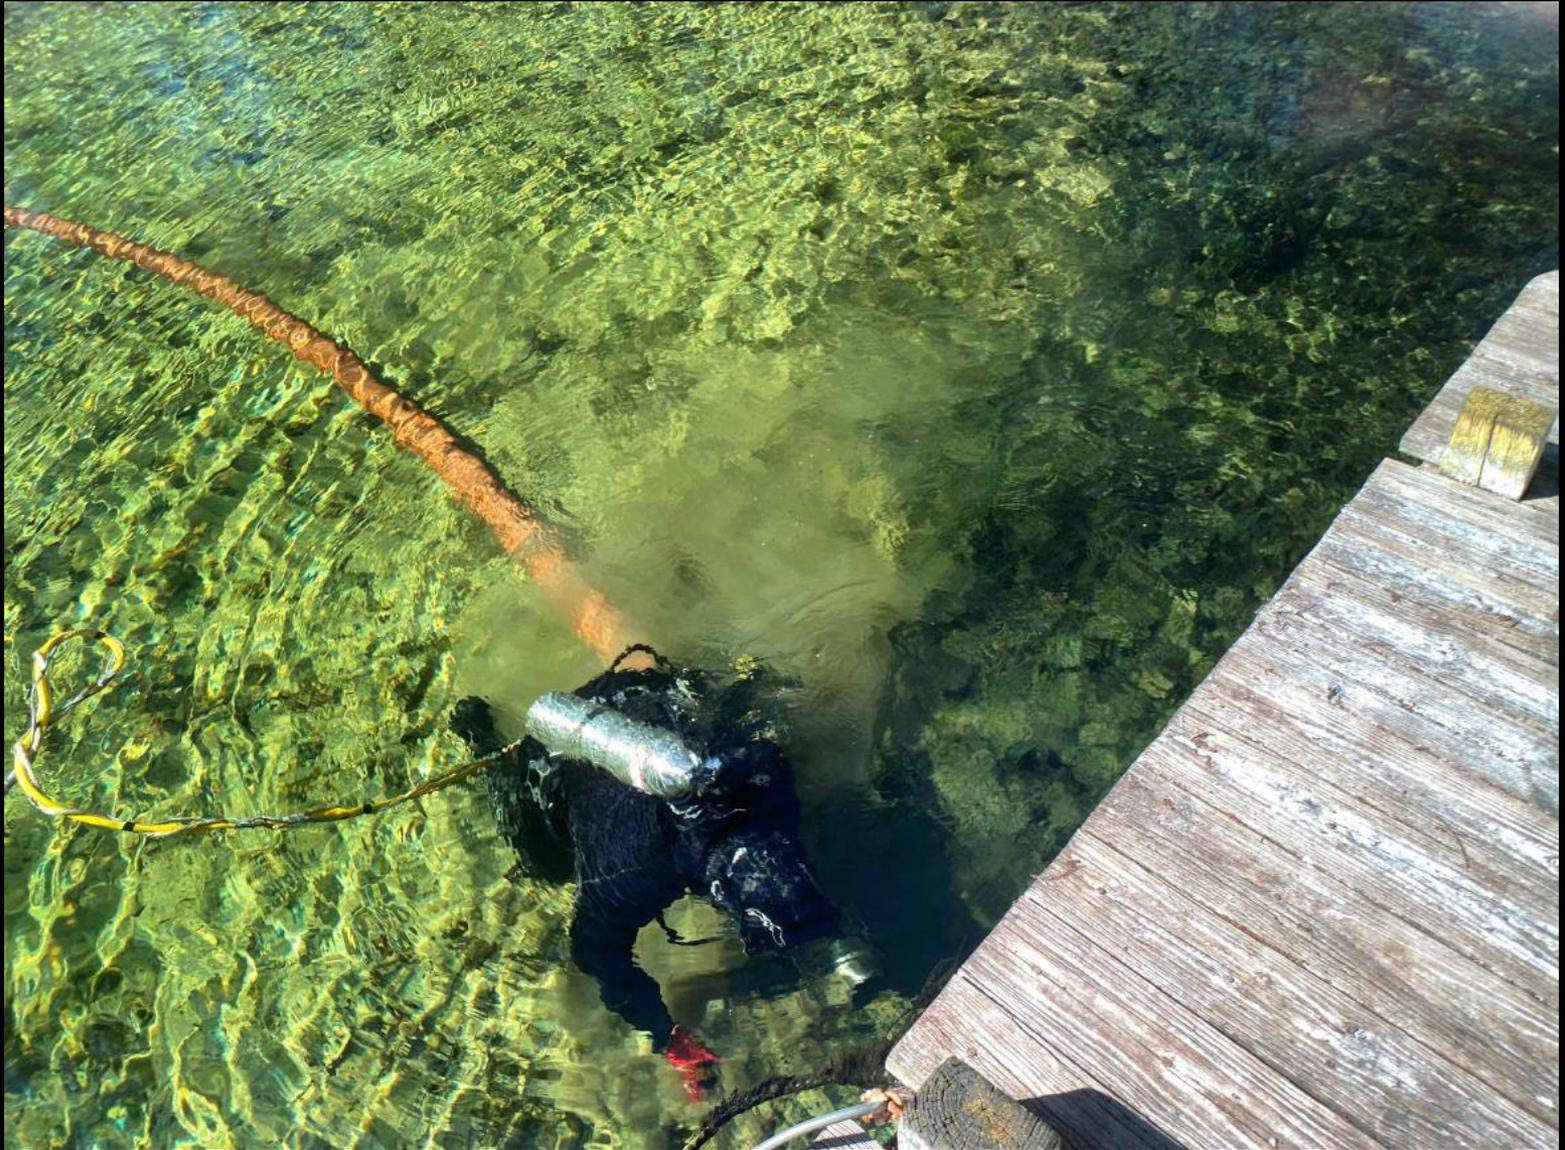
Diver Using Suction Dredge
