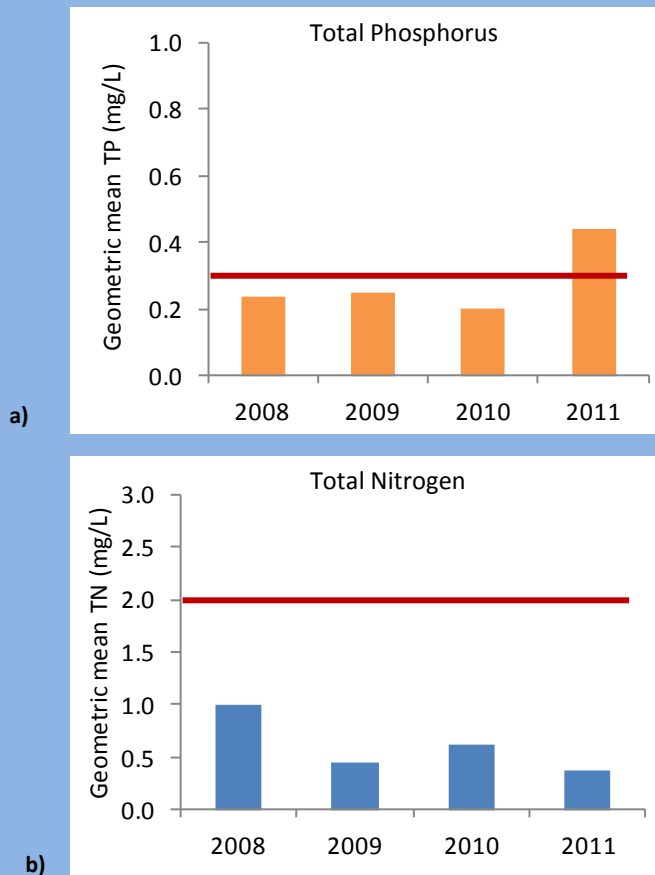
Figure 3. Annual Geometric mean of a) total phosphorus (TP) and b) total Nitrogen (TN) data collected by Alachua County Environmental Protection Department. FDEP nutrient standards for the North Central eco region are represented by the red line a) TP of 0.30mg/L and b) TN of 1.87 mg/L.

Nutrients: The proposed FDEP water quality nutrient standards will be effective in 2012. Tumblin Creek will be considered impaired for TP (total phosphorus) when these standards become effective. Major sources of phosphorus in the watershed include fertilizers in stormwater runoff, as well as naturally occurring phosphorus minerals in the Hawthorn Group formations that are eroded away in high velocity stormwater flows. Nitrogen concentrations in Tumblin Creek are well below FDEP proposed standards.

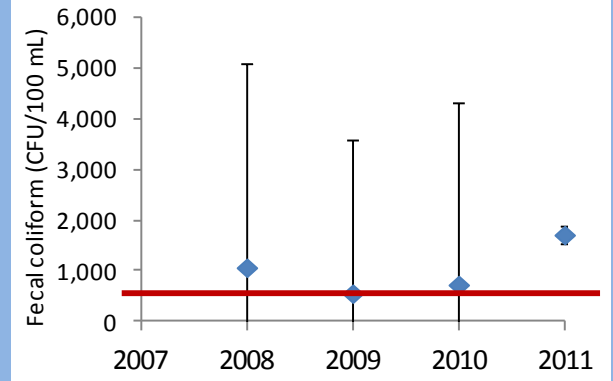
Figure 4. Geometric mean fecal coliform abundance in Tumblin Creek data collected by Alachua County Environmental Protection Department. (red line indicates 800 CFU/100mL, error bars indicate standard deviation).

Bacteria: Tumblin Creek was found to be impaired by FDEP for fecal coliform, an indicator for the possible presence of pathogens. State standards are 800 cfu/100mL for a single sample, which is frequently exceeded in Tumblin Creek. Possible sources for these bacteria include both domestic and wild animal waste, leakage from sanitary sewer lines, faulty private sanitary sewer connections, and failing septic tanks.
