# Turkey Creek Fact Sheet

## The Watershed

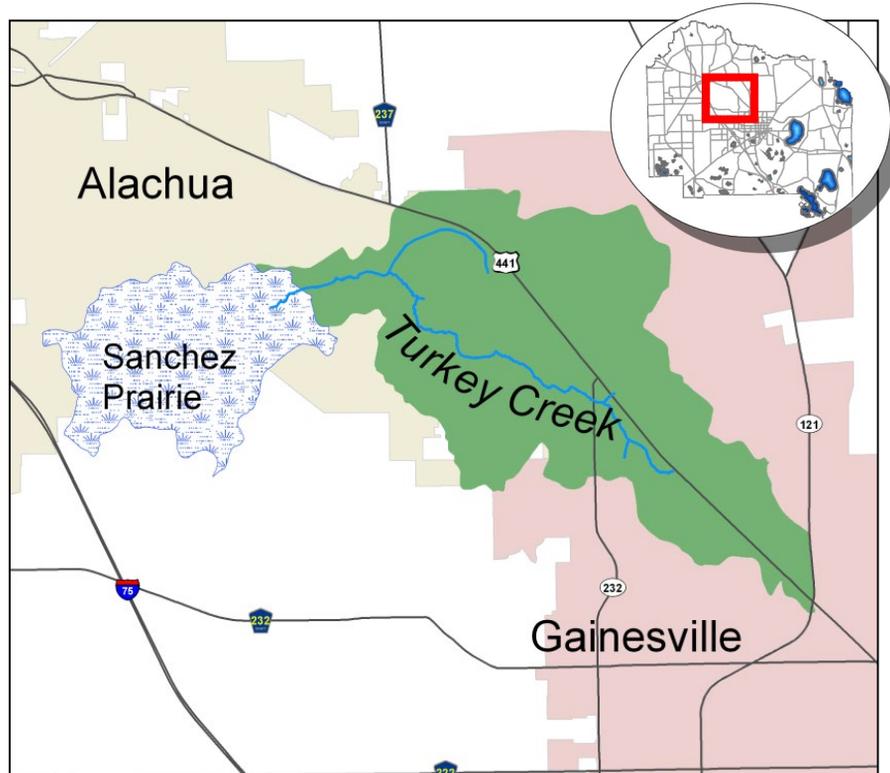
Map of Turkey Creek watershed (green).

- The Turkey Creek watershed is ~ 12.4 square miles.
- Turkey Creek flows northwest into San Felasco Hammock State Preserve and into Sanchez Prairie, where it recharges the Floridan aquifer through Split Rock Sink.
- Land use in the area includes residential, silviculture, pasture, and a coal-fired electric plant.

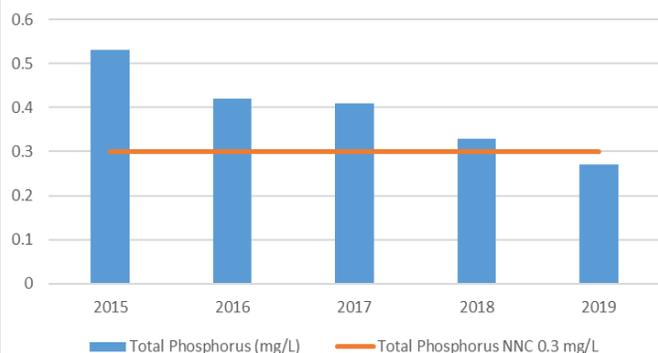
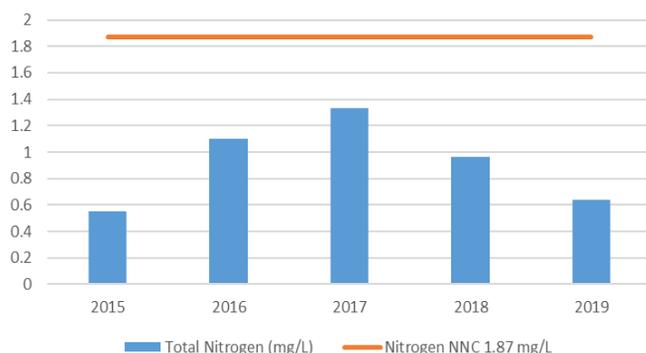
Turkey Creek Total Phosphorus A

Turkey Creek Total Nitrogen B

Figure 1. Annual geometric mean of A) total phosphorus (TP) and B) total nitrogen (TN).

**Nutrients:** The current FDEP water quality rule on nutrient standards went into effect February 2016. Turkey Creek has been above the Numeric Nutrient Criteria (NNC) threshold for total phosphorus (TP) but not for total nitrogen (TN). Potential phosphorus sources are the erosion of phosphorus rich soils that compose the Hawthorn clays which underlay the stream bed and agricultural inputs of fertilizer and storm water runoff. It does not appear that the elevated TP concentrations are influencing the stream biota.

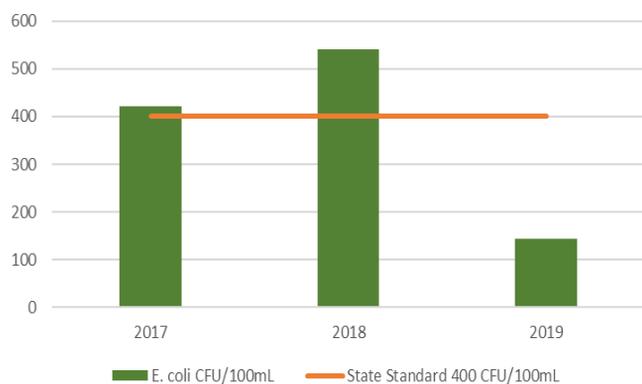
Turkey Creek *E. coli* Concentration

Figure 2. Annual Geometric Mean fecal coliform colony forming units (CFU)/ 100 mL.

**Bacteria:** Turkey Creek has had high abundance of *E. coli* bacteria, an indicator of fecal contamination. State standards for a single sample are 400 colony forming units (CFU)/100mL. Possible sources of this bacteria include domestic and wild animal waste, leakage from sanitary sewer lines, faulty private sewer connections and overflows, persistence and regrowth of bacteria in creek sediments, and failing septic systems. Decreased coliform abundance in 2019 most likely resulted from increased creek flow diluting the number of fecal coliforms present. Turkey Creek is listed as impaired for fecal coliform abundance.
