# POE SPRINGS AREA HYDROLOGIC FEATURES STUDY

Prepared For:  
Alachua County Environmental Protection Department  
408 W. University Avenue, Suite 106  
Gainesville, Florida, 32601

**Karst Environmental Services, Inc.**  
5779 NE County Road 340 High Springs, Florida 32643  
(386) 454-3556    [kes@atlantic.net](mailto:kes@atlantic.net)

**September 24, 2015**

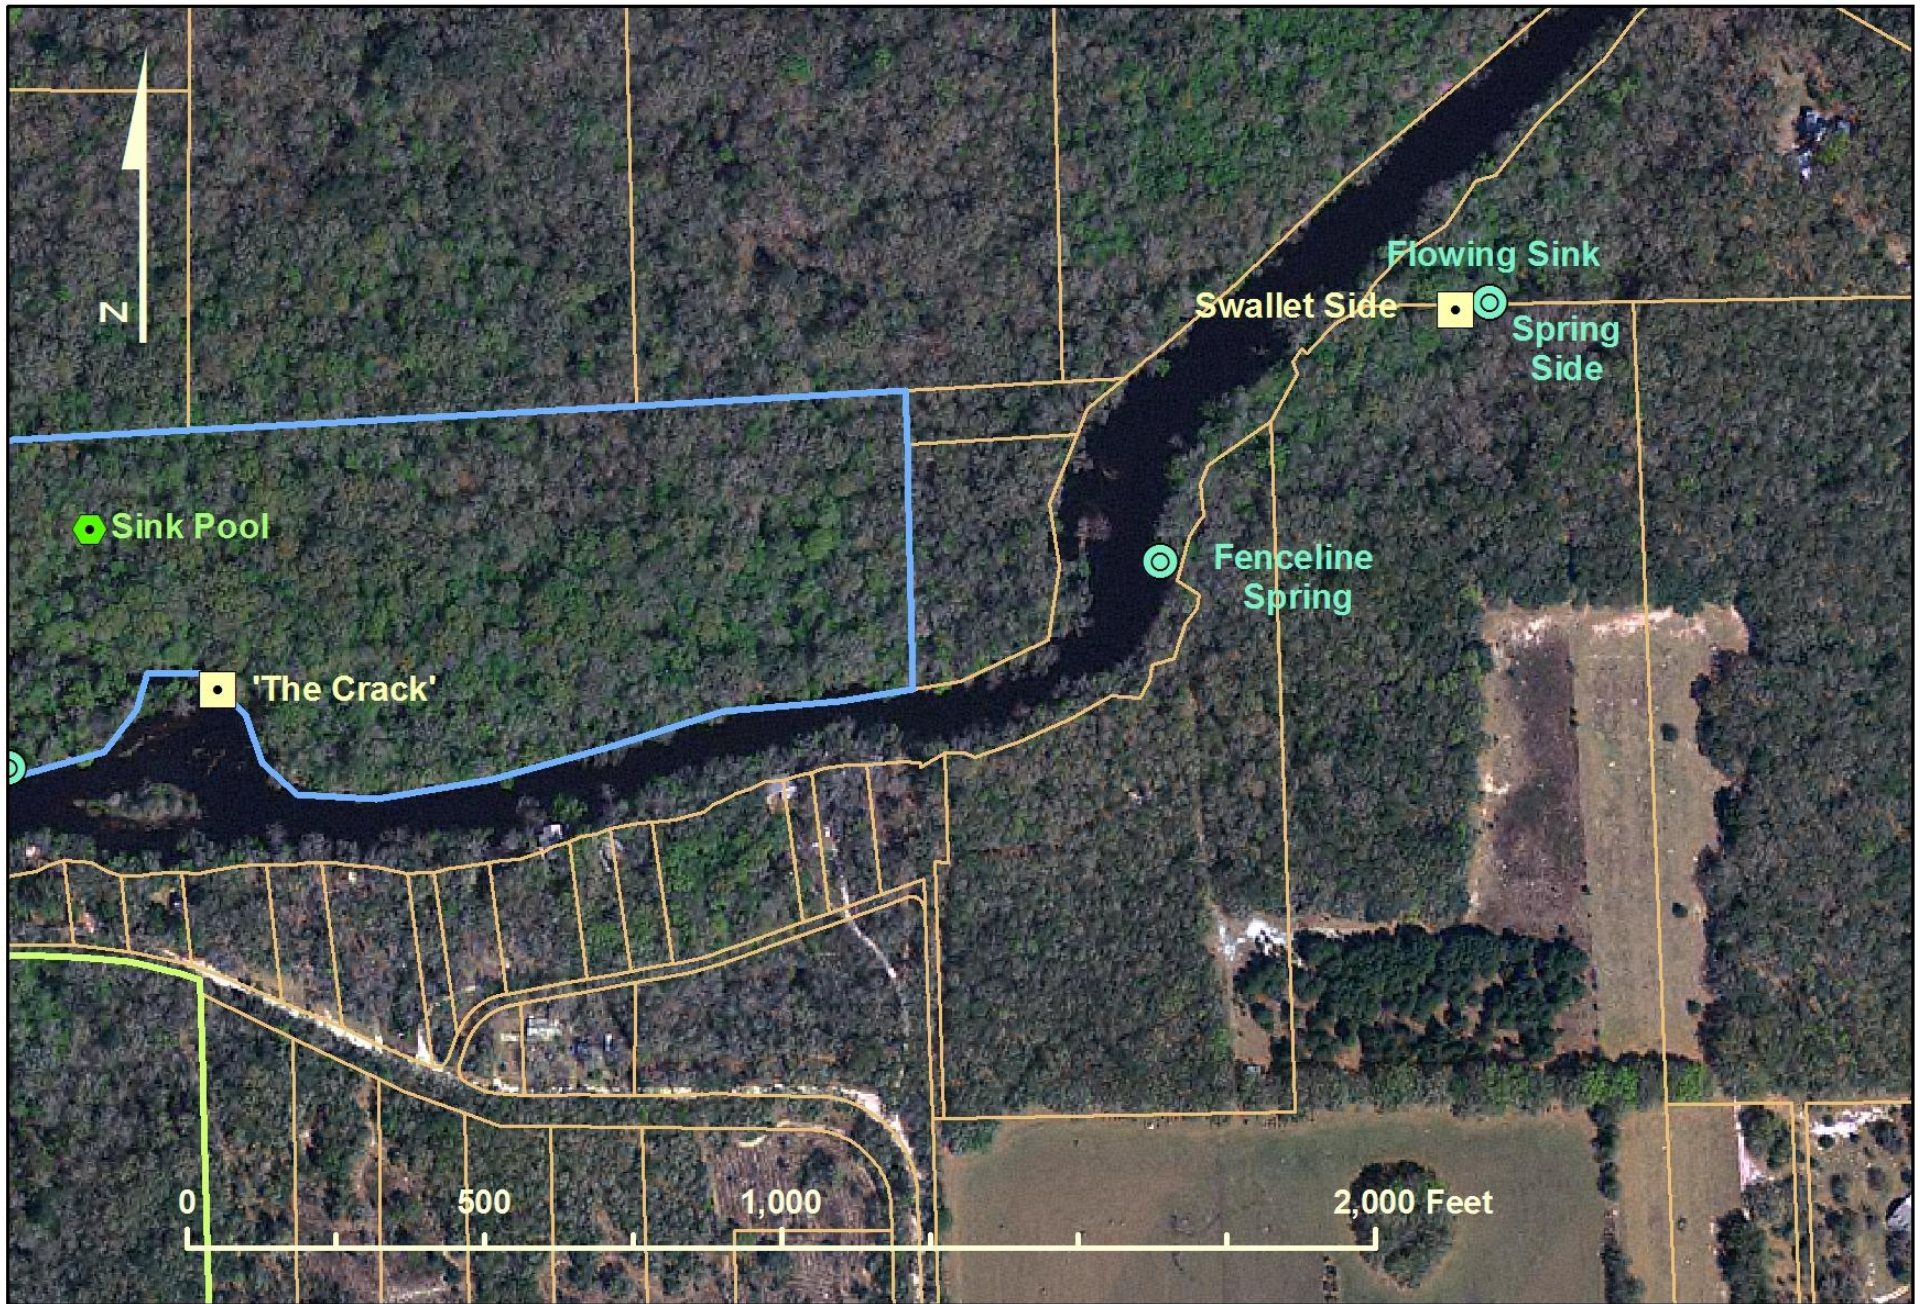
Figure 2. Map of the upper Poe Springs Area Hydrologic Features Study area.

This sinkhole feature is a karst window, or fenster, located on the river bottomland along the edge of a vertical rock outcrop about 700 feet northeast of Fenceline spring. See Figure 2 and Photos 1, 2 and 3. It has a spring vent on its northeast side, and flows about 100 feet to a siphon on its southwest side. It is located on private property. Under normal, non-flood conditions, it has no surface connection to the river. Initial water quality analyses and field parameters of water from the spring side indicate that the discharge is very similar to that of other springs in this area. No discharge measurements were attempted, but directional water movement was observed, with a significant duckweed accumulation on the downstream siphon side.

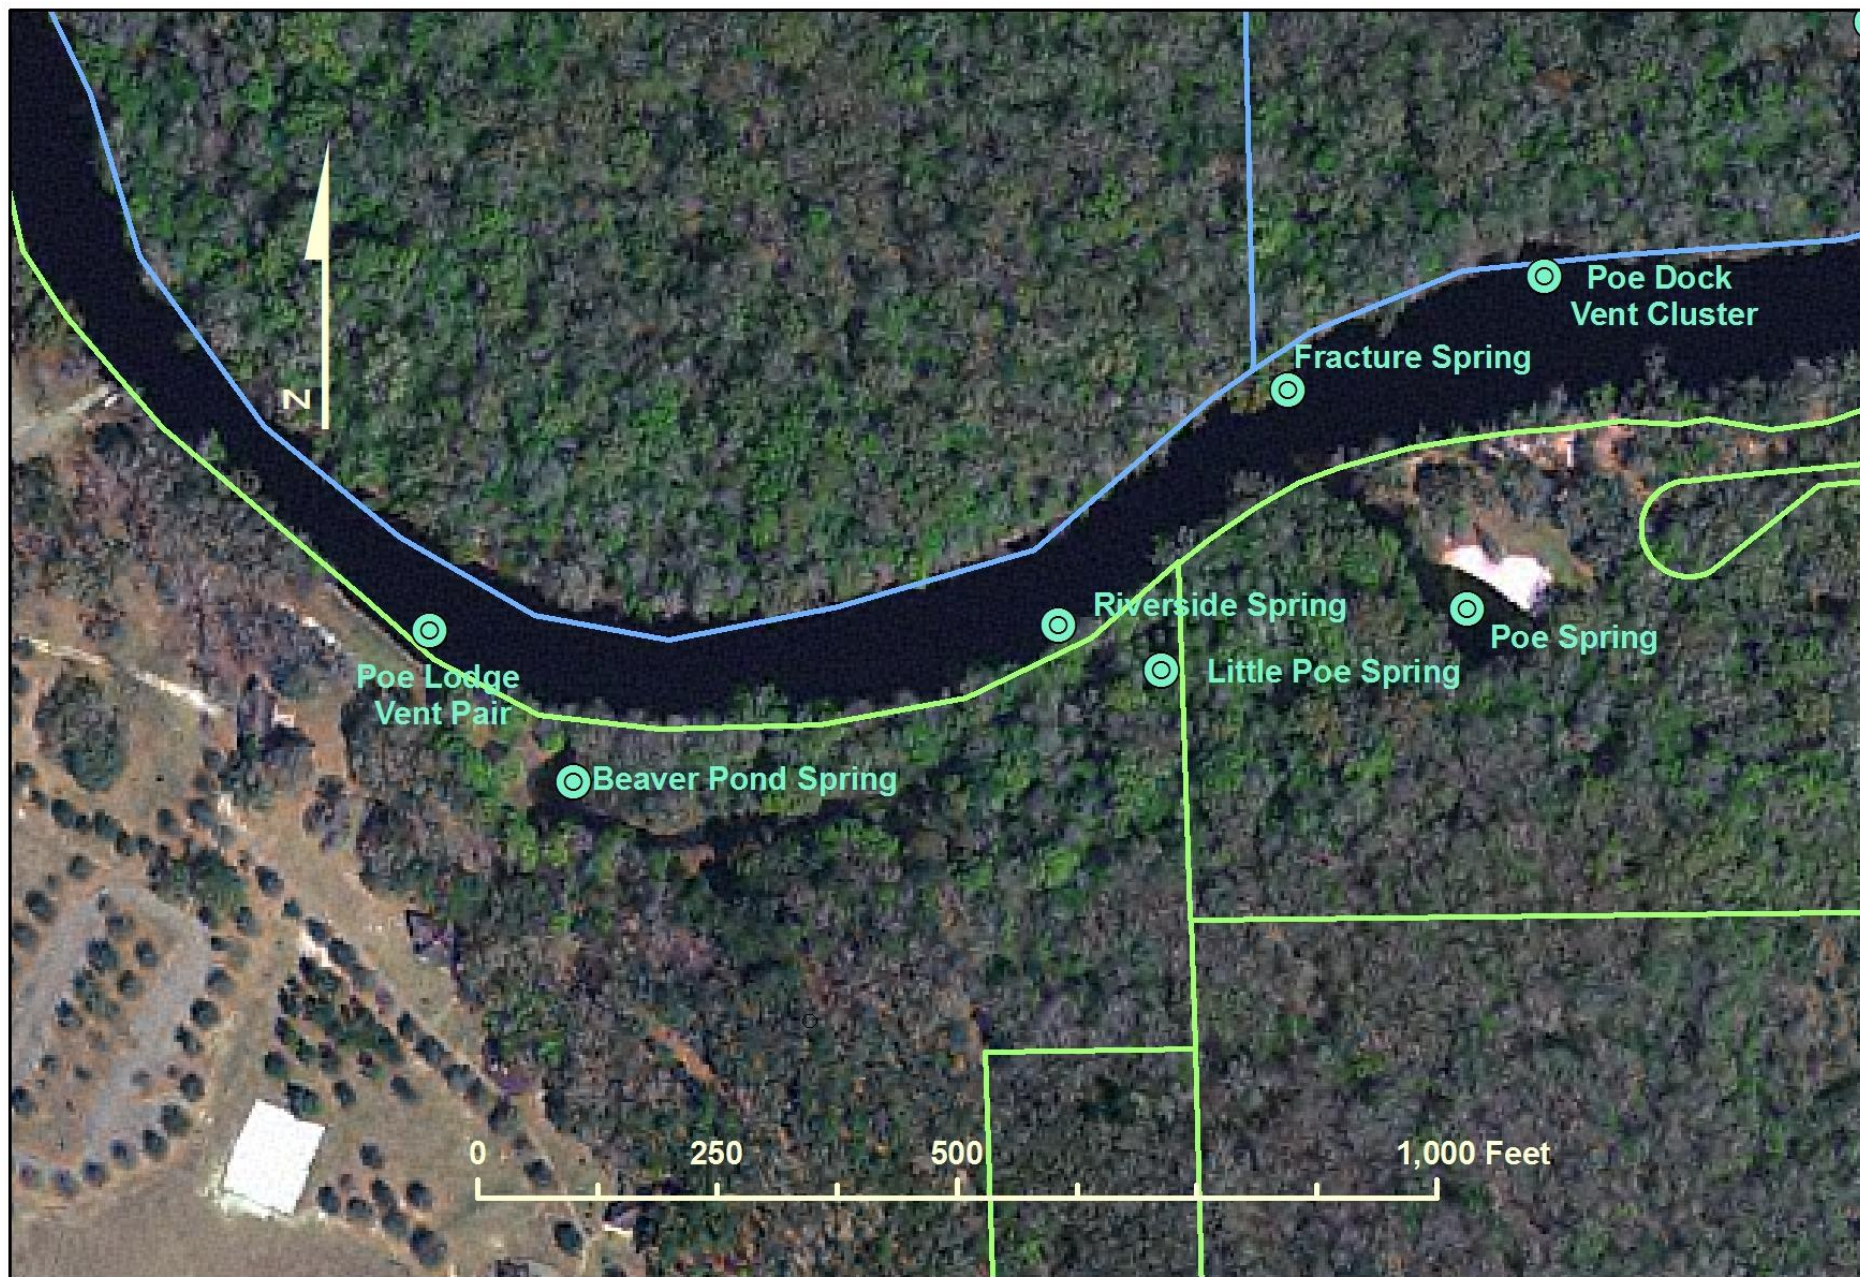
Figure 4. Map of the Poe Springs County Park springs.

The Poe Dock Vent Cluster consists of at least three small spring vents located on the shallow river bottom along the right bank of the SFR, across from, and about 100 feet downstream of, the upstream Poe Springs Park boat dock. The vents discharge directly from the bedrock bottom, and contain scattered organic debris. The vents are collectively estimated to be in the fifth magnitude category range. They can produce a boil on the surface during low water conditions. See Figures 3 and 4, and Photo 17.

Fracture Spring is a relatively large feature located on the right bank, directly across from the Poe Spring Run confluence. See Figure 4 and Photos 18 and 19. The rock ledge that makes up the bank drops directly into this nearly 100 foot long feature. Significant spring vents are located all along the fissures length, with the largest vents located at the upstream end, and producing visible boils on the surface during low water conditions. The fissure contains natural debris, and some of the vents at the downstream end are visible as sand boils.

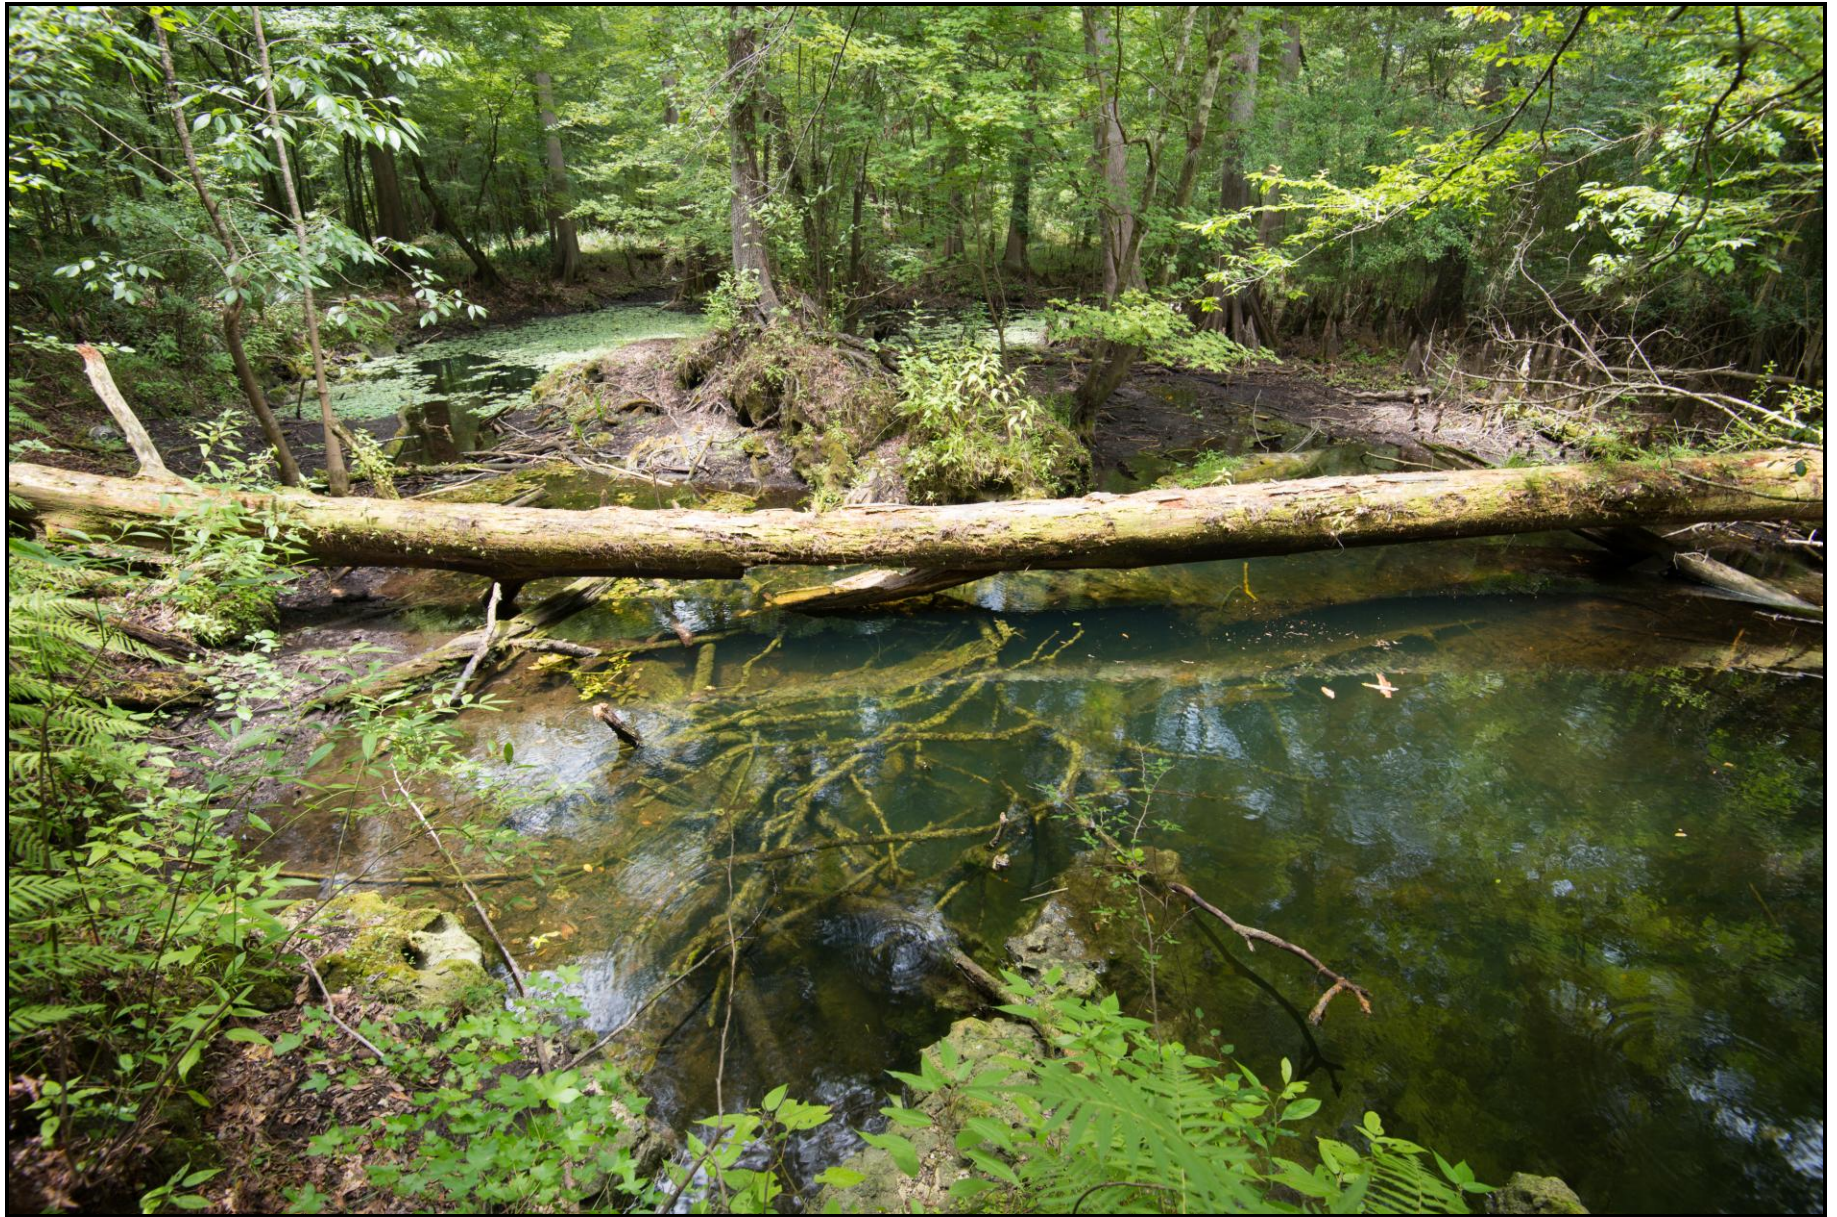
Photo 1. Flowing sink upstream of Fenceline Spring. Viewed from sink center to downstream.  
Photo taken on July 31, 2015 by Jennifer Adler.

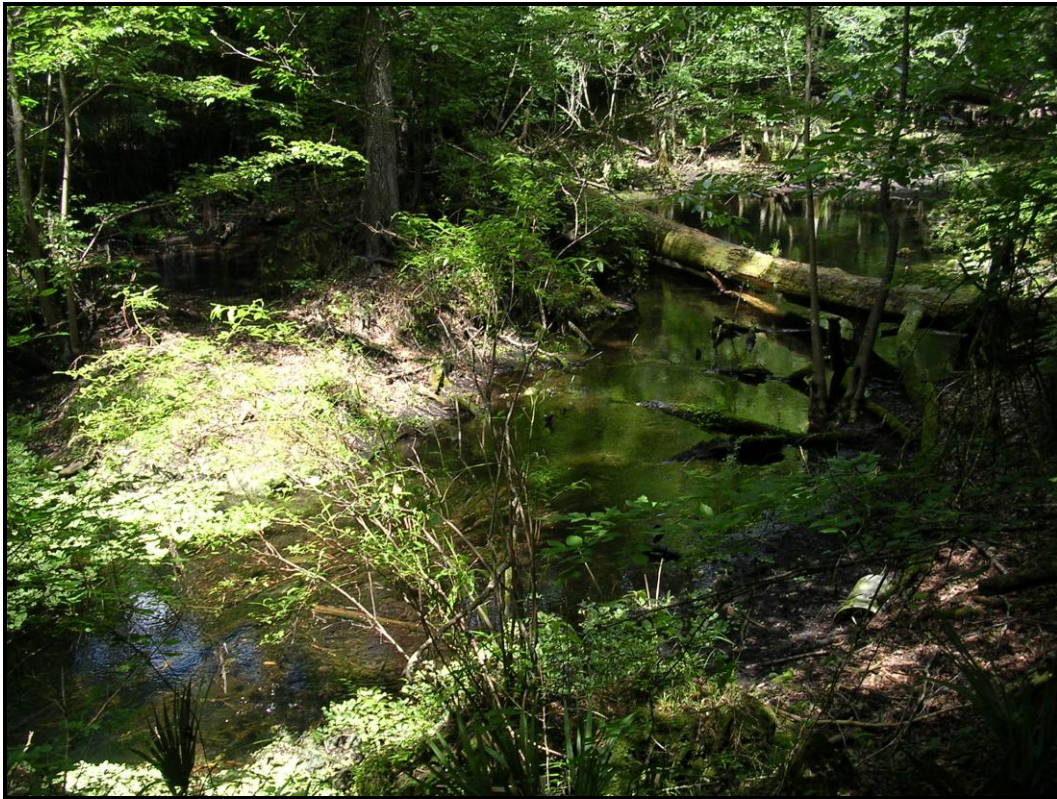
Photo 2. Flowing sink upstream of Fenceline Spring. Viewed from sink center to upstream. Photo taken on April 30, 2015.

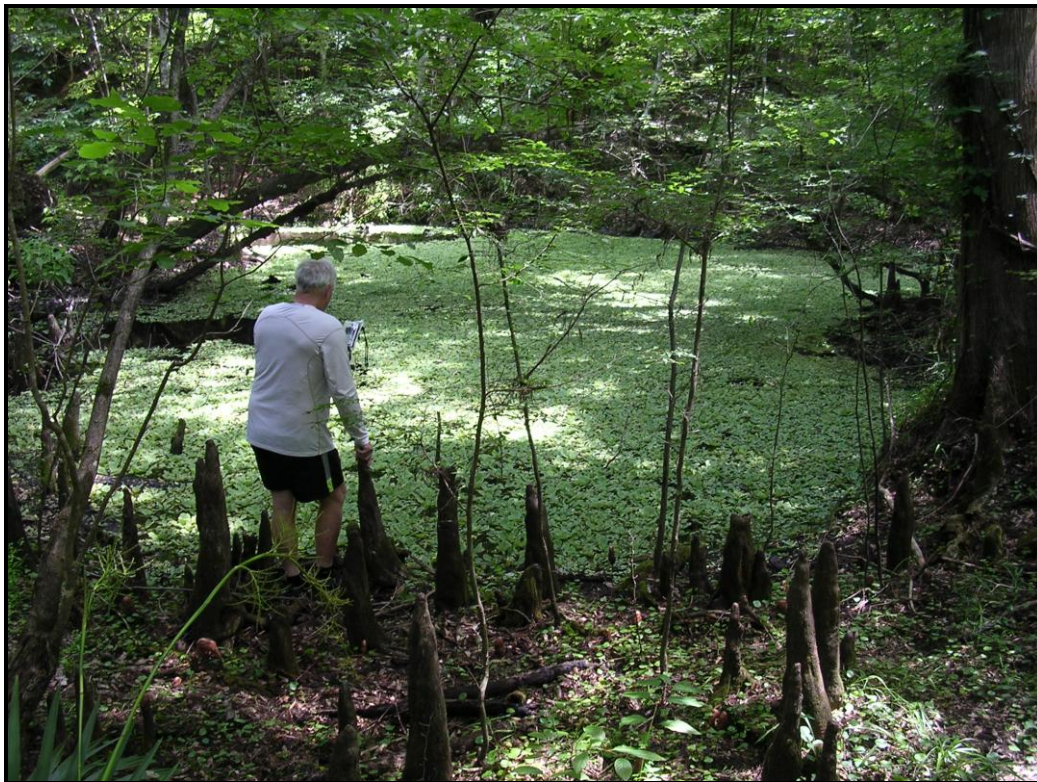
Photo 3. Flowing sink upstream of Fenceline Spring. View of downstream siphon side. Photo taken on April 30, 2015.

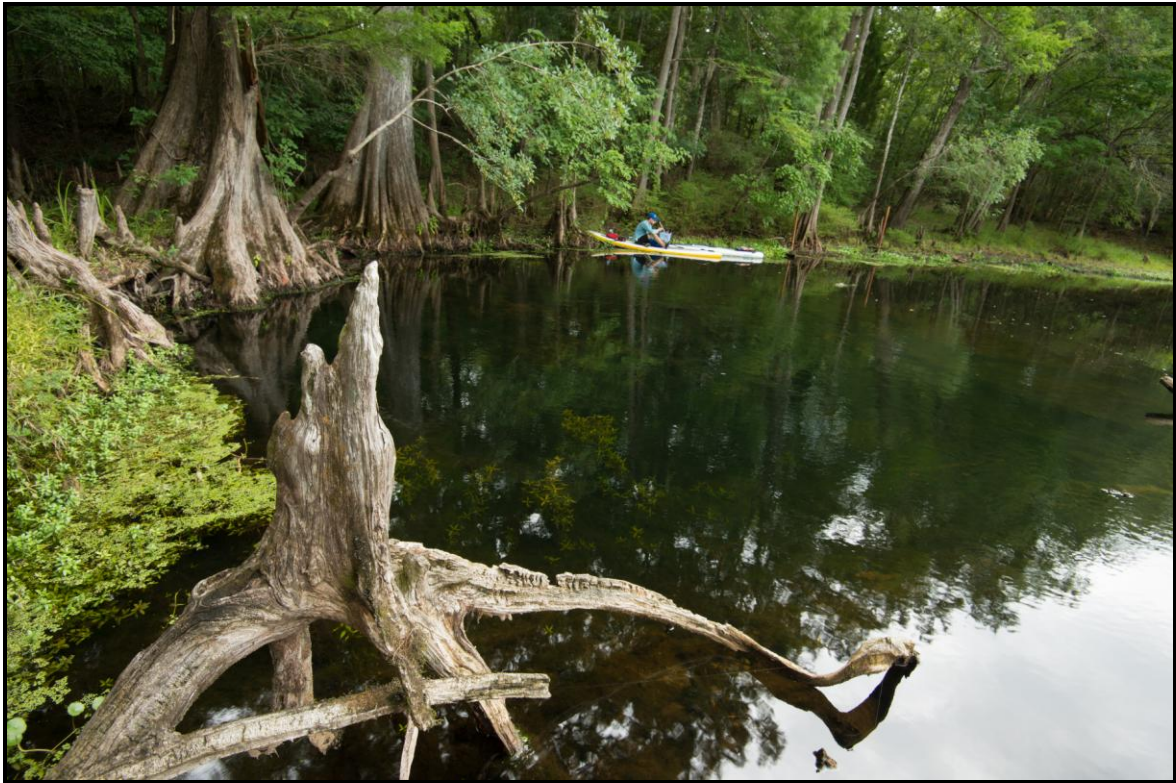
Photo 4. Fenceline Spring. Spring is located in river in front of the two cypress trees. Photo taken on July 31, 2015 by Jennifer Adler.

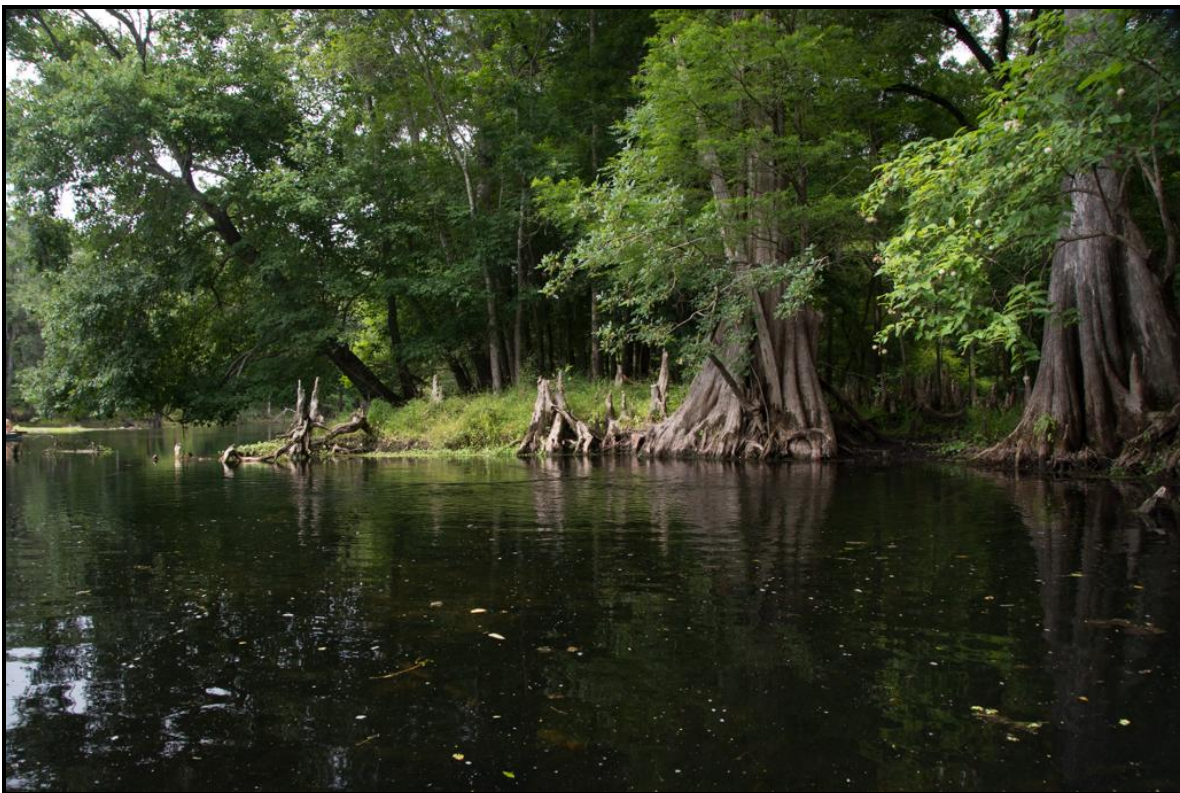
Photo 5. Fenceline Spring. Spring boil can be seen in river in front of the two cypress trees. Photo taken on June 12, 2015.

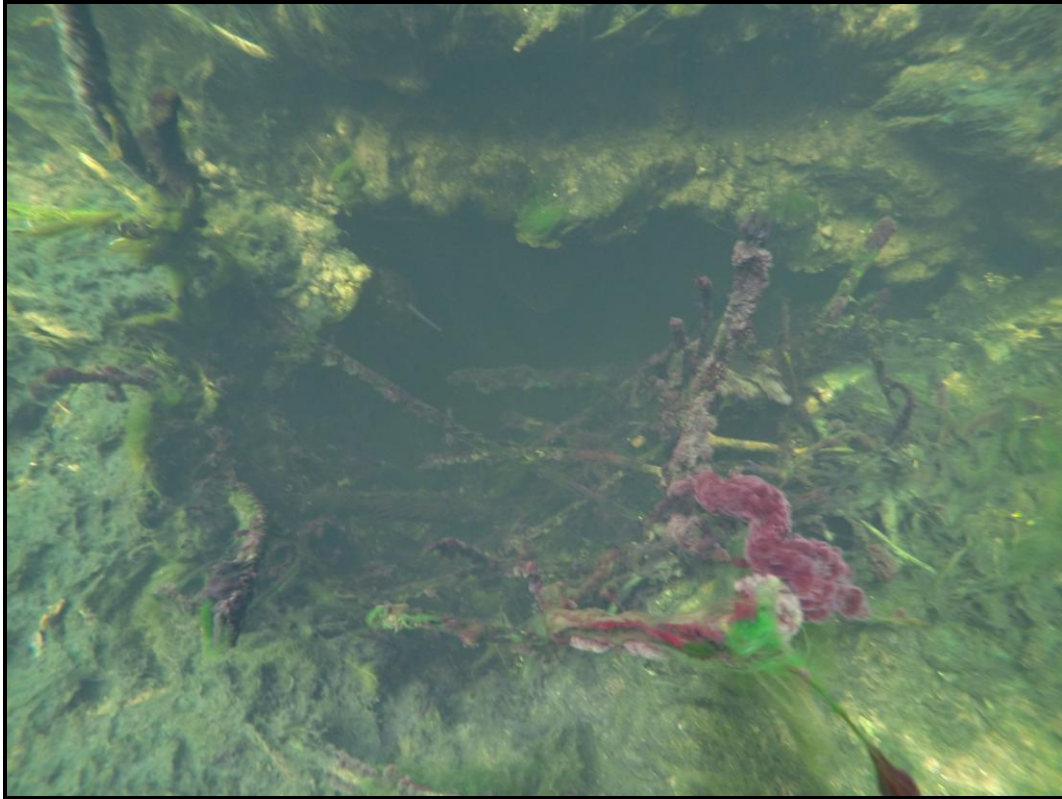
Photo 6. Fenceline Spring. Submerged vent and detritus coated with algae. Periphyton specimens were collected here. Photo taken on June 12, 2015.

ACEPD staff also collected algae (periphyton) samples from selected springs, and these were delivered to Water & Air Research, Inc. of Gainesville Florida for analysis. Ten periphyton samples collected on July 31, 2015 were analyzed for filamentous algae and chain forming diatoms. Results of the periphyton sampling and analyses are included in Appendix III of this report. See Photo 44 for an example of algae growth observed and sampled.

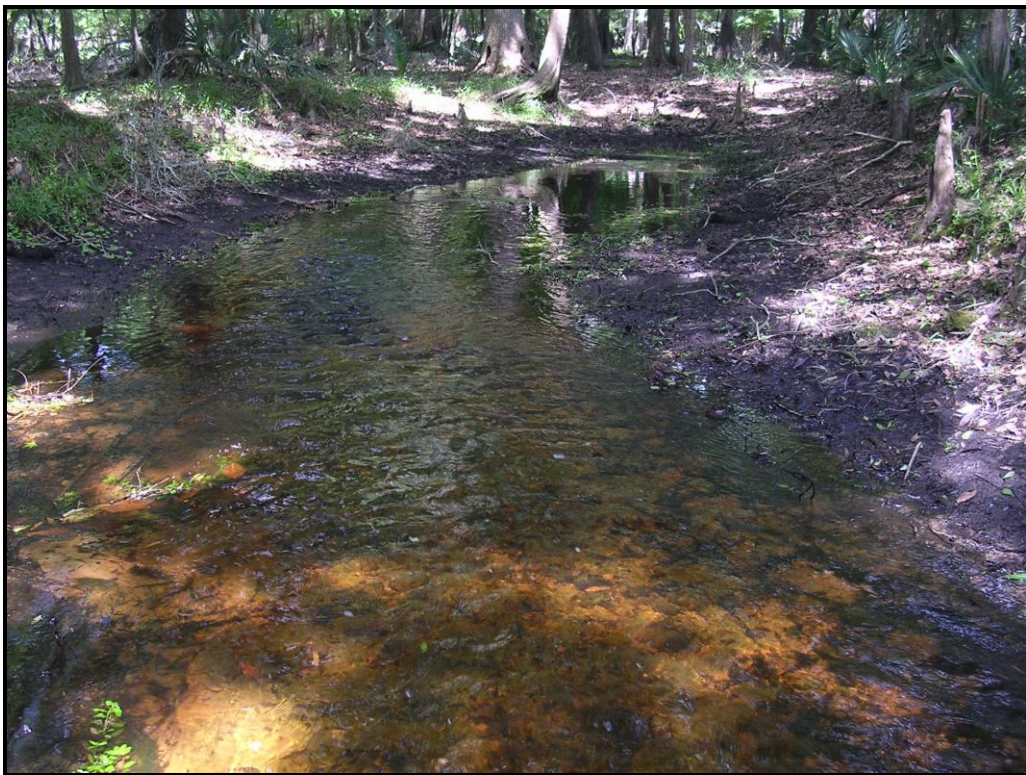
Photo 7. 'The Crack' Estavelle. Water from the Santa Fe River is flowing into the feature. Photo taken on April 30, 2015.

'The Crack' is a unique feature located on the right bank approximately 1300 feet upstream of the Poe Spring Run confluence. It connects to the upstream end of the river braid that bypasses the northernmost of two islands that are part of the nearby shoals in the river. The Crack is a fissure in the limestone at the end of the short channel that runs north from the river braid. See Figure 2 and Photos 7 and 8. The Crack is listed as spring number COL428982 by SRWMD, as Allen Spring in the FDEP Florida's Springs 2008 Master List, and known to some local cave divers as 'Labatt's Blue'. Although officially listed as a spring, this feature is often observed receiving river water under non-flood conditions, as was the case during this survey. It has also been observed as isolated from the SFR. It is suggested that this feature be considered an estavelle for descriptive and classification purposes.

Cave diver Wes Skiles investigated The Crack and reported that the fissure intersects with an upstream-downstream cave passage at its bottom. He also reported that, at low river levels when The Crack was discharging, water in the upstream passage also flowed into the downstream passage. Other observations within the cave indicated that, when siphoning, the upstream tunnel flow reverses, taking in river water. The downstream passage appears to be taking water in a route that is sub-parallel to the river. The downstream flow may discharge at one or more of the many springs downstream of this feature.

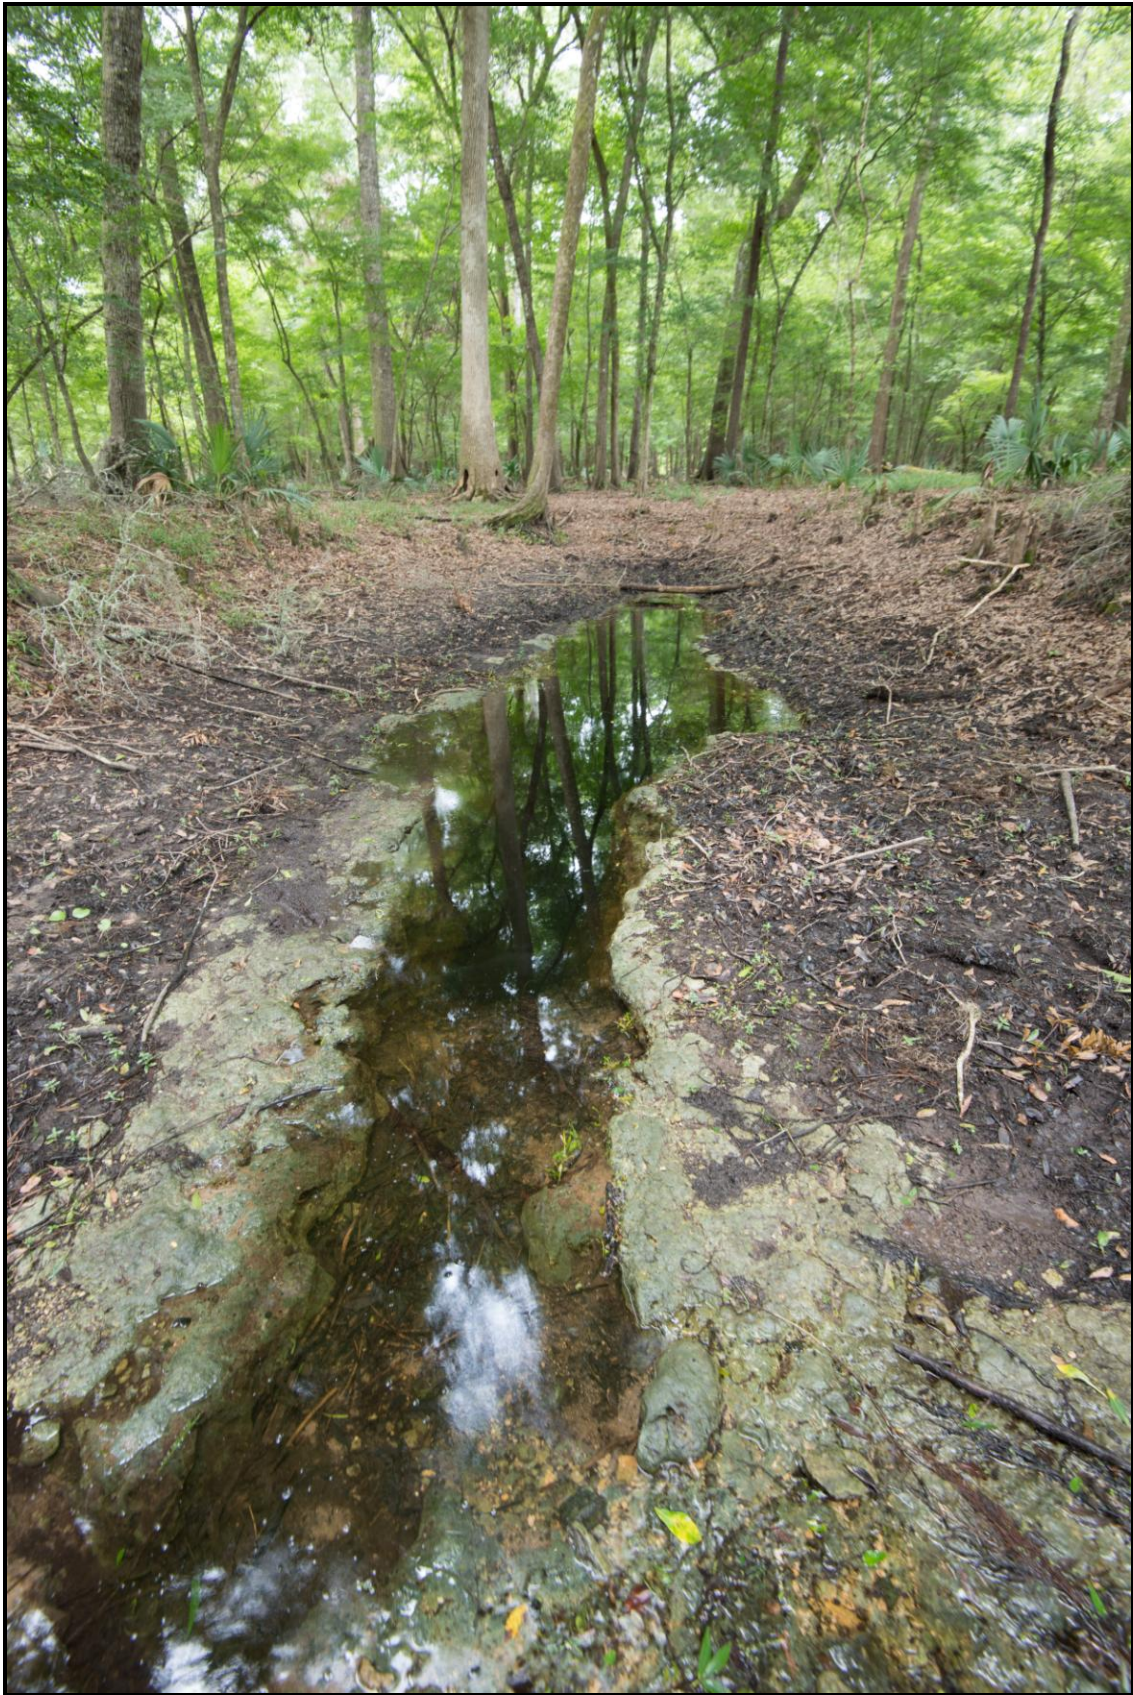
Photo 8. 'The Crack' Estavelle. The feature is siphoning river water at low flow conditions. Photo taken on July 31, 2015 by Jennifer Adler.

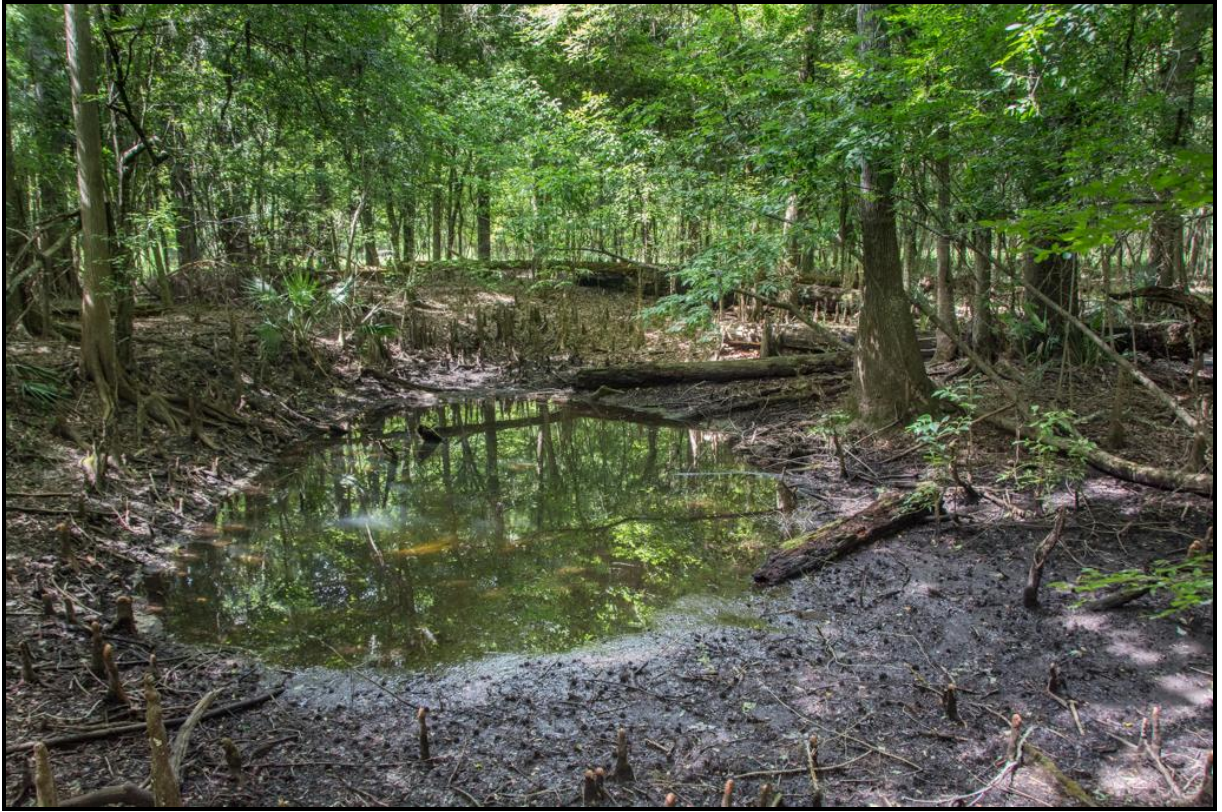
Photo 9. Sink pool north of 'The Crack'. Photo taken on June 12, 2015.

This isolated water feature is located in the SFR floodplain about 300 feet northwest of The Crack. It has no surface connection to the The Crack or the SFR during normal water levels. The pool had dimensions of about 30 by 20 feet, and was about 4 feet deep. See Figure 2 and Photo 9. It contained clear water with a conductivity in the range of nearby local spring water. A low bank on one side of the sink suggests that this may be an active spring or siphon feature at higher river levels

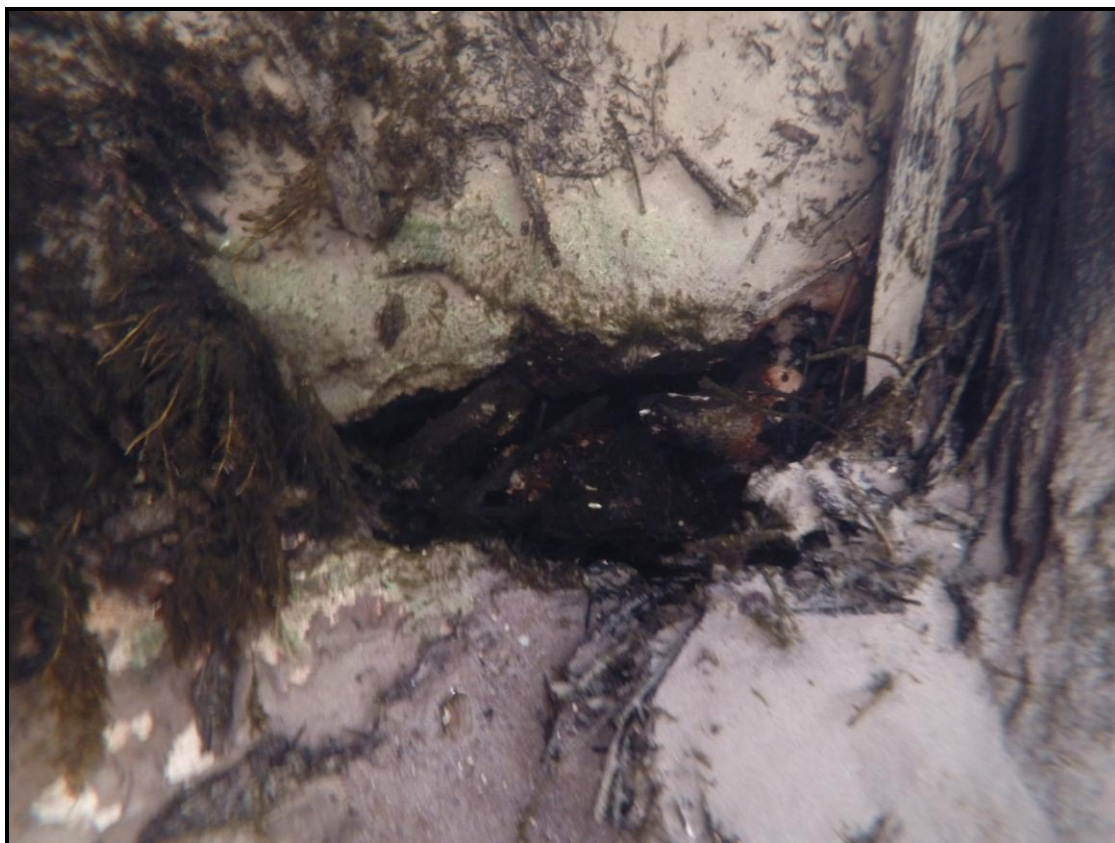
Photo 12. Twin Cypress Spring Upstream Vent 1. Photo taken on June 12, 2015.

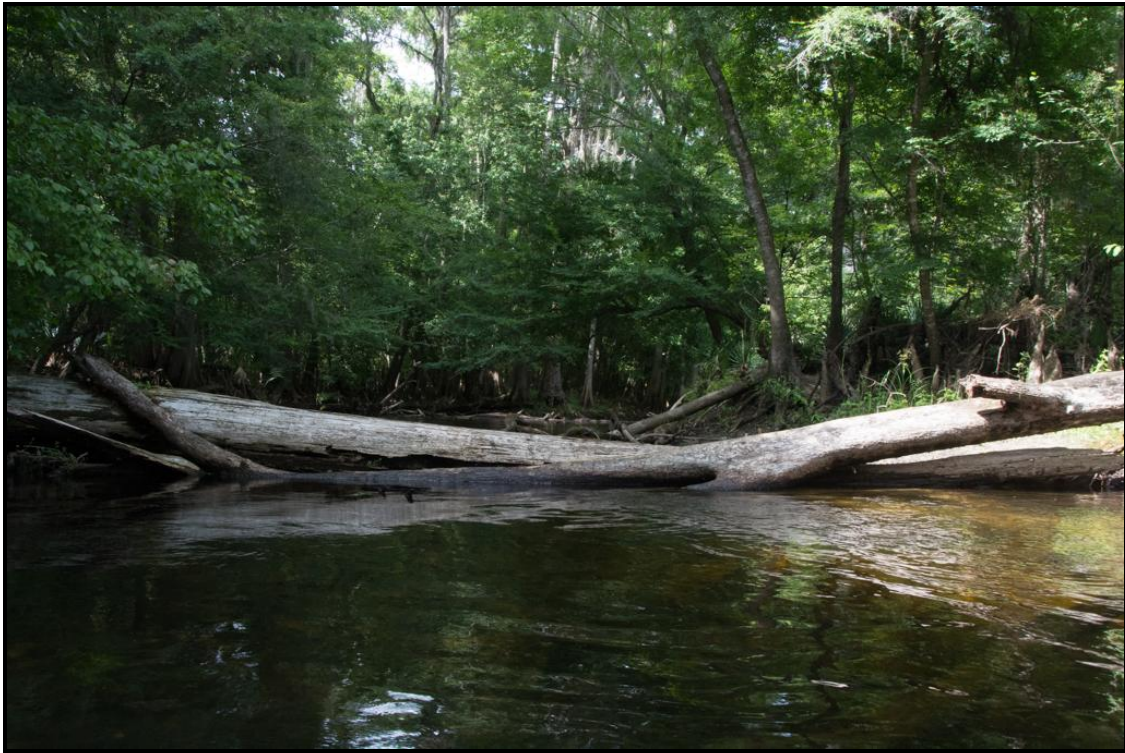
Photo 13. Tiny Channel Vent location downstream of Twin Cypress Spring. This is at the confluence of the northern island braid with the SFR. Photo taken on June 12, 2015.

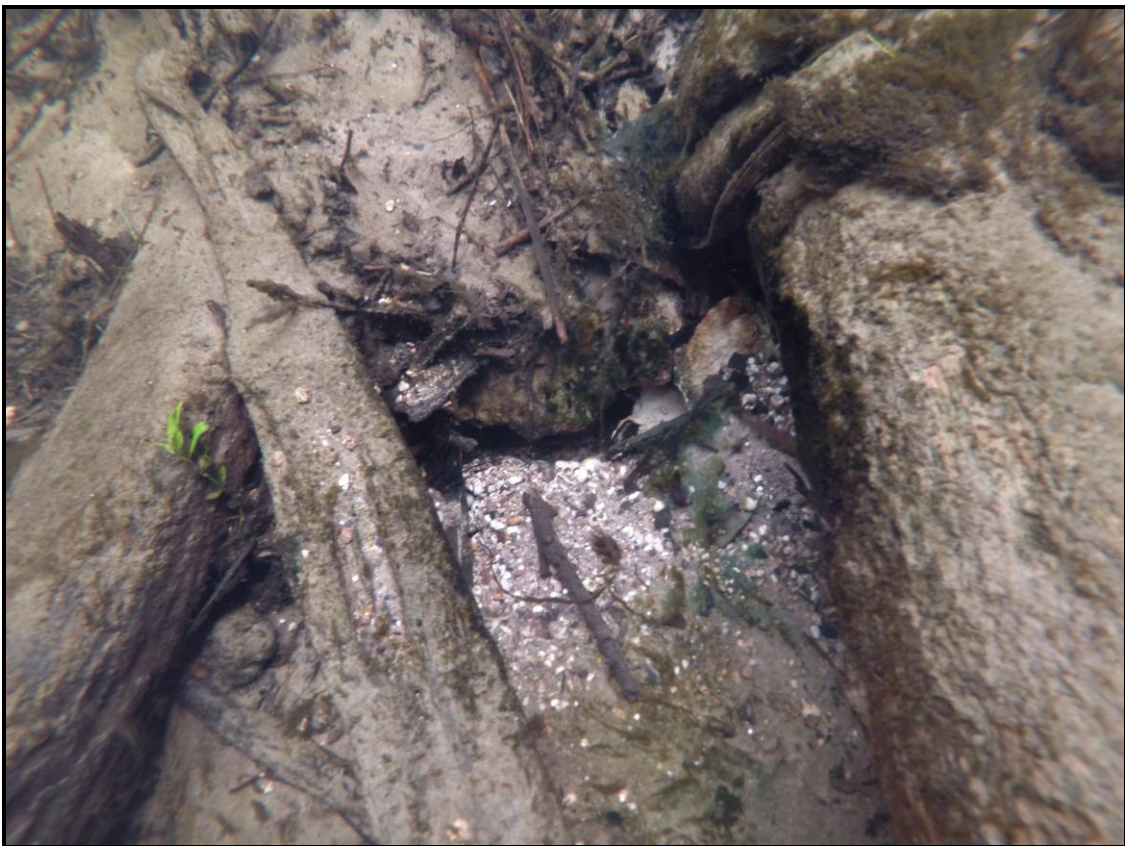
Photo 14. Tiny Channel Vent downstream of Twin Cypress Spring. Photo taken on June 12, 2015.

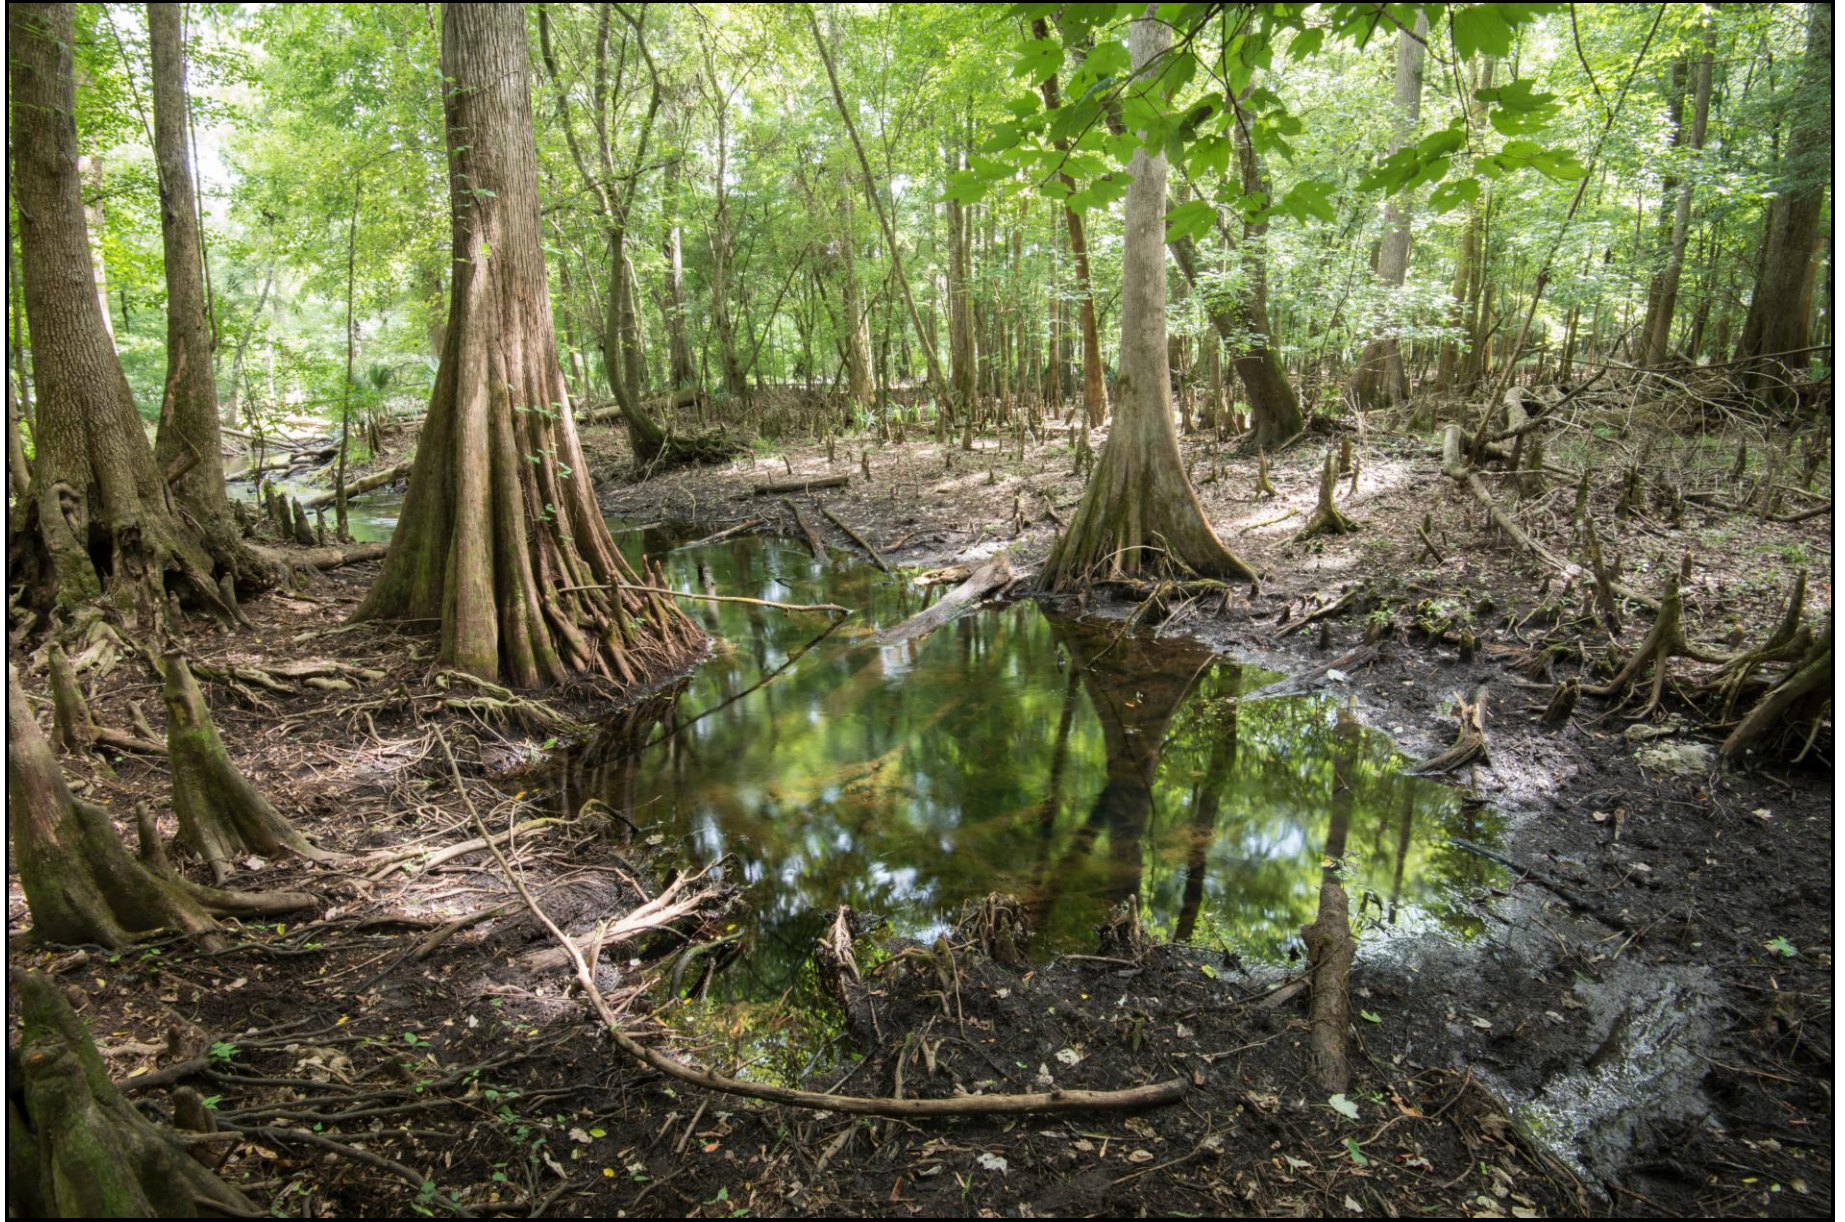
Photo 15. Three Vent Run, viewed from the Head Spring Vent. Photo taken on July 31, 2015 by Jennifer Adler.  
Poe Springs Area Hydrologic Features Study, 2015

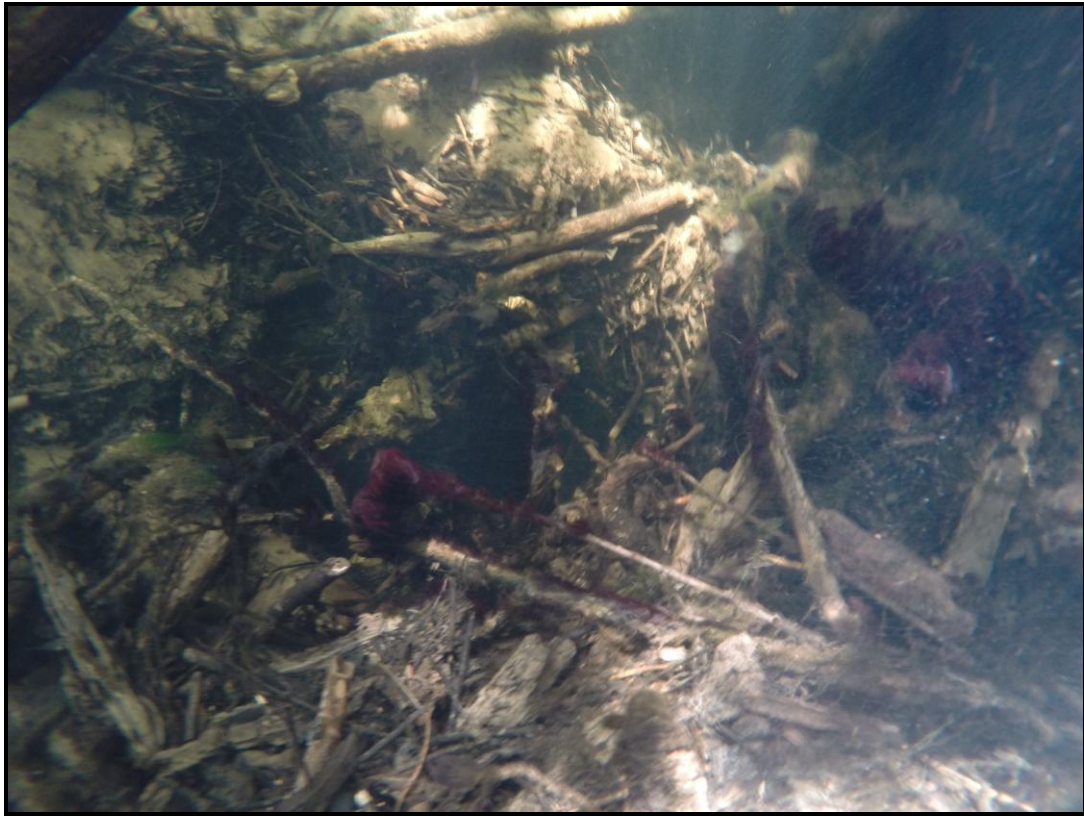
Photo 16. Three Vent Run; underwater view of Top of Run Vent showing algal growth present. Photo taken on June 12, 2015.
