# POE SPRINGS AREA HYDROLOGIC FEATURES STUDY

Prepared For:  
Alachua County Environmental Protection Department  
408 W. University Avenue, Suite 106  
Gainesville, Florida, 32601

**Karst Environmental Services, Inc.**  
5779 NE County Road 340 High Springs, Florida 32643  
(386) 454-3556    [kes@atlantic.net](mailto:kes@atlantic.net)

**September 24, 2015**

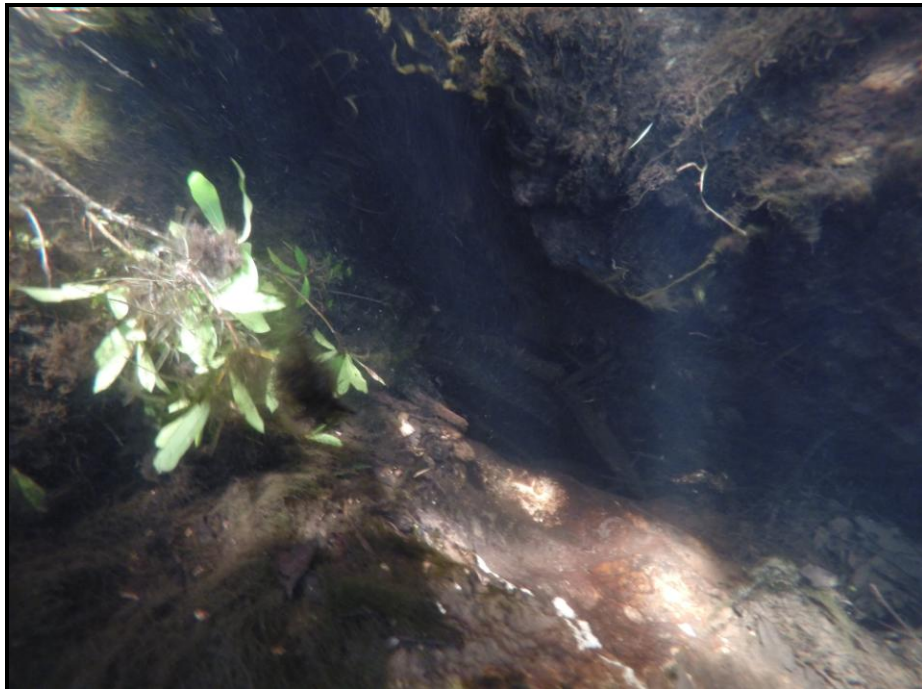
Photo 19. Fracture Spring. Underwater view looking down into one of the active vents along the feature's bottom. Photo taken on June 12, 2015.

Fracture Spring is a relatively large feature located on the right bank, directly across from the Poe Spring Run confluence. See Figure 4 and Photos 18 and 19. The rock ledge that makes up the bank drops directly into this nearly 100 foot long feature. Significant spring vents are located all along the fissures length, with the largest vents located at the upstream end, and producing visible boils on the surface during low water conditions. The fissure contains natural debris, and some of the vents at the downstream end are visible as sand boils.

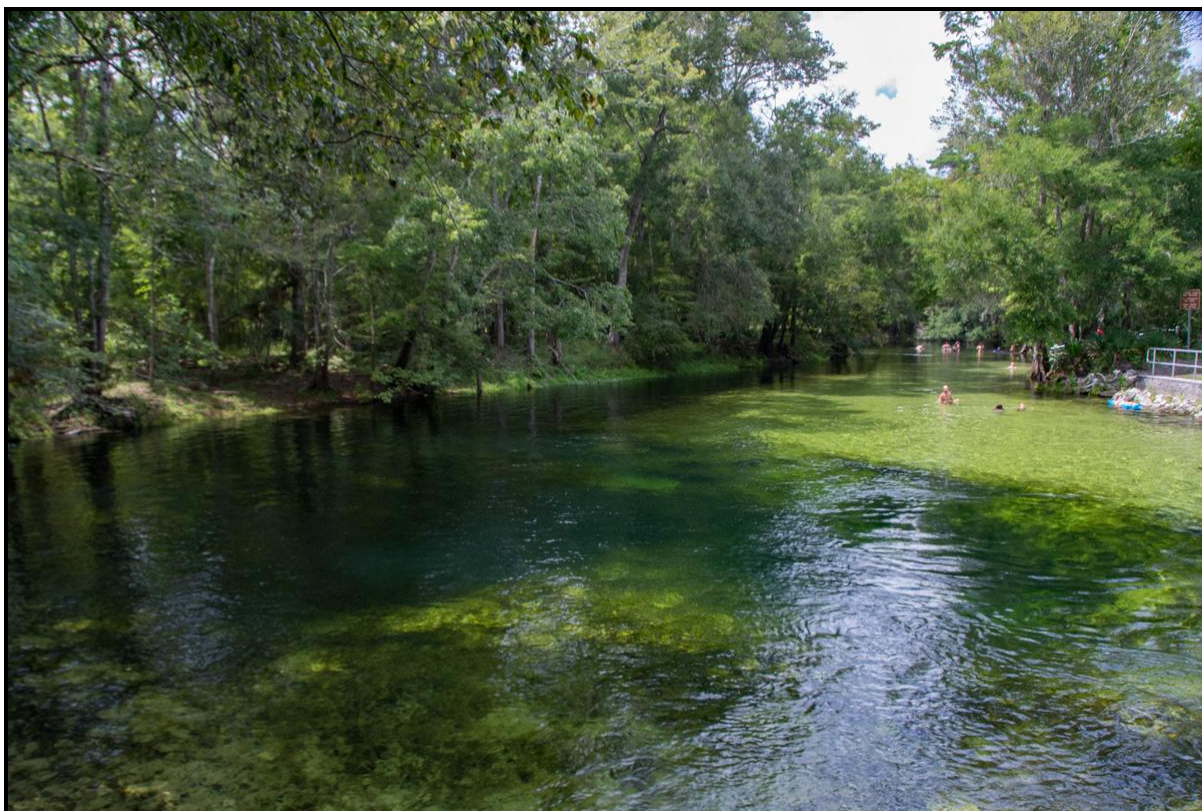
Photo 20. Poe Spring. View of spring and run to SFR. Photo taken on August 30, 2015.

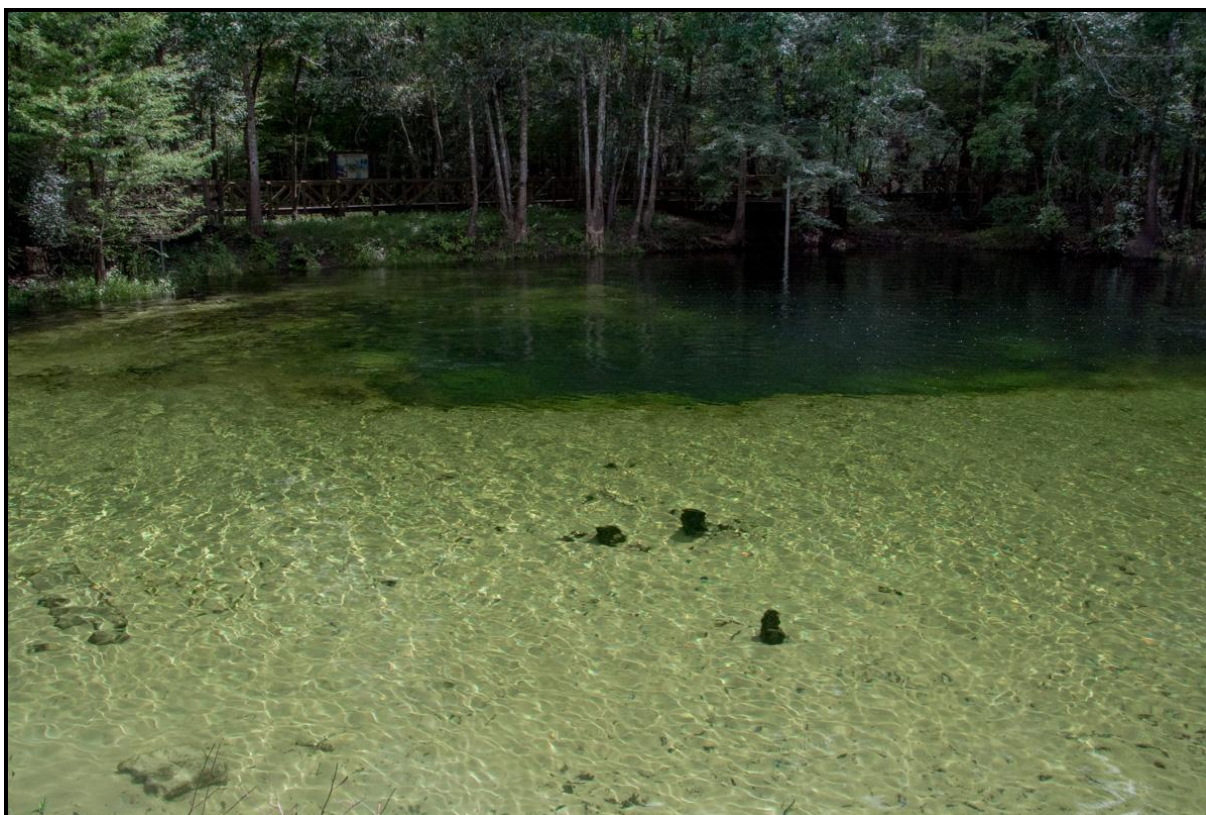
Photo 21. Poe Spring. View upstream to spring basin. Photo taken on August 30, 2015.

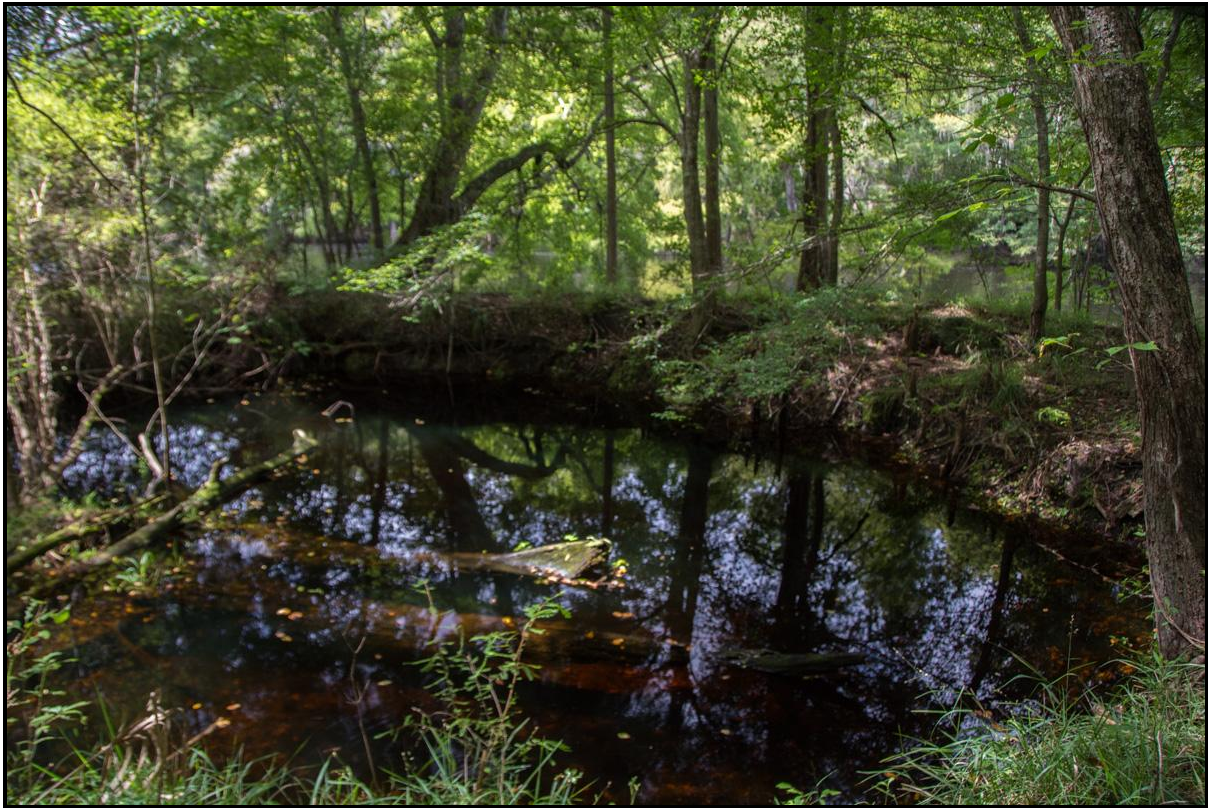
Photo 22. Little Poe Spring. Spring vents are in the center of the spring pool. Santa Fe River is visible beyond the high bank. Photo taken on August 30, 2015.

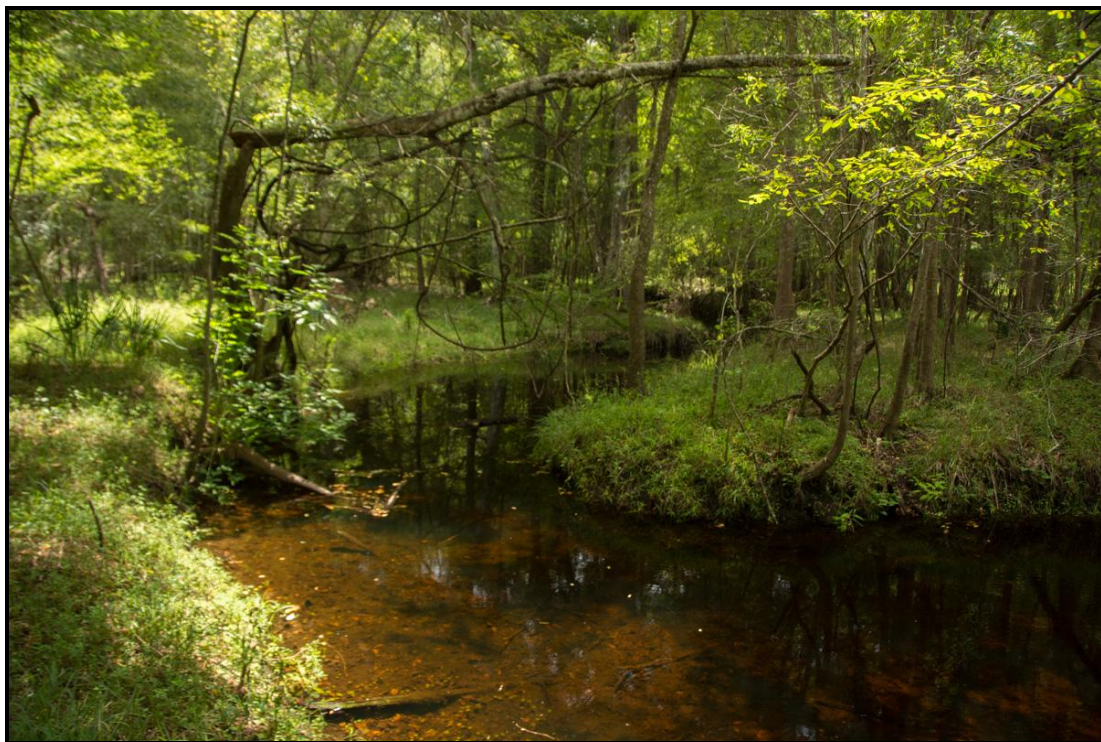
Photo 23. Little Poe Spring Run. This run flows through bottomland parallel to the river, and joins the river at Beaver Pond Spring. Photo taken on August 30, 2015.

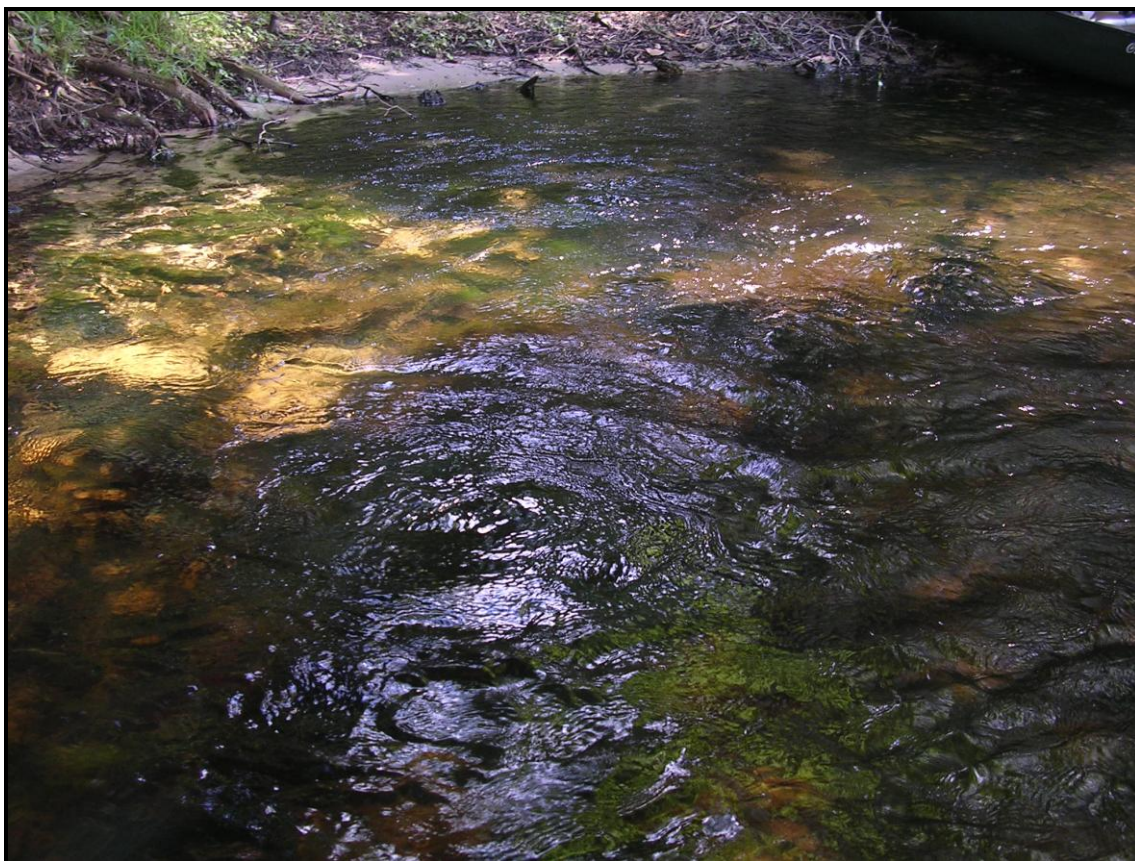
Photo 25. Riverside Spring. Close-up view of the boils. Photo taken on April 30, 2015.

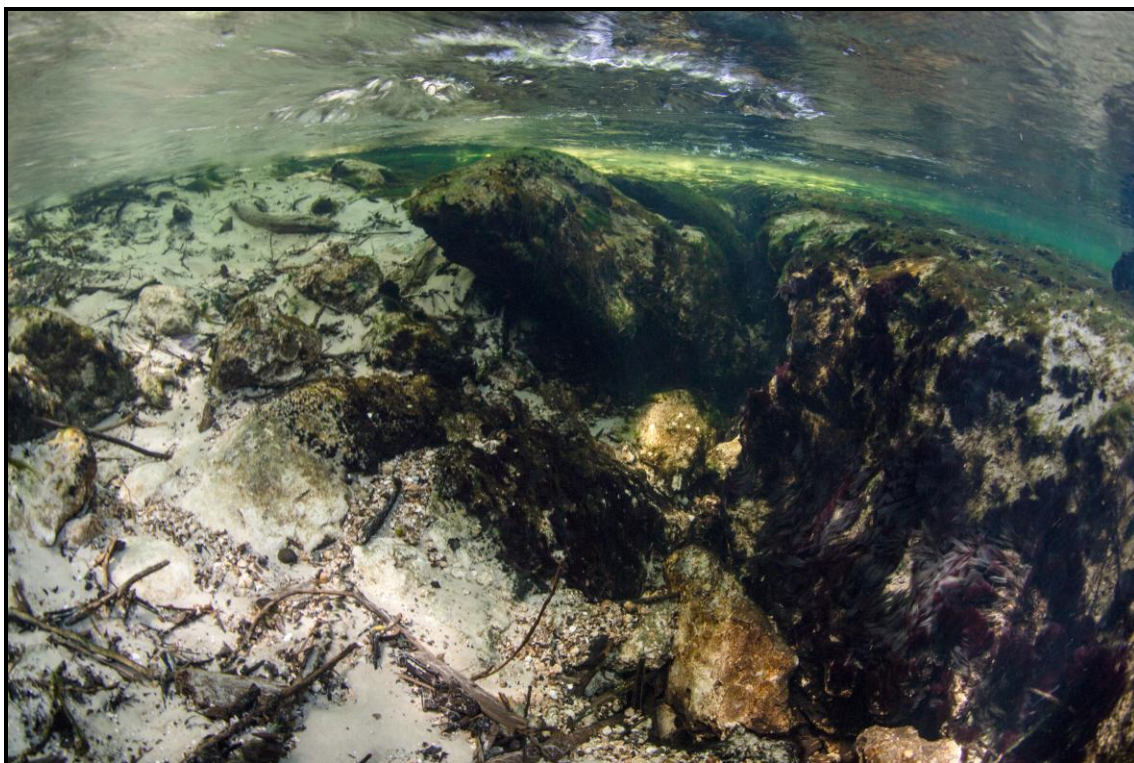
Photo 26. Riverside Spring. Underwater view of the vents. Algal growth is visible on the right vent wall. Photo taken on July 31, 2015 by Jennifer Adler.

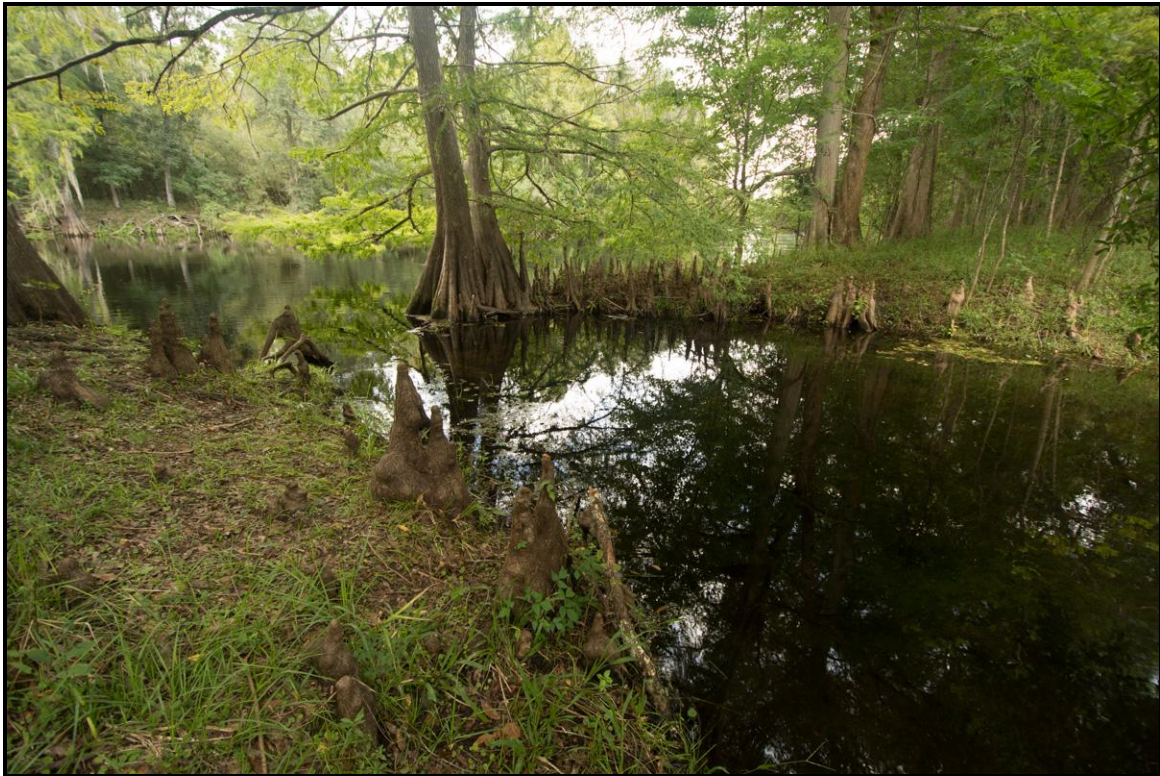
Photo 27. Beaver Pond Spring. Spring vent is in front of cypress knees on the left side of the pond. Photo taken on August 30, 2015.

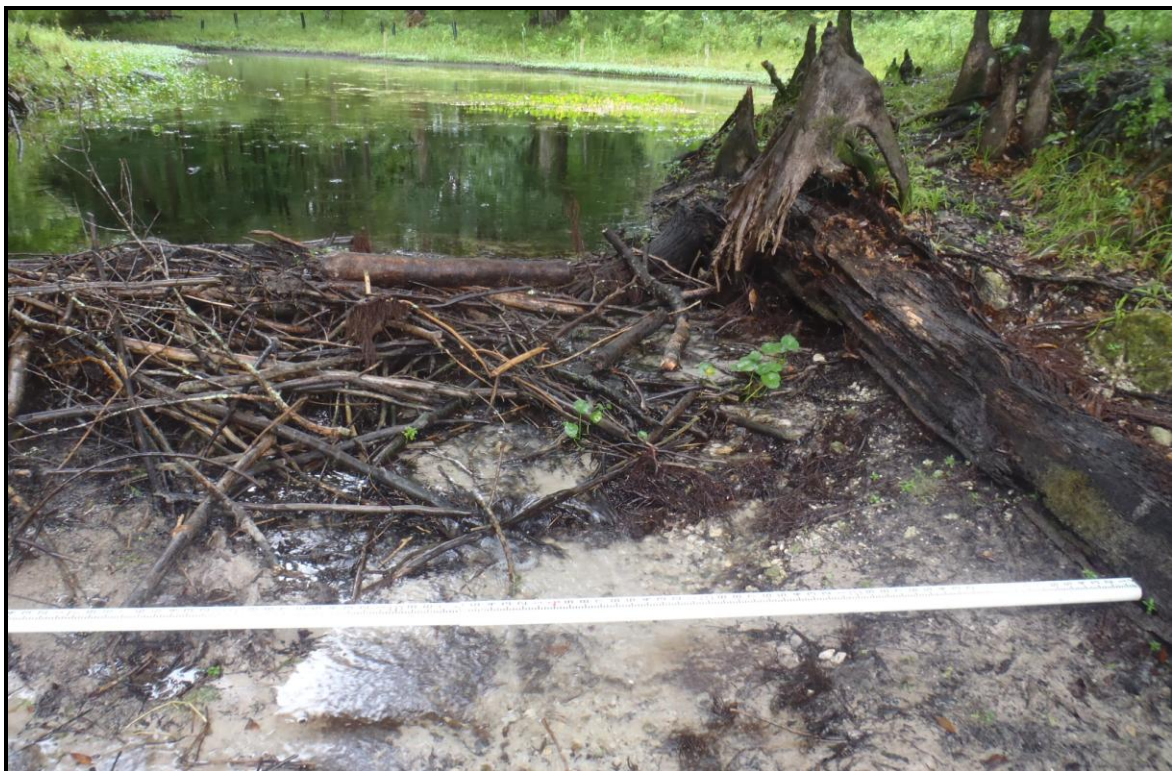
Photo 28. Beaver Pond Spring. Spring vent is located in pond behind cypress knees on right side of photo. Beaver dam and discharge measurement cross-section in the foreground. Photo taken on June 29, 2015 by ACEPD staff.

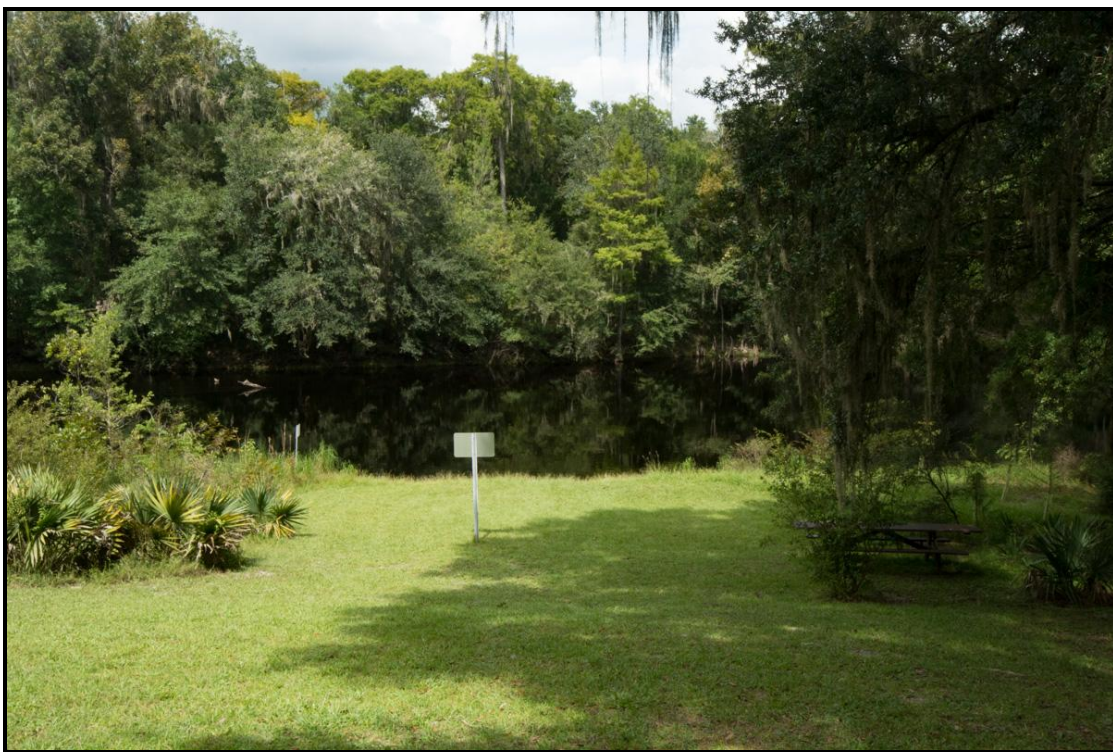
Photo 29. Poe Lodge Vent Pair. These two small vents are on the river bottom just offshore of the clearing. Photo taken on August 30, 2015.

from the cleared area in front of the Poe Springs Lodge. See Figure 4 and Photo 29. They are located on the left side of the channel just offshore of the cleared area east of the park lodge. Each vent is about one foot in diameter. See Photos 30 and 31.

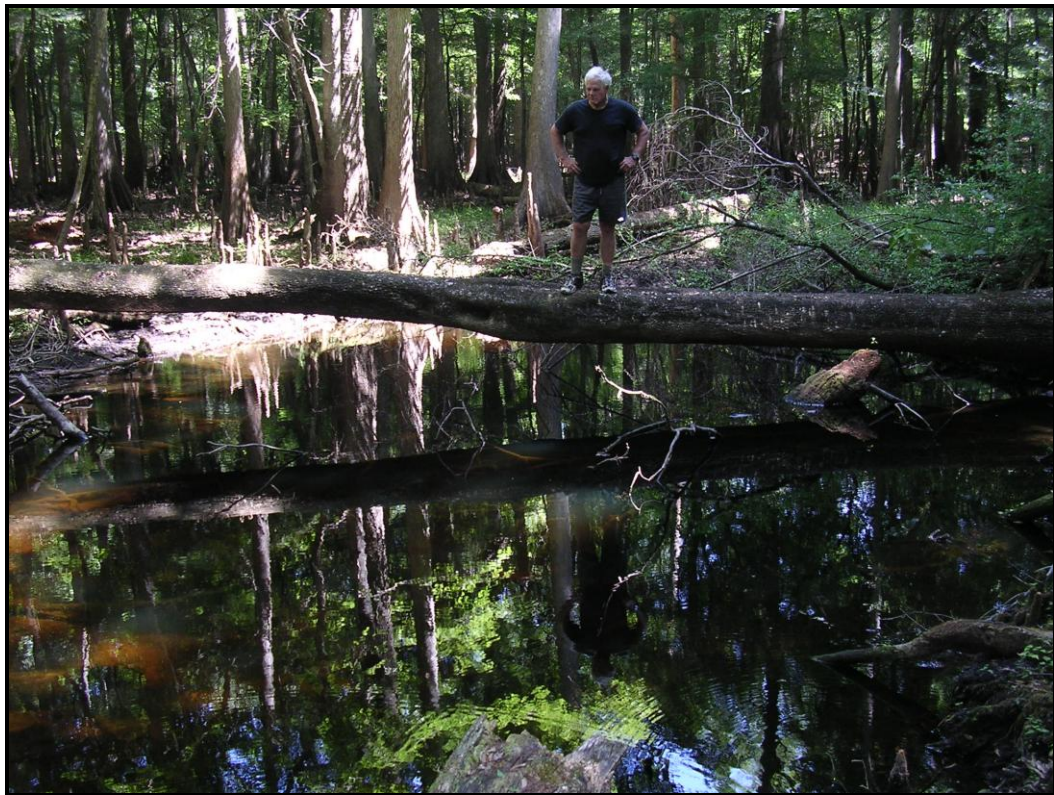
Photo 32. Seven Sisters Spring cluster. One of the larger basins that make up the cluster. Photo taken on May 22, 2015.

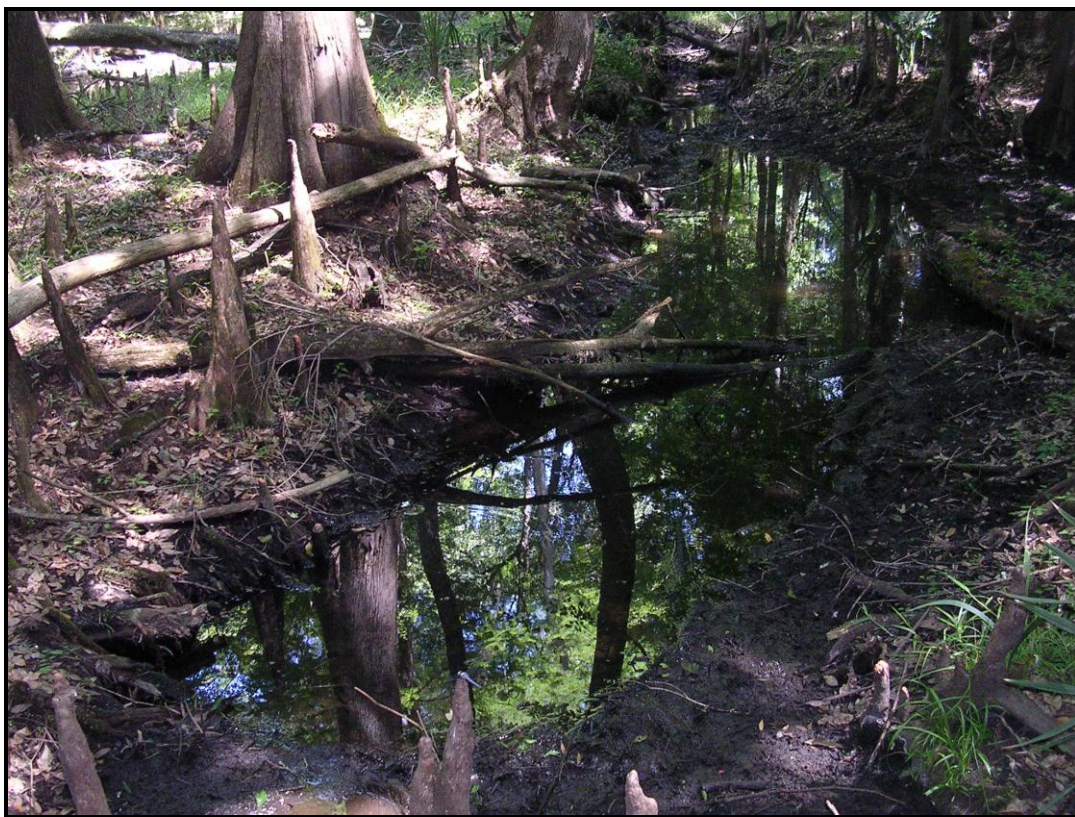
Photo 33. Seven Sisters Spring cluster. One of the linear features that make up the cluster. Photo taken on May 22, 2015.

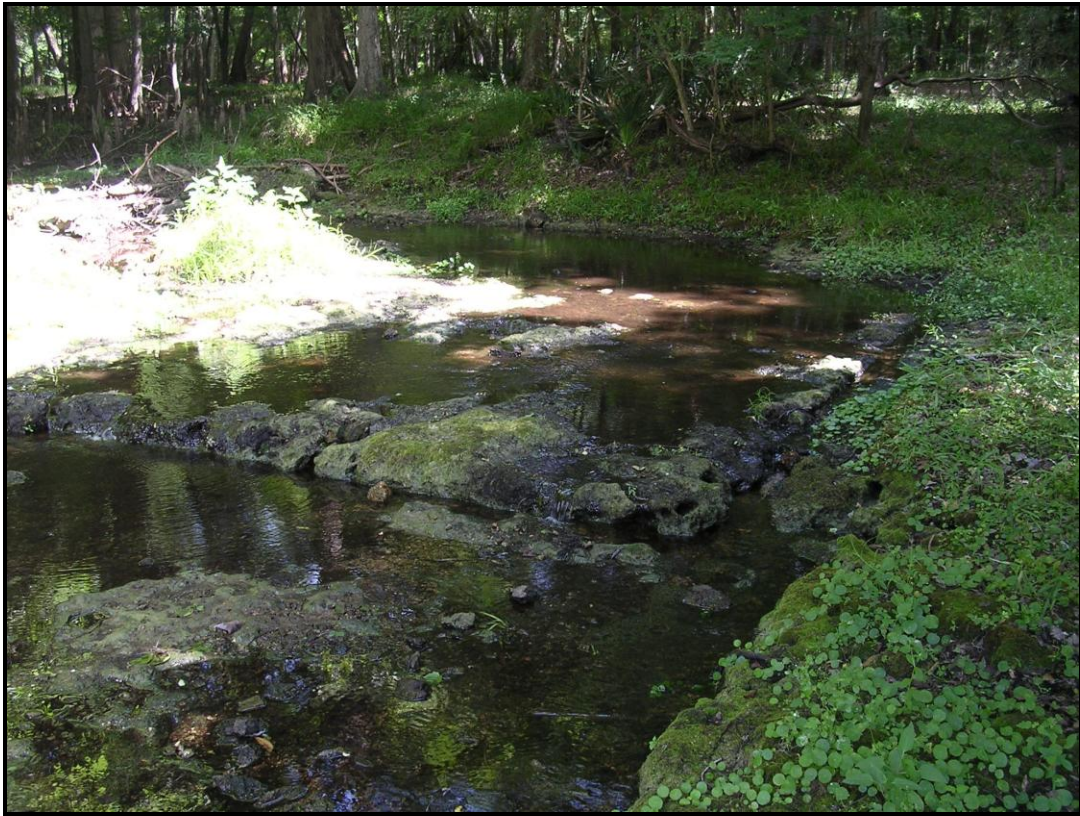
Photo 35. Seven Sisters Spring Run at the Santa Fe River. The bedrock here has been shaped to support a former gristmill dam. Photo taken on May 22, 2015.

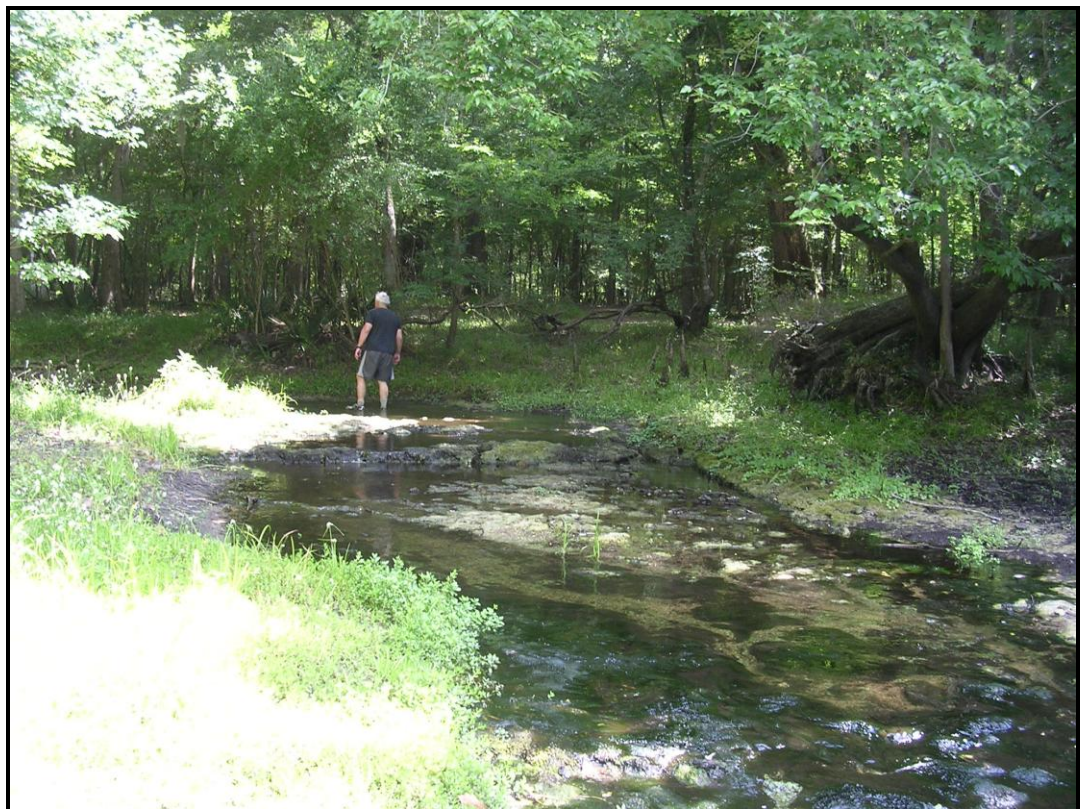
Photo 36. Seven Sisters Spring Run at the Santa Fe River. Photo taken on May 22, 2015.

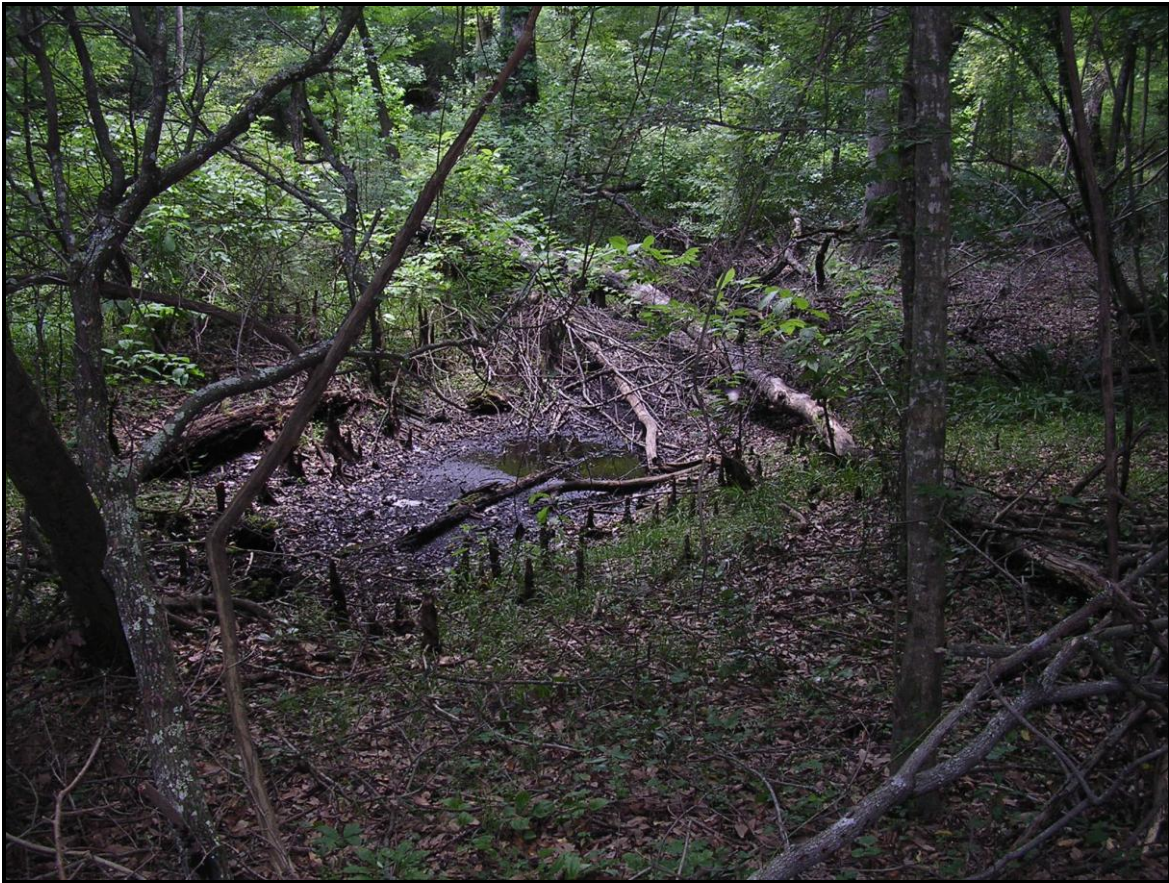
Photo 37. Poe Woods Spring at low river level. Photo taken on June 11, 2015.

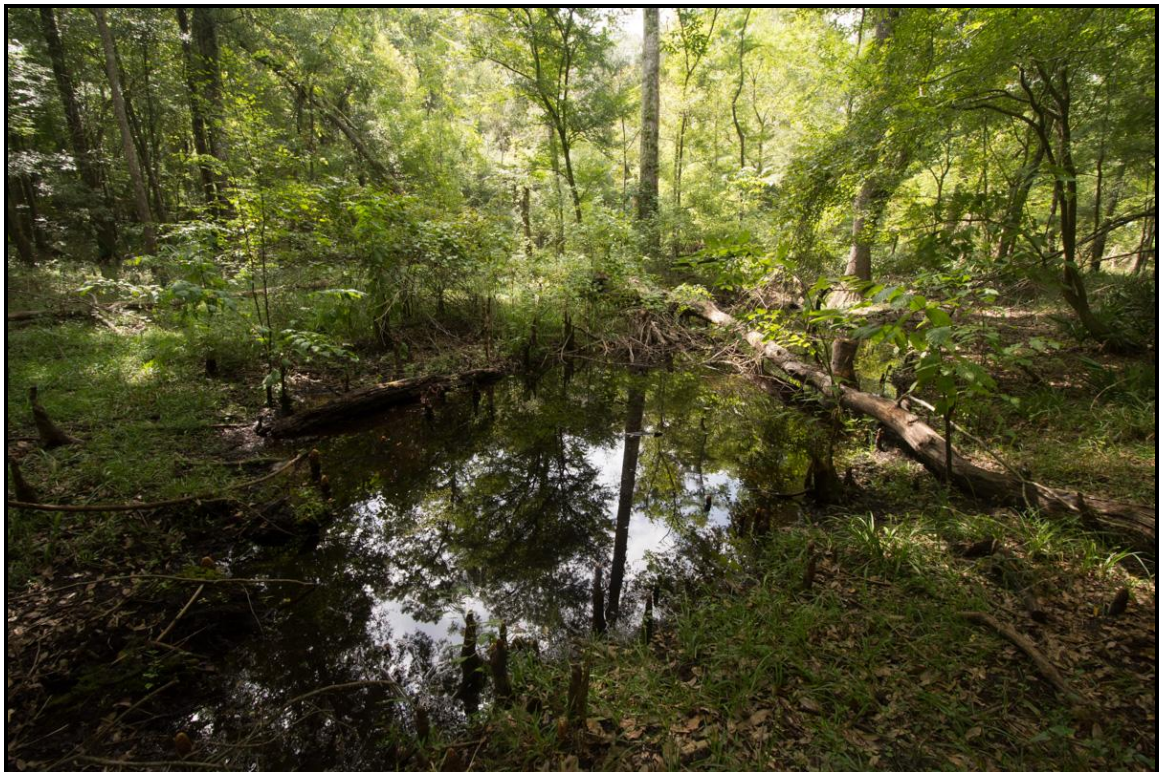
Photo 38. Poe Woods Spring at rising river level. Photo taken on August 30, 2015.

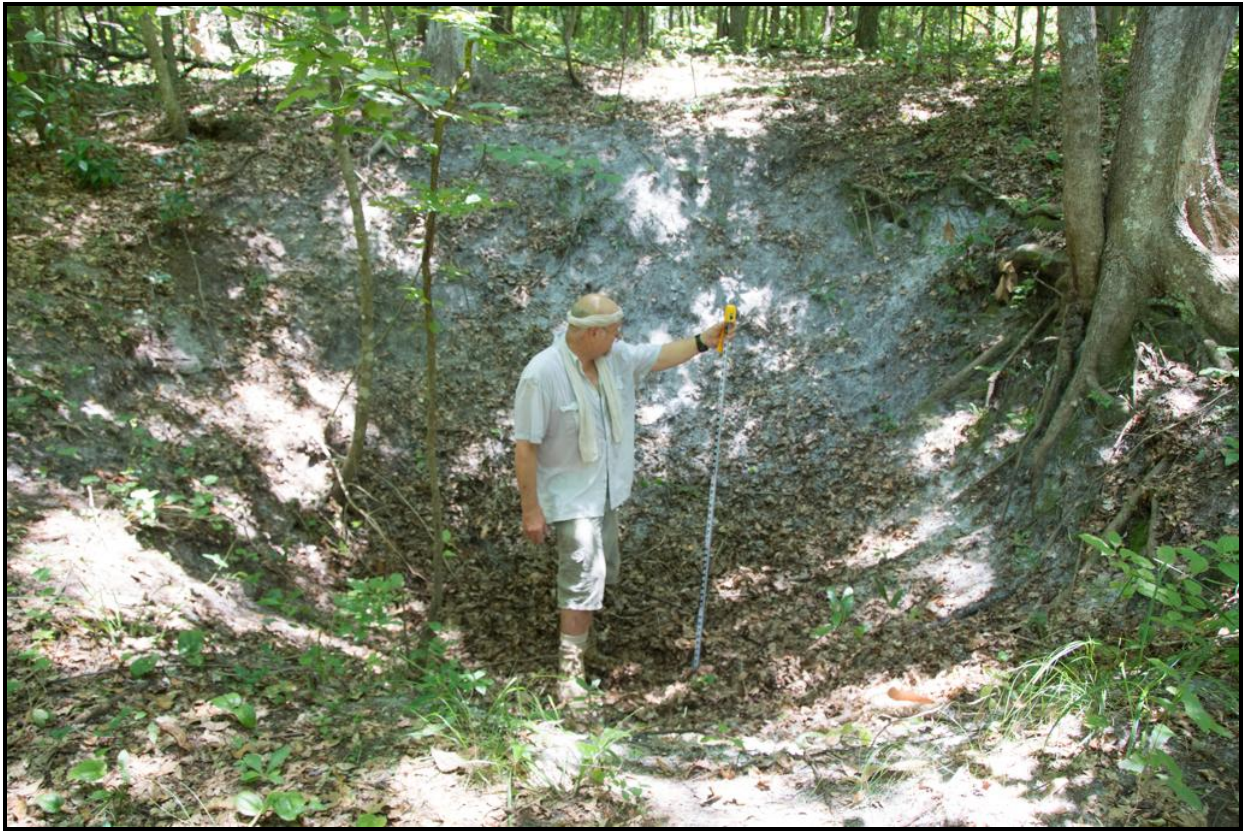
Photo 39. Poe Woods Spring; dry sink on southern slope. Photo taken on June 19, 2015.

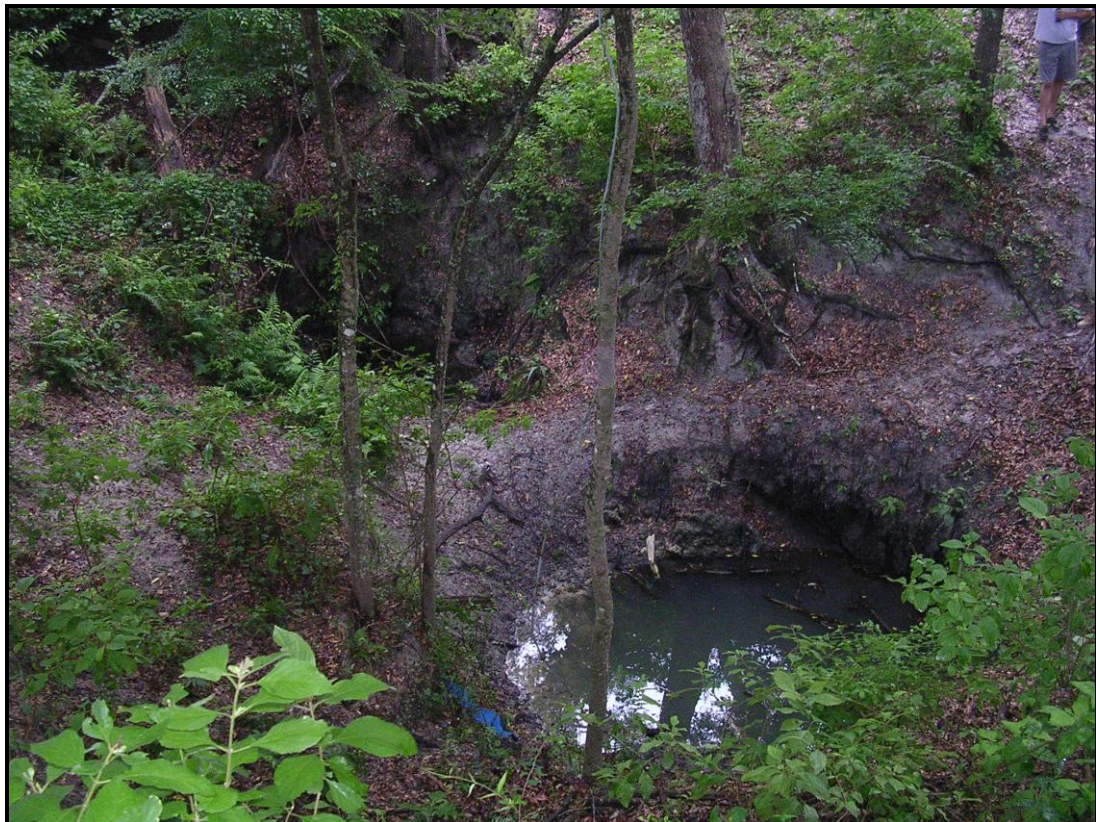
Photo 40. Cave sink south of Poe Springs Road. Photo taken on June 25, 2015.

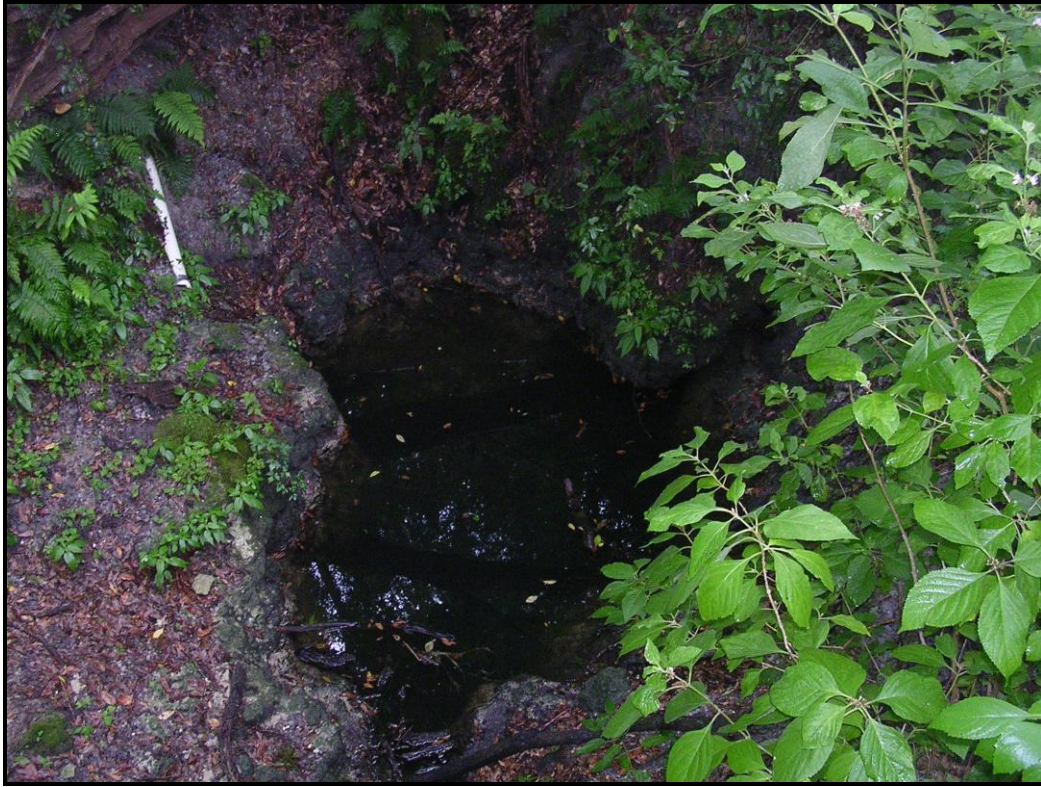
Photo 41. Cave Sink south of Poe Springs Road. A large debris cone lies about 15 feet below the two openings. Photo taken on June 25, 2015.

The large, deep sink identified as 'Cave Sink' has two surface openings at the bottom of the sink that open into a cavern room at least 55 feet deep and about 200 feet in diameter. The water-filled cavern is dominated by a large debris cone about 15 feet deep at its highest point. Cave divers who have visited this site have indicated that water in the cavern has color similar to that of Poe Spring. The elderly owner related to those divers that the site was used in the past as a swimming hole, had clearer water, and was observed to rise and fall with the SFR level.

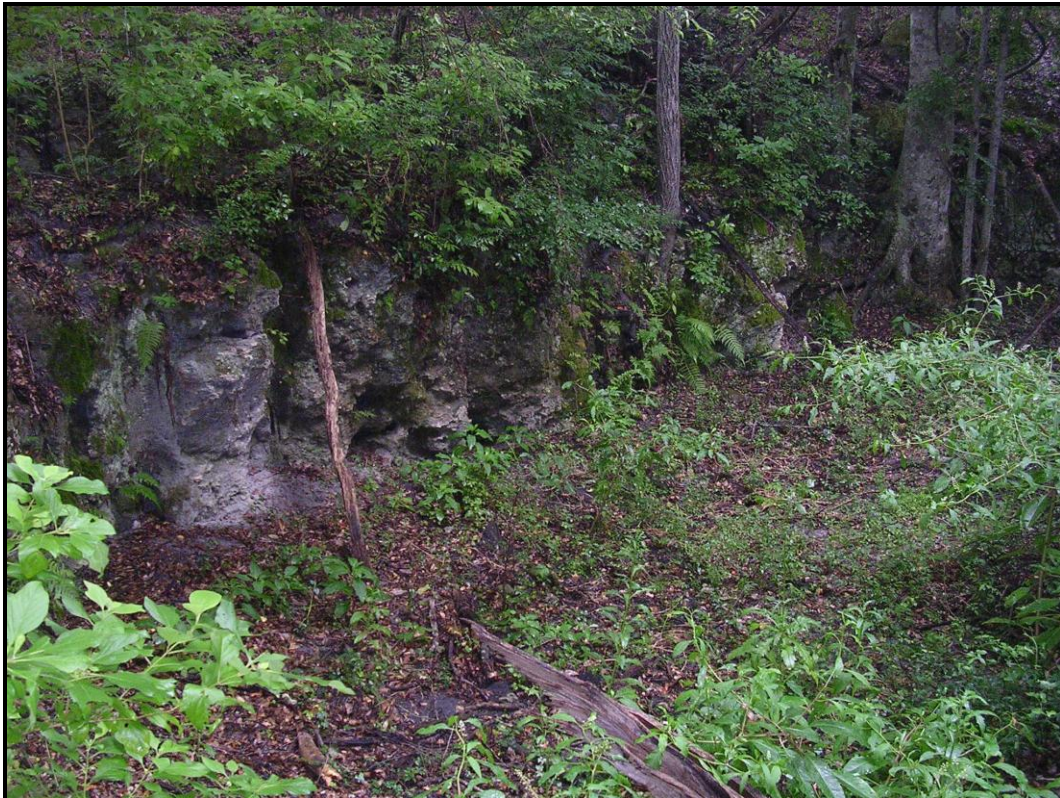
Photo 42. Dry Sink south of Poe Springs Road. A twelve-foot high bedrock wall is on the south side. Photo taken on June 25, 2015.

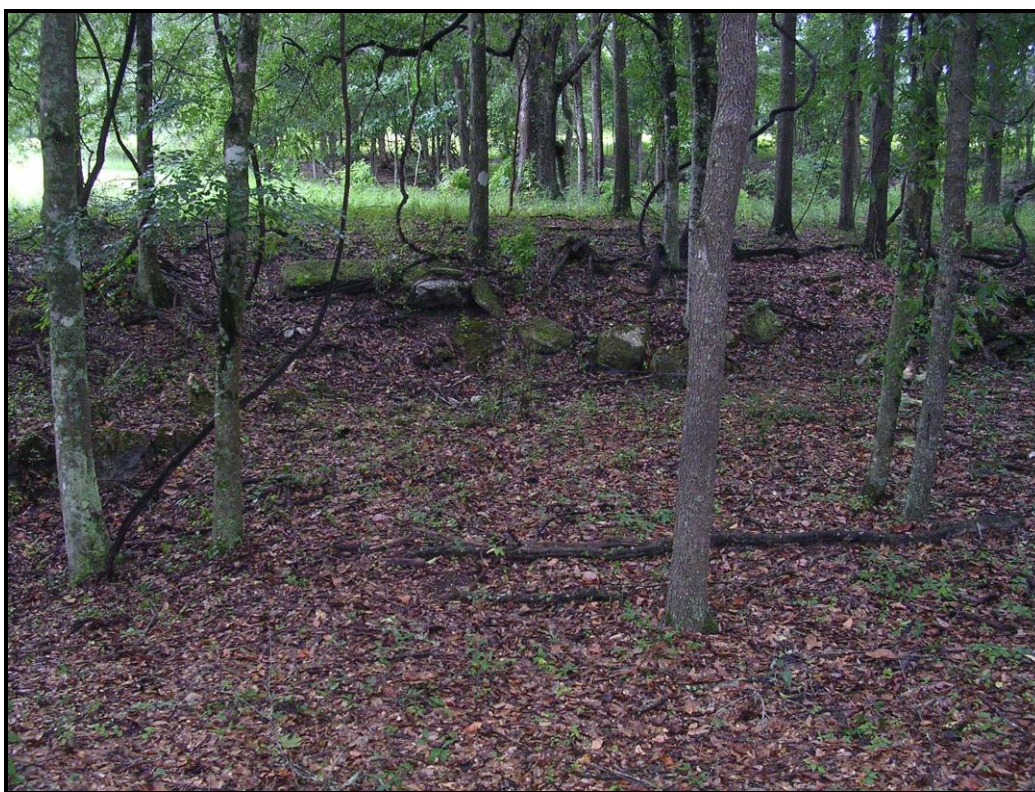
Photo 43. Shallow Dry Sink south of Poe Springs Road. The deeper Dry Sink is visible in the distance. Photo taken on June 25, 2015.

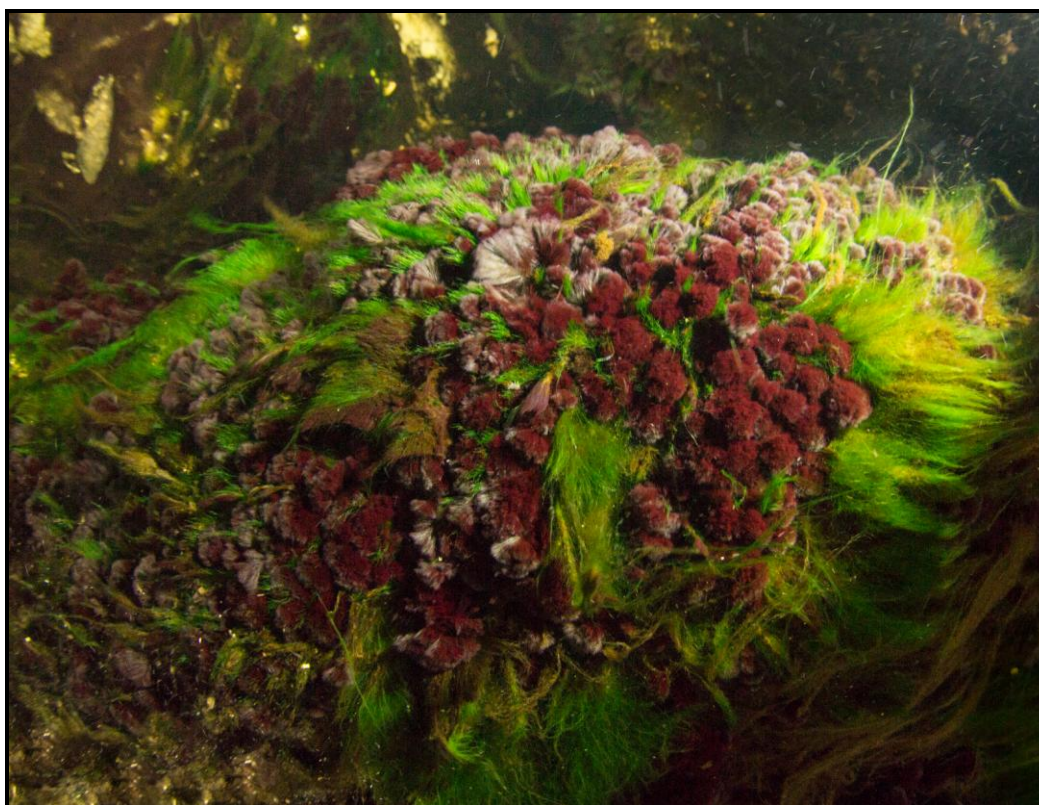
Photo 44. Example of algae growth observed and sampled during the study. Photo taken on July 31, 2015 by Jennifer Adler.

ACEPD staff also collected algae (periphyton) samples from selected springs, and these were delivered to Water & Air Research, Inc. of Gainesville Florida for analysis. Ten periphyton samples collected on July 31, 2015 were analyzed for filamentous algae and chain forming diatoms. Results of the periphyton sampling and analyses are included in Appendix III of this report. See Photo 44 for an example of algae growth observed and sampled.

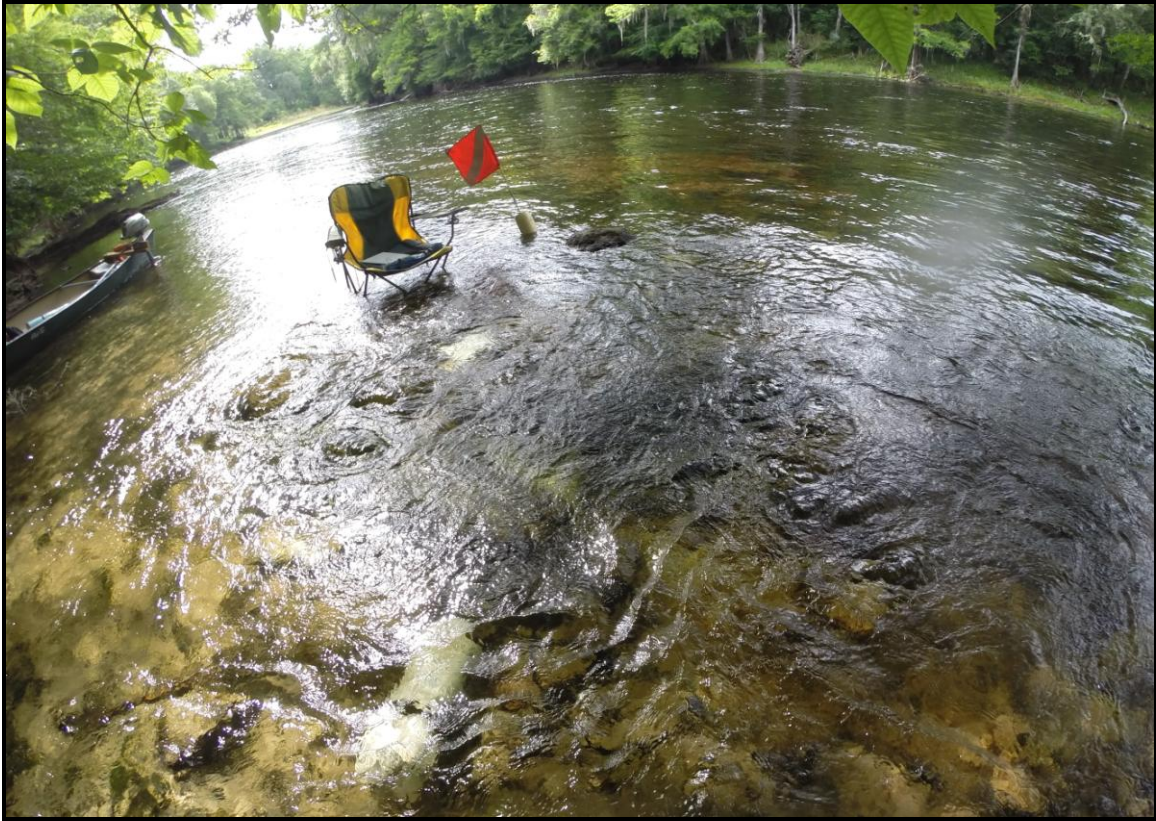
### **DISCHARGE MEASUREMENT: RIVERSIDE SPRING**

**Discharge Measurement:  
Riverside Spring,  
Alachua County, Florida;  
May 5, 2015**
