# POE SPRINGS AREA HYDROLOGIC FEATURES STUDY

Prepared For:  
Alachua County Environmental Protection Department  
408 W. University Avenue, Suite 106  
Gainesville, Florida, 32601

**Karst Environmental Services, Inc.**  
5779 NE County Road 340 High Springs, Florida 32643  
(386) 454-3556    [kes@atlantic.net](mailto:kes@atlantic.net)

**September 24, 2015**

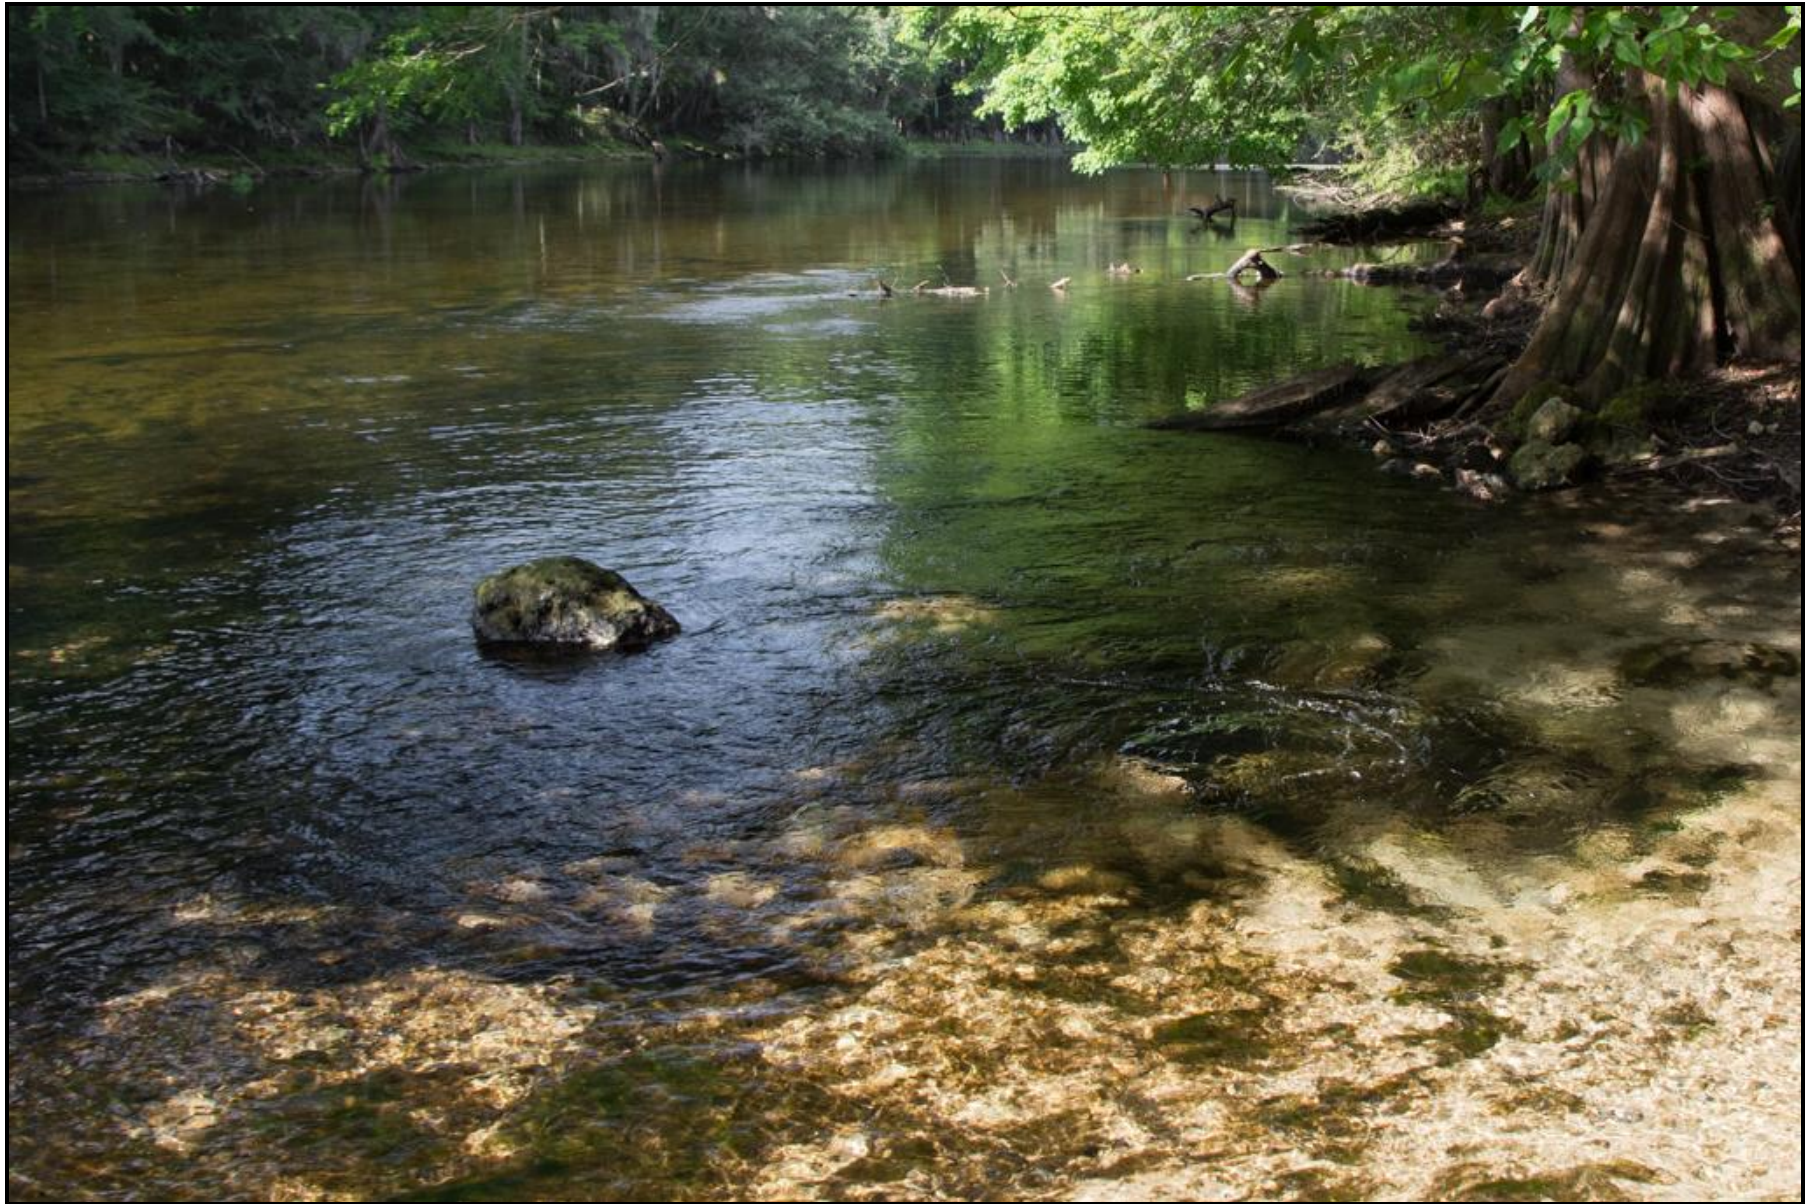
Figure 1. Riverside Spring. This view of Riverside Spring is from the Alachua County bank looking upstream to the Santa Fe River. The spring vents are between the boulder and the bank. Vent A is the prominent boil in the foreground, with the boils from Vents B and C visible behind it.

Riverside Spring is a submerged spring on the bottom of the Santa Fe River. It is located on the left bank of the river, about 320 feet downstream of the mouth of the Poe Spring Run. Under normal conditions, this spring is visible as a pronounced set of boils near the bank. The vents of this spring are formed along a crack in the bare limestone river bottom, with a total length of about 14 feet, lying about 10 feet from the shoreline during normal water level conditions. The maximum depth in the accessible vents is about 4.5 feet. See Figure 1.

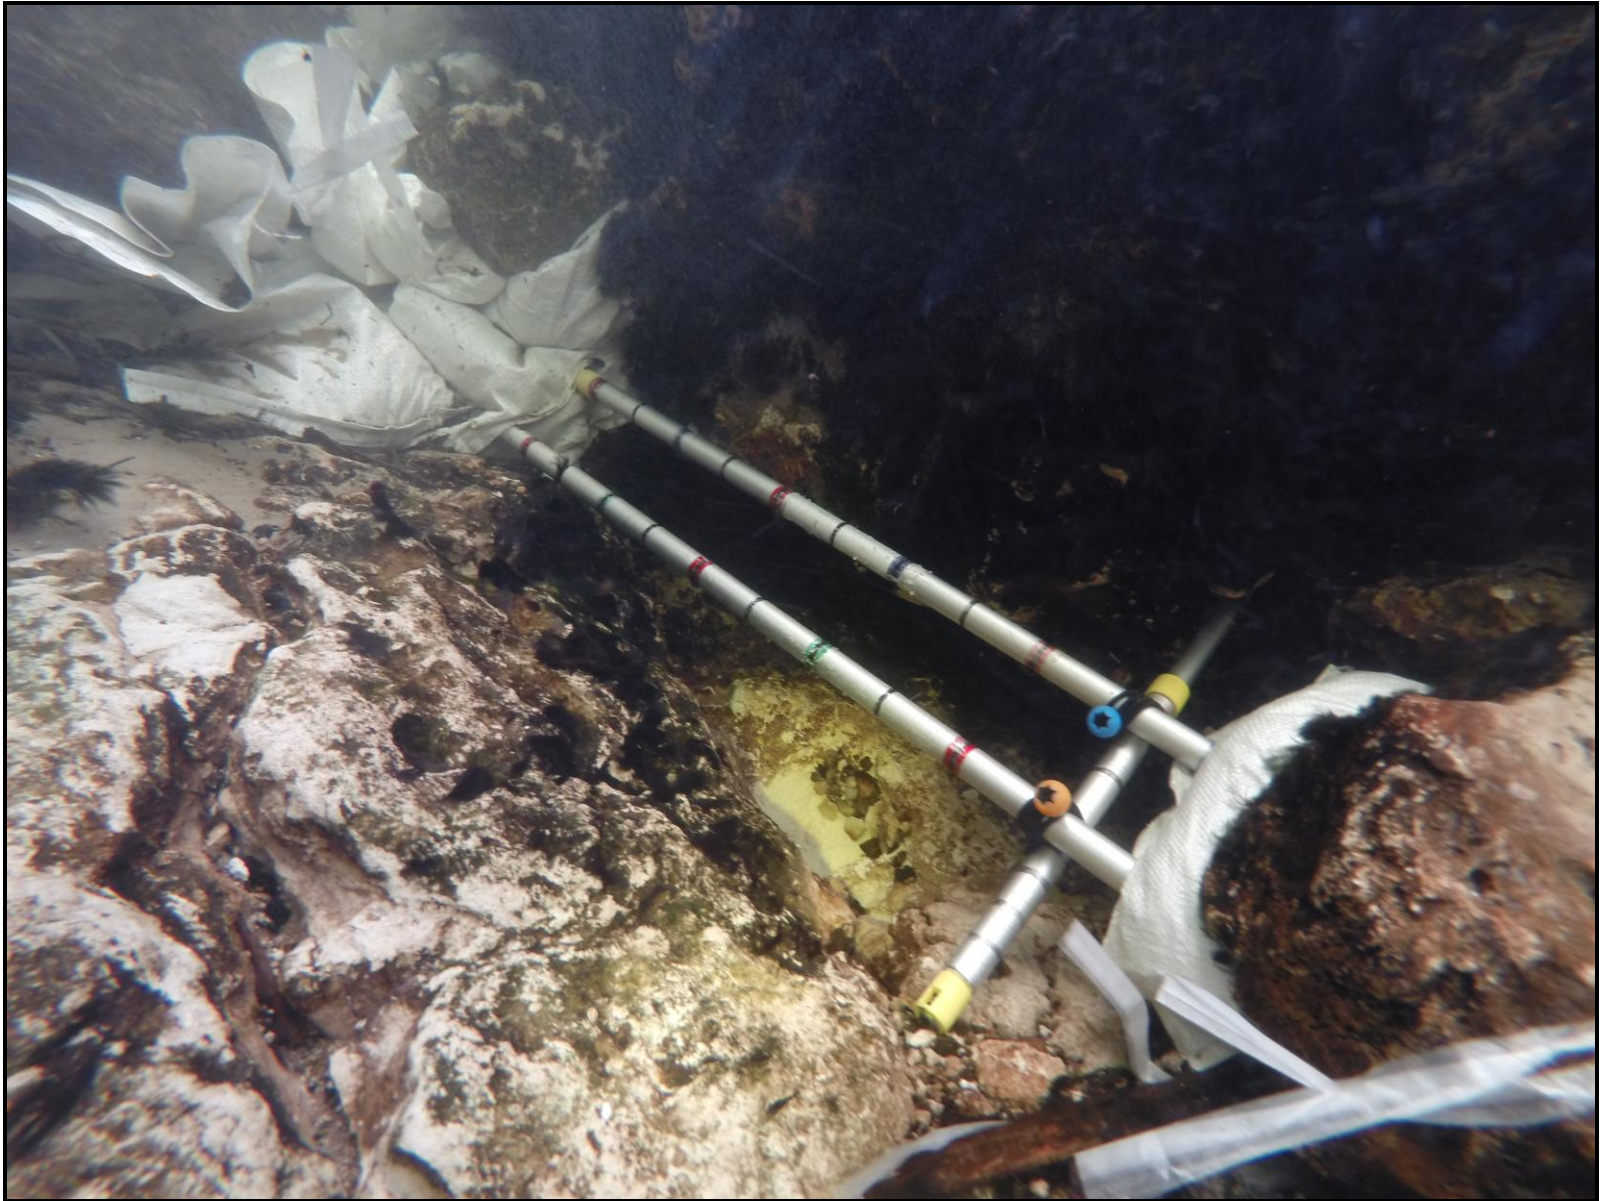
Figure 2C. View of Vent C, Riverside Spring during the May 5, 2015 submerged discharge measurement, showing sensor support poles and gravel bags in place.

This spring consists of a small horizontal vent (Vent A in this report) with an adjacent vent (Vent B) extending along the same crack. The third and largest vent (Vent C) also lies along the crack to the upstream. Since the vents of this spring are located on the floor of the river, its discharge cannot be measured by conventional discharge measurement methods. However, these three horizontal openings, when modified, provided suitable locations for discharge measurements with the application of an appropriately adapted instrument. See Figures 2(ABC).
