## 2.1 Introduction

### 2.2 Watershed Description

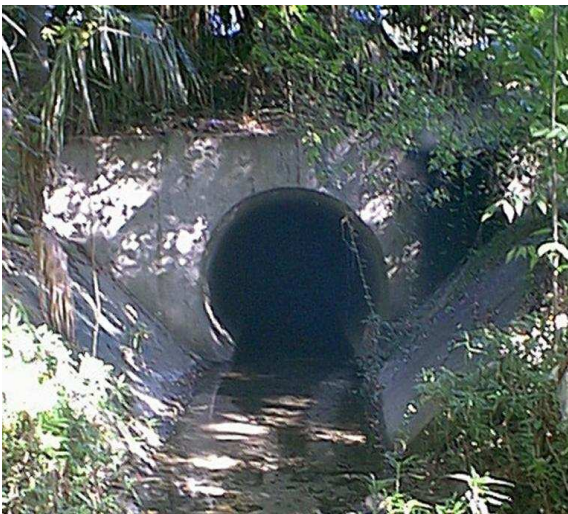
The stream emerges from a 60-inch reinforced concrete pipe (RCP) culvert at the southern end of the Shands at AGH parking area. (Fig. 2.2). The stream flows south through a residential area that includes St. Croix Apartments and several single-family homes. At the end of SW 7<sup>th</sup> Terrace, a 72-inch RCP culvert provides a second source of baseflow to Tumblin Creek. A large deep pool at the base of this culvert, formed by erosion processes, indicates the large volumes of water the culvert inputs to Tumblin Creek during storm events. This confluence occurs at the north end of Tumblin Creek Park, located on the corner of SW 6<sup>th</sup> Street and Depot Avenue. The stream has eroded the banks in the park, exposing landfill debris which includes glass bottles that appear to date from the early 1900's.

Tumblin Creek at the 60-inch culvert at Shands at AGH just north of SW 5<sup>th</sup> Avenue

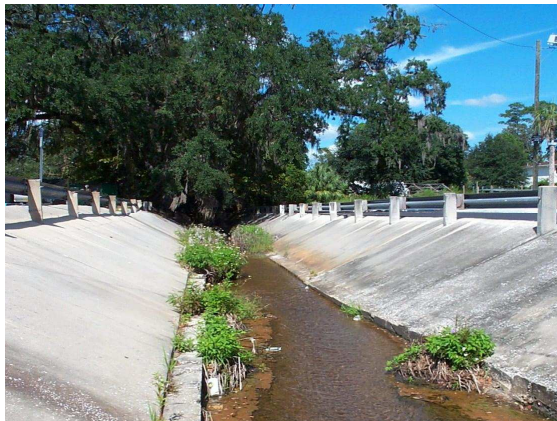
The creek emerges beneath SW 16<sup>th</sup> Avenue in a concrete-lined channel that continues west under US 441 through box culverts. The concrete channel and larger culverts under US 441 were installed in 1969 to increase the stream velocity, thus alleviating the flooding problems of the

**Tumblin Creek flowing through a concrete channel behind Subway at US 441**

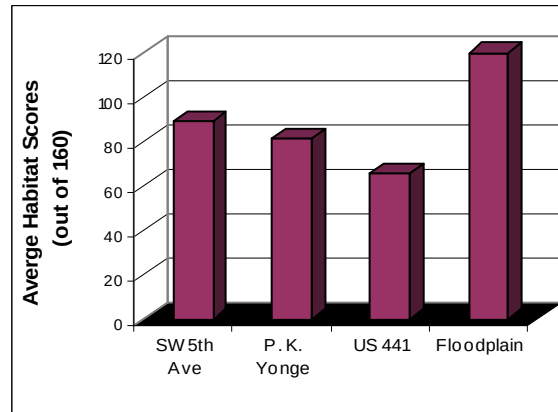
**Figure 2.3 Average Habitat Assessment scores for four sites on Tumblin Creek**

Tumblin Creek at SW 5<sup>th</sup> Avenue scored an average of 89, or 56%, of the total possible score on the Habitat Assessments. It received low scores in the water velocity, riparian buffer zone width, and vegetation quality categories. The overall score would have been even lower if the concrete rubble in the streambed, a decidedly unnatural element, had not been considered a potential substrate for macroinvertebrates. The extremely low BioRecon scores further substantiated the impaired status.

Habitat Assessments at this site resulted in an average score of 81, or 51%. It also received low scores due to slow water ve-

locity, lack of a sufficient riparian zone, and poor quality of vegetation in the riparian zone. This site also has concrete rubble in the streambed, implying the Habitat Assessment score might have been even lower if the rubble had not been considered habitat. BioRecon scores were similarly very poor at this site, indicating an impaired status.

This site received the lowest average Habitat Assessment score of 66, or 41%, of the total possible points. Low scores were received in the following habitat characteristic categories: substrate availability, habitat smothering, artificial channelization, bank stability, riparian zone width, and riparian vegetation quality. Due to these factors, a diverse macroinvertebrate population could not be supported in this degraded stretch of creek as proven by the impaired BioRecon rating.

Tumblin Creek, as it flows through the Bivens Arm floodplain, had the highest average Habitat Assessment score (120) of all sites on Tumblin Creek. However, it too was characterized impaired by the

BioRecon. The primary cause for the impairment is extensive sand smothering.

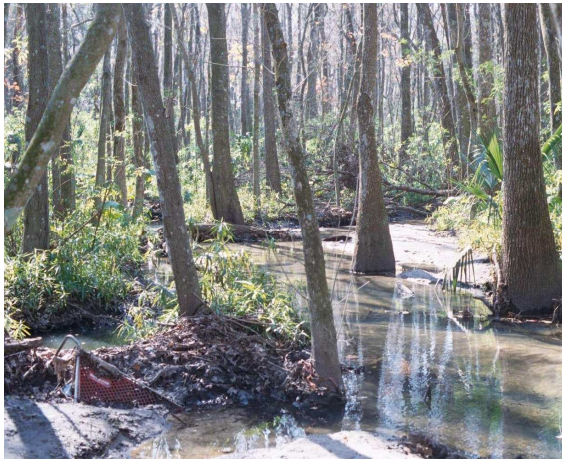
**Bivens Arm forested wetland**

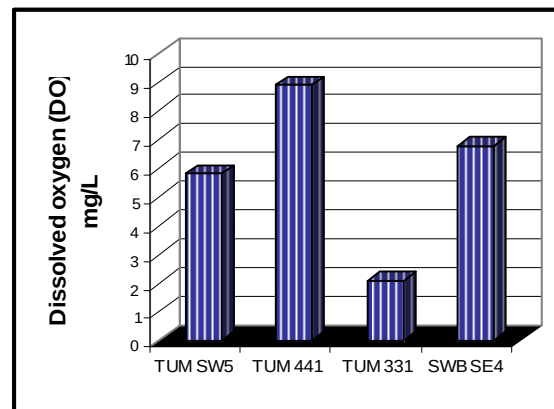
**Figure 2.5 Comparison of median dissolved oxygen (DO) concentrations for the three sites on Tumblin Creek and Sweetwater Branch at SE 4th Street**

Dissolved oxygen (DO) showed high variability in Tumblin Creek (Figure 2.5). The lowest DO of all sites monitored in this study occurred at TUM331, with a median

concentration of 2.13 mg/L. DO is likely reduced as Tumblin Creek flows through the wetlands upstream of TUM331. In contrast, one of the highest DO values in this study occurred on Tumblin Creek at US 441, with a median value of 8.91 mg/L. The DO in the upper part of the watershed, at TUMSW5, was 5.75 mg/L, somewhat lower than the majority of the urban streams in this study.

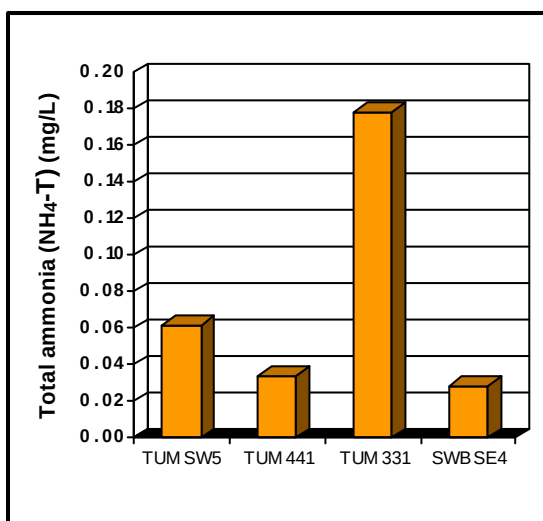
**Figure 2.7** Comparison of median total ammonia ( $\text{NH}_4\text{-T}$ ) concentrations for the three sites on Tumblin Creek and Sweetwater Branch at SE 4th Street

Total ammonia ( $\text{NH}_4\text{-T}$ ) concentrations in Tumblin Creek were higher than almost all other sites in this study. Median total ammonia concentrations in the upper part

of the watershed, at TUMSW5, were 0.062 mg/L (Figure 2.7) which is higher than all other urban stream sites except for Sweetwater Branch at NE 10<sup>th</sup> Avenue. The median total ammonia concentration further downstream at TUM441 was 0.034 mg/L. Median total ammonia concentrations on TUM331, below Bivens Arm, was 0.178 mg/L, the second highest concentration observed in this study. These high concentrations are likely caused by the downstream transport of organic nitrogen compounds from Bivens Arm, which are converted to ammonia by biologic processes in the wetland.

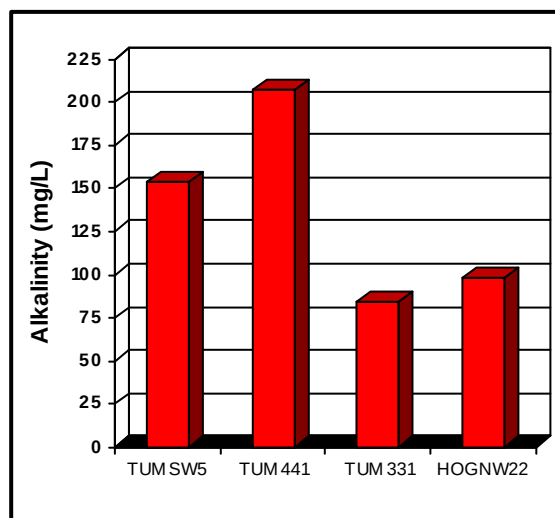
**Figure 2.8** Comparison of median alkalinity for the three sites on Tumblin Creek and Hogtown Creek at NW 22nd Street

Median alkalinity concentrations at both TUMSW5 (153.8 mg/L) and at TUM441

(206.8 mg/L) were substantially higher than all other sites in this study (Figure 2.8). High alkalinities indicate the presence of a high concentration of inorganic carbon (Manahan 1984). In addition, the high alkalinity at TUM441 may have been influenced by the two discharges from the Floridan aquifer.

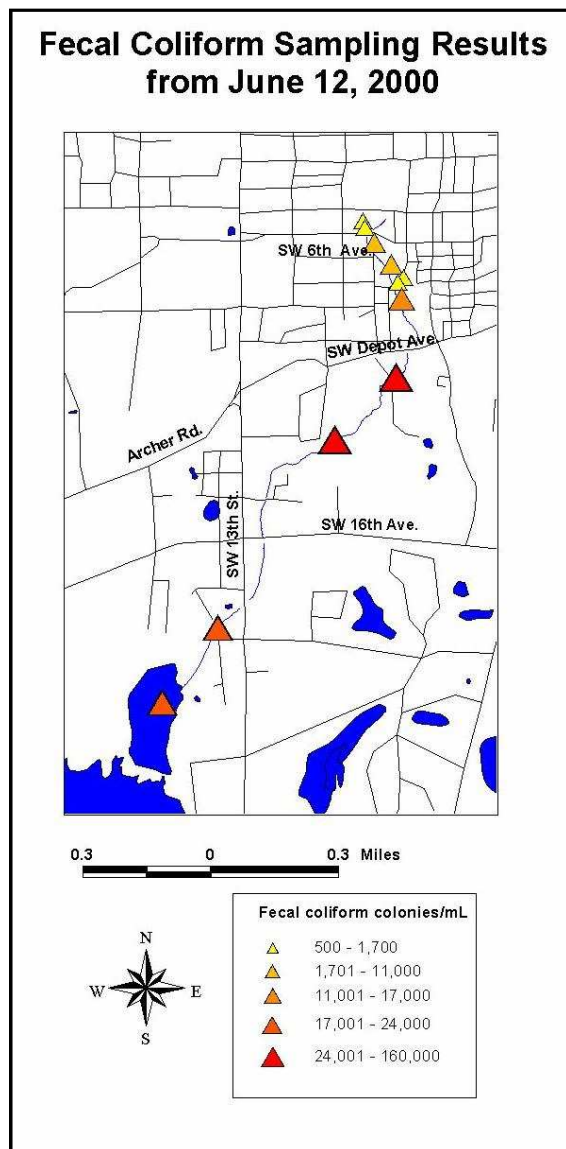
**Figure 2.9 Fecal coliform bacteria sampling results in the Tumblin Creek Watershed from June 12, 2000**

From a human health standpoint, the consistently high levels of fecal coliform bacteria found in Tumblin Creek are the most important water quality concern in the watershed (Figure 2.9). The Class III water quality standards allow for a one time maximum of 800 colony forming units (CFU)/100mL, and a monthly average no greater than 200 CFU/100mL (FDEP 1996a). Sites throughout the Tumblin Creek Watershed all failed to meet this standard and, in some cases, have had levels several orders of magnitude higher than the standard.

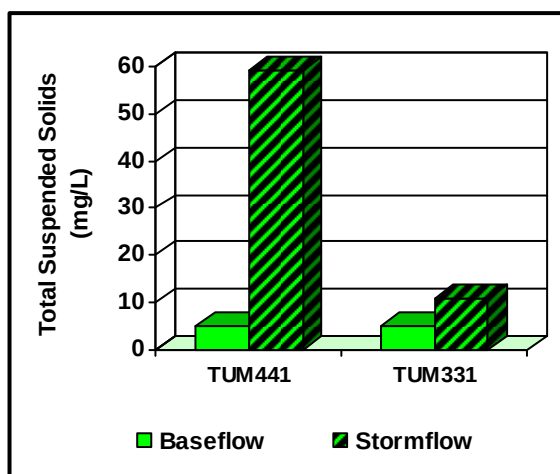
**Figure 2.10** Increase in total suspended solids (TSS) during stormflow compared to baseflow periods in Tumblin Creek

Total suspended solids (TSS) increased by 1,800% at TUM441 during stormflow, compared to median baseflow concentrations (Figure 2.10). This was the second highest percent increase in TSS of all sites monitored in this study; only Possum Creek showed a higher increase in TSS. Median TSS concentrations during stormflow periods were 59 mg/L, compared to the median concentration of 5 mg/L during baseflow periods.

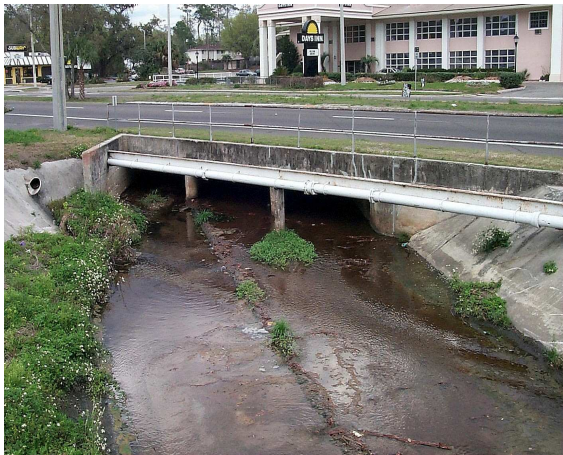
These dramatic increases in total suspended solids, total organic carbon, nitrogen, and phosphorus reflect the highly urbanized nature of this watershed, which includes large areas of impervious surfaces. Surface runoff into Tumblin Creek is significant. Increased stormflow volumes and velocities contribute to greater erosion by widening and deepening the stream channel, resulting in increased suspended sediment in stormflow.

Stormflow on Tumblin Creek at US 441
