9.1 Introduction

9.2 Watershed Description

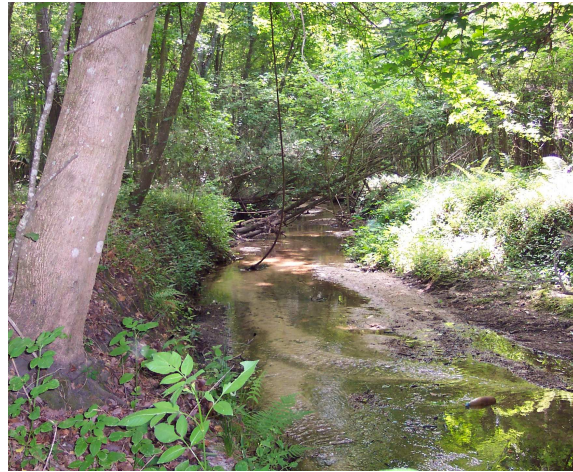
Hogtown Creek at SW 2nd Avenue

Total suspended solids (TSS) increased at the upstream site (HOGNW22) by about 280%, from a median baseflow concentration of 5 mg/L to a median stormflow concentration of 19 mg/L. Further downstream at SW 2nd Avenue, TSS concentrations increased from a median baseflow concentration of 5 mg/L to a median stormflow concentration of 45.5 mg/L, an 810% increase.

A major cause of the higher TSS concentrations at the HOGSW2 during stormflows is likely related to sediment resuspension from sediment accumulated between the weir, NW 34th Street, and SW 2nd Avenue. Additional sediment loads

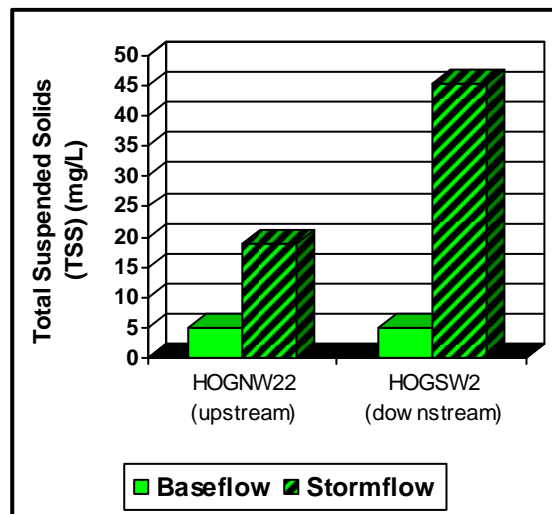
Figure 9.6 Comparison of total suspended solids (TSS) concentrations at two sites on Hogtown Creek during baseflow and stormflow periods

may come from Possum Creek, which joins Hogtown Creek after HOGNW22 but before HOGSW2. HOGSW2 also receives considerable surface runoff from major roadways in the area. These high storm-flow TSS concentrations are indicative of the large volume of sediment in both Hogtown and Possum creeks.

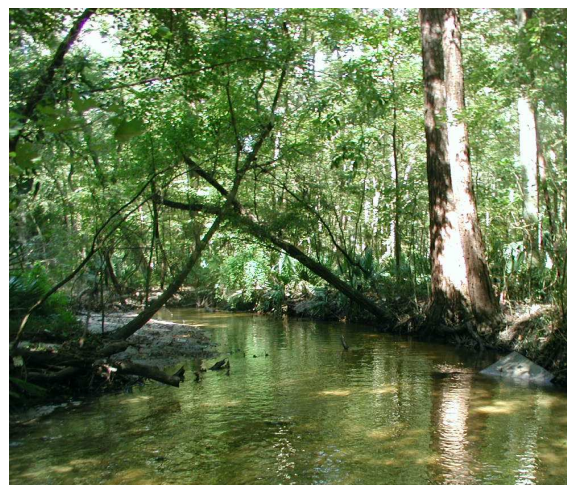
A wide section of the creek, with low banks and some sinuosity

The restoration of floodplain functions would provide significant benefits to reducing stream bank erosion and downstream channel sedimentation. Where possible, creek stormflows should be allowed to flow over the banks and onto the floodplain, where velocities would be reduced and sediment deposited. The design of these floodplain and stream bank reconfiguration projects is critical, as is flood protection in the watershed. Natural stream channel design criteria should guide these floodplain and channel restoration projects.
